MURRAH RIVER REHABILITATION PROJECT

S.Brennan
Southern Rivers Catchment Management Authority

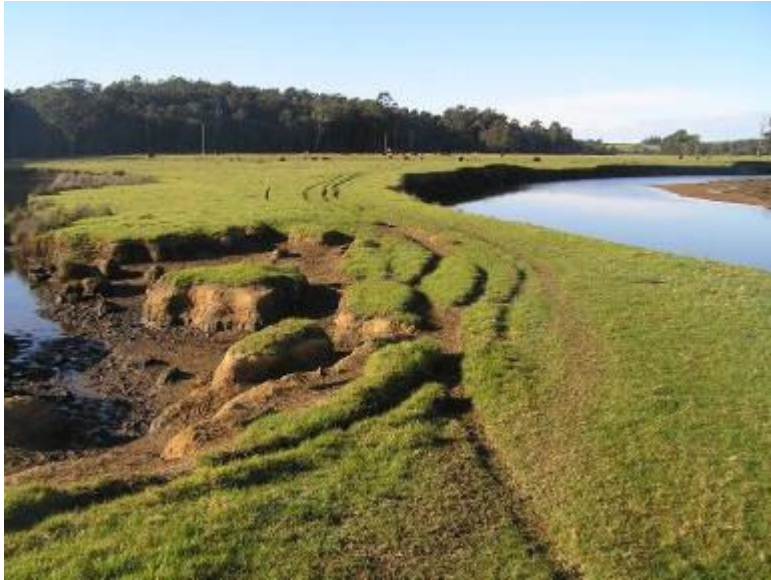
Investigations of the erosion site on initiation of the project identified a degraded condition with significant bank instability, unrestricted stock access and poor riparian vegetation cover (along the banks and floodplain). On-going bank collapse was increasing the risk of avulsion between the main river and a large flood channel which is overtopped during overbank events (see Figure 2).

- flood flows undercutting the bank toe
- lack of floodplain, bank and bed vegetation
- drawdown failure of saturated banks (slumping) on the falling stage of floods
- exposed soils dispersive in fresh (flood) water; and
- wave action largely from wind and boats (boat traffic is largely limited to small tinnies and canoes and traffic rates are low).

Figure 2 – Photo showing erosion, a lack of riparian vegetation and unrestricted stock access along the Murrah River at commencement of the project – at the narrowest point only 4 m of land remained between the main river (on the right) and the top of a flood channel (to the left).

Based on evidence of erosive factors present (e.g. high risk of avulsion and significant toe erosion) it was determined that vegetation and stock exclusion alone would be insufficient in stabilising the banks, particularly on the outer bend. Instead the use of a combination of engineered and revegetation strategies were employed throughout the design.

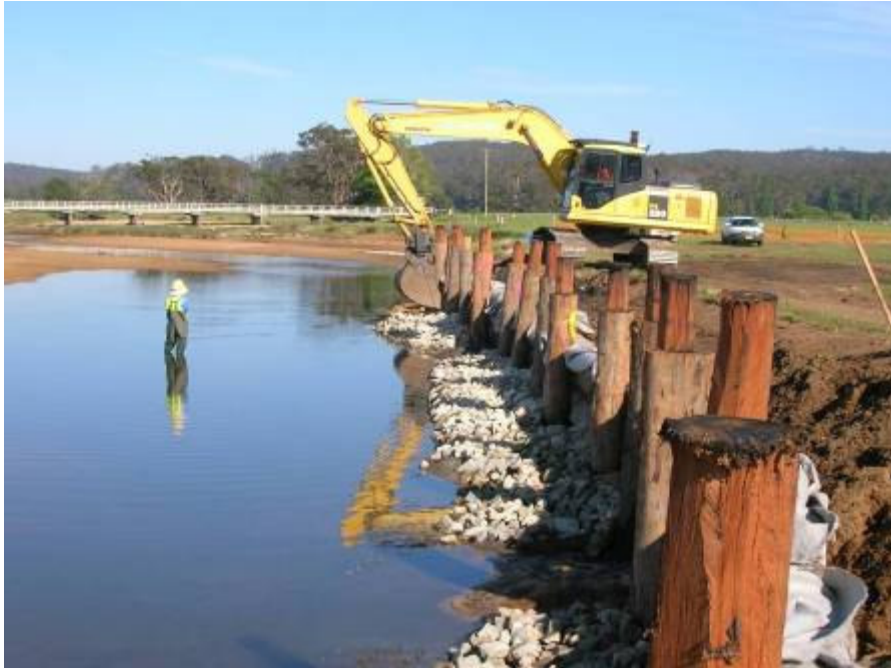
Figure 3 – Log wall construction, Nov 07

- Design: Horizontal logs stacked and held in place with vertical pins. Rock beaching at the toe protects the toe of the wall from scour and increases roughness encouraging deposition. These works were designed to stabilise 70 m of banks most under threat from avulsion.
- Life expectancy: 10 -20 years. Key threat is marine borers. Main timber used was ironbark (for pins) and blue stringy eucalypts.
- Advantages:
 - full bank protection – protects against all causes of erosion
 - enables the bank face to be planted behind the wall
- Disadvantages:

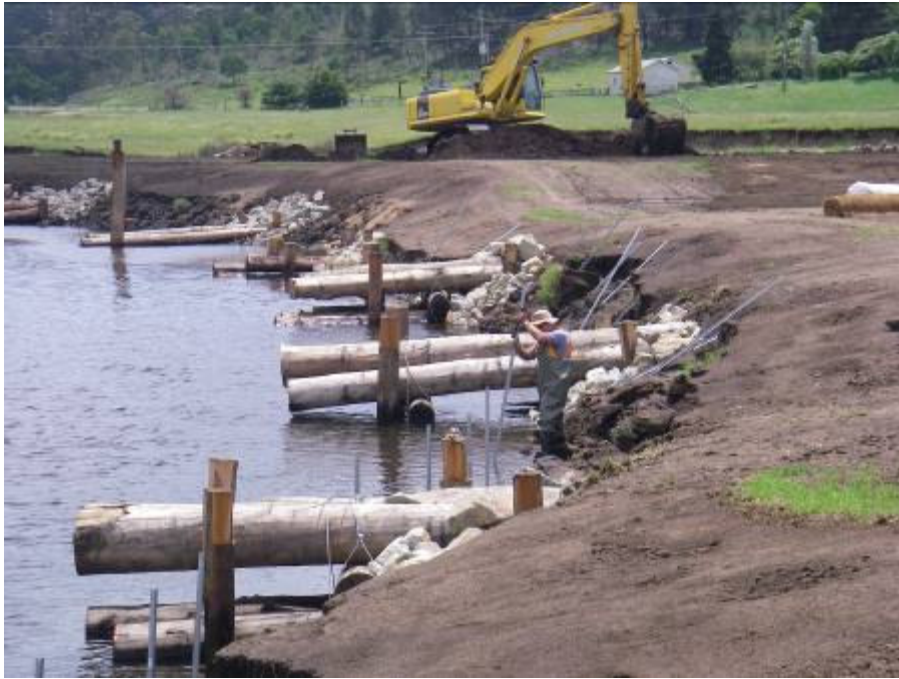
Figure 4a – Fish habitat (in foreground) and bundle groynes (in background) post installation Nov 07

- Design: 19 timber based groynes were installed around 500 m of river bank to assist with protecting banks against erosion from flow. Three types of groyne were installed – fish habitat (logs crossed layered and cabled together), bundle (bundles of logs cabled together – see Figure 4a) and pin (vertical logs driven into the ground – see Figure 4b). The fish habitat and bundle groynes were built on the floodplain and lowered into position using a crane with at least 4 m of log buried into the banks. Pin groynes were driven directly into the ground from the banks. All groynes were aligned on a new curve to direct flow into the middle of the stream.

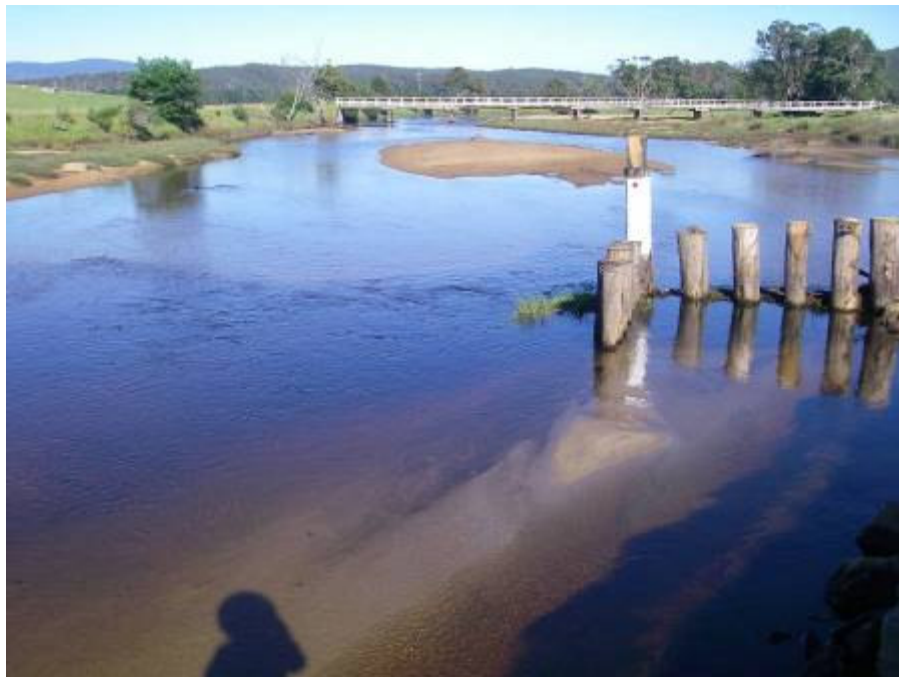
- Life expectancy: 10 -20 years. Key threat is marine borers. The primary timber used was ironbark (for pins).
- Observations to date: Since completion of works, there has been one bankfull event which demonstrated the groynes effectiveness in halting erosion from flow by slowing water between the structures and pushing the main flow into the centre of the channel. The subsequent formation of scour pools up to 2m deep around the ends of groynes (see Figure 4b) and substantial increases in the growth of sea-grass beds where sediments have deposited are key indicators of the current success of these structures.

Figure 4b – Pin groyne and scour pool/sand deposit formed following the first bankfull flow event in Feb 08.

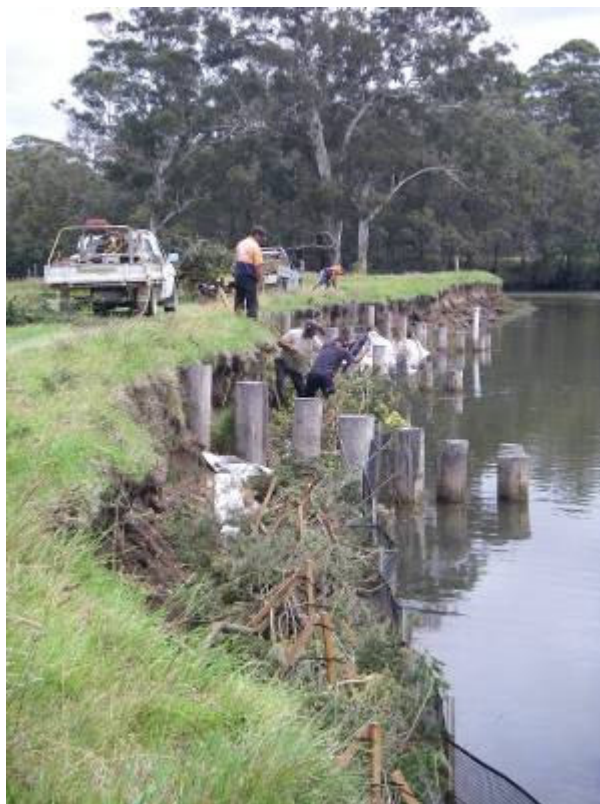
- Observations to date: Whilst there have been no flood events since construction of the bundles they are currently assisting with trapping sediment at the bank toe. Vegetation planted behind the bundles is starting to establish.

Figure 5 – Brush bundles installed along the toe of the banks, Dec 2008

- Design: Bundles of wattle sourced from the landholder's property were tied together with rope and staked into place using hardwood stakes 12 months after completion of stage 1 of the project (timber groynes and log wall). Brush bundles were installed primarily to stabilize the toe of banks that were still eroding from wind erosion between groynes (i.e. where no log wall was constructed – see Figure 5).

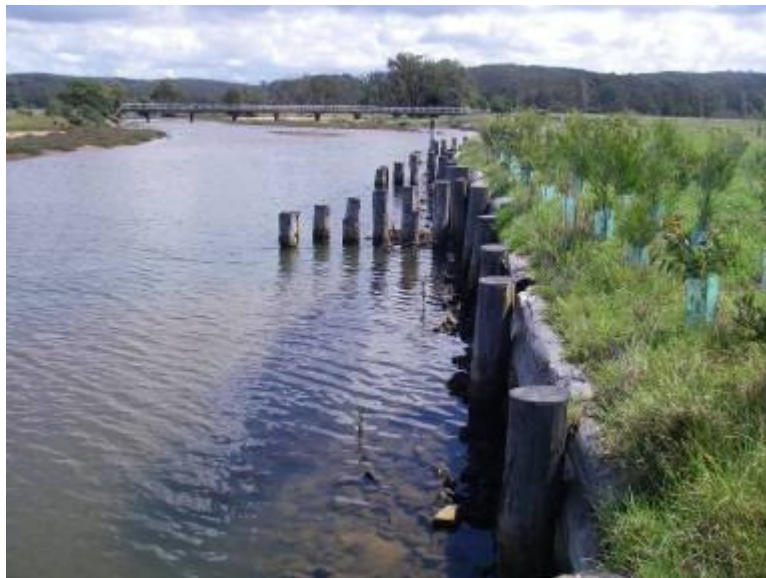
Monitoring to date has shown a 95% success rate achieved with planted floodplain and bank face vegetation using species that were native and endemic to the area. This suggests that the risk of avulsion will be reduced (i.e. by reducing the energy of overbank flows) and that vegetation will play an integral role in maintaining long term stability. Furthermore, the long-term role of vegetation in enhancing floodplain function by trapping and storing sediment in the floodplain zone will assist in protecting the values of the estuary.

Figure 6a – Plants established on the banks above the log wall in March 2009. Also note the young mangrove plants growing through the rock beaching and the sea grass in the water (to the left of the rock beaching).

Revegetation works have also formed an integral part of the project design. In conjunction with stock exclusion fencing, they have been carried out along 3 km of river bank (including the bank face and floodplain – see Figure 6a) to result in a continuous riparian corridor from vegetated reaches upstream of the project site to intact estuarine reaches at the downstream extent.

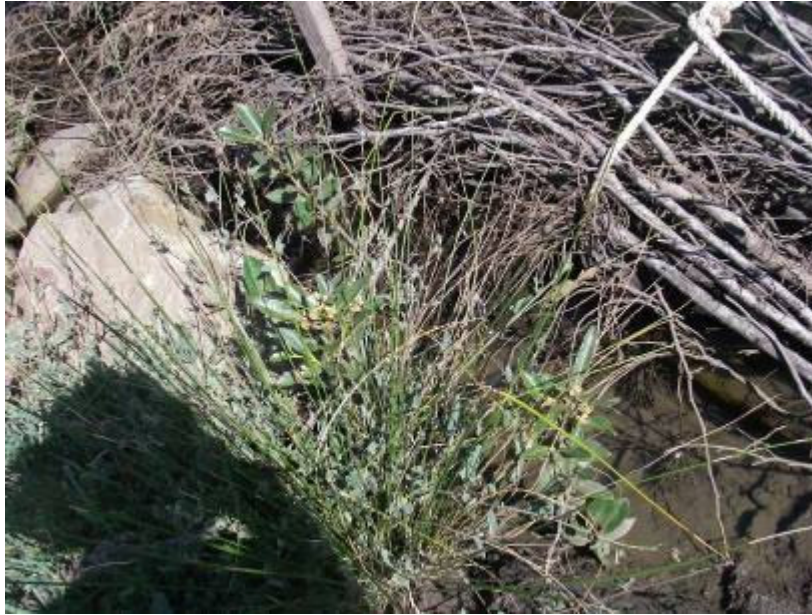
Figure 6b – A mangrove and sea rush plant planted behind a brush bundle, March 2009

In addition to planting along the floodplain, Grey Mangroves (*Avicennia marina*) and Sea Rush (*Juncus kraussii*) were planted along the bank toe upstream of structures and behind brush bundles (see Figure 6b). Results to date have highlighted that mangrove colonization has been very effective from seed, particularly on straighter stream reaches where energy is lower and plants were protected from existing stands of Common Reed (*Phragmites australis*). Sea rush planted from cells have also been effective in establishing at the toe of banks, particularly once brush bundles were installed.
