INVESTIGATING STRATEGIES TO REPAIR HISTORIC TIDE WALLS ON THE CLARENCE RIVER AND ADJACENT BEACH AND RIVER BANK PROTECTION

I Jayewardene¹, A Hartley², B Blumberg¹, E Couriel¹

Abstract

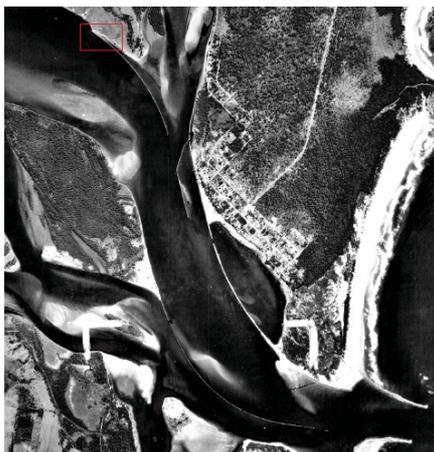
Figure 2: 1966 aerial photo indicating Collis Wall connected to Goodwood Island

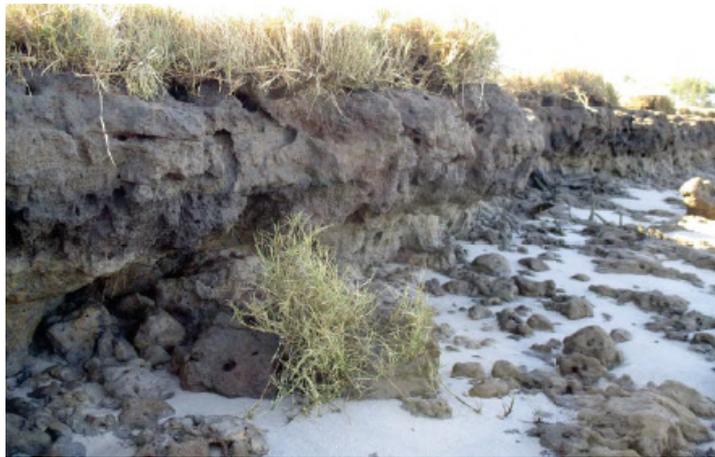
Goodwood Island is experiencing a rapid rate of bank erosion, as evidenced by the steep scarp and loss of vegetation into the river (**Figure 4a**). Discussions with local residents and the harbour master provide further anecdotal evidence that the island is receding. Aerial photos establish that the island was connected to the wall in 1966 (**Figure 2**). The drivers of this recession include tidal and catchment runoff in the river, wind waves generated by strong south to south-easterly winds, and boat wakes.

Figure 4a: Erosion at Goodwood Island

The field visit indicated that there is active bank erosion on the southern side of Goodwood Island (**Figures 4a to 4c**). It is also apparent from the 1949 chart that the line of the bank was much closer to the line of Collis Wall. A review of the available charts and aerial photos from 1949 onwards indicates that there is steady erosion of Goodwood Island, rather than a dramatic erosion starting at a particular time. Further, it can be seen the original location of the Collis channel leads are different from the current location, with the forward lead actually located at the head of Collis Wall. The Goodwood Island reach front lead has also been moved from the crest of Collis Wall to the edge of Goodwood Island between 2009 and 2014, though this lead at the crest of Collis Wall could not be found during the site inspection.

A simple strategy is to armour the banks of Goodwood Island, noting, however, that the property is somewhat diminished in size.

This option is likely to be relatively cheap, as it can be constructed largely from land, by use of backtipping or excavator.

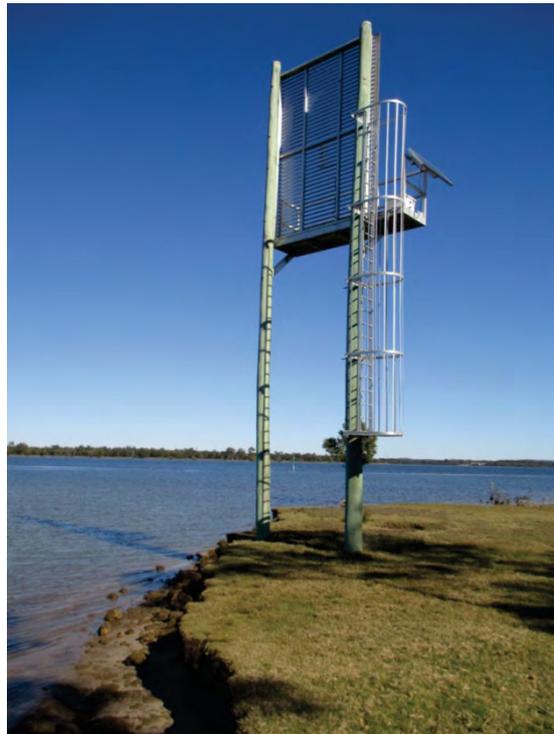
Navigation aids located on Collis Wall and Goodwood Island are at risk due to failure of the wall and significant erosion of the island (**Figure 4a**).

Figure 4b: Imminent danger to navigation aids on Goodwood Island

Associated with the ongoing damage to the wall and island, navigational aids will continue to be damaged through undermining of their foundations.

A relatively simple solution for the support of the navigation aids without extensive repairs to Collis Wall is to drive deep piles for each of the aids. The piles would need to be sufficiently deep to allow future erosion, so a design will need to estimate the maximum rate of erosion.

The use of piles may be much cheaper than rock rubble solutions for protection of the navigation markers, though mobilisation may be expensive. Piles may have to be moved if the channel migrates over time, particularly if the effectiveness of the Collis Wall diminishes over time if not repaired.

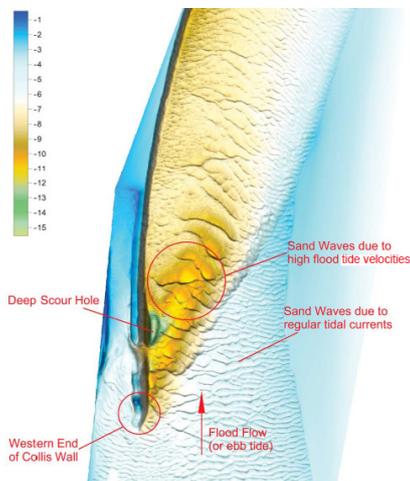
Collis Wall is experiencing ongoing damage to both the western and southern ends of the wall. This is progressive damage that has been shortening the wall at each end over approximately the last five to ten years as evidenced by recent aerial photos and bathymetry and profile measurements (**Figure 3–Figure 5**).

Figure 5: Scour processes indicated by bathymetry measurements in 2015

The impact of catchment runoff is clearly evident in recent high resolution bathymetric scans of the river bed (see **Figure 5**). The scour pattern shows deep and long sand waves, indicating either very fast or turbulent flows in this region. The bathymetry and levels indicated the following:

- The large scour hole present immediately adjacent to the half-tide peak of the wall is very deep, approximately –15 m AHD. This is much lower (by 3–4 m) than any recorded depth in the earlier surveys. The April 2007 survey did record a depth of 12.4 m in a similar area.
- The scour hole appears to be moving with collapsed head. The western 120 m of Collis Wall has been damaged in this way.
- A long section of wall (150 m) is then subject to scour depths of around –14 m AHD. This has caused a destabilisation of the rock wall, with the southern end of the wall collapsing into the scour hole. Approximately 60 m of crest length (**Figure 5**) has been lost in this way.

A well designed scour blanket is an effective tool in mitigating scour that may undermine a structure. Without scour protection of some form it is highly likely that Collis Wall will be further damaged by future flood events. This is recommended regardless of any of the other repair options selected, and can be implemented in conjunction with any of the other recommendations.

The actual toe depth of the original structure is not known. This information would be useful in determining the extent of scour blanket required, however, it can reasonably be assumed that the majority of the length of the wall is at risk. So it is recommended scour protection be added to the full length of the river side (south-western side) of the wall.

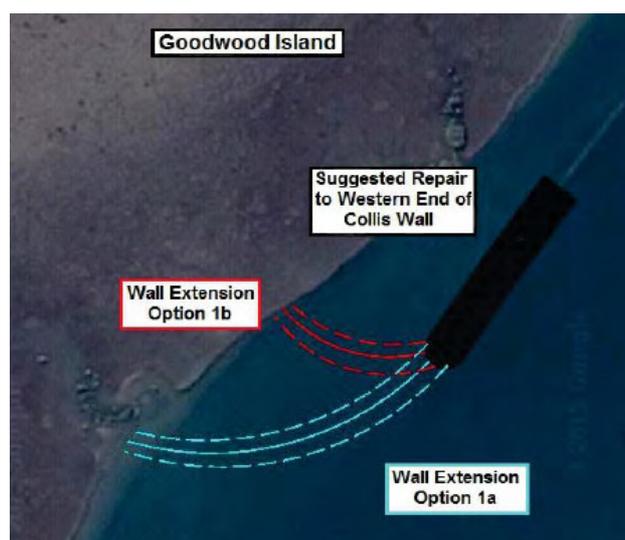
Dredging in close proximity to the wall may have influenced the sediment available for recovery of the bed between flood events. Future strategies to reduce erosion of the Goodwood Island river bank in close proximity to the wall could be centred around dredge spoil being disposed on the river bank and enclosed by a repaired wall (**Figure 7**).

Figure 7: Extension of wall to protect erosion at Goodwood Island
