# **RISK ASSESSMENT METHODS FOR ASSESSING EROSION PROTECTION STRUCTURES – BYRON BAY CASE STUDY**

**Adamantidis, C. A. (WorleyParsons)**

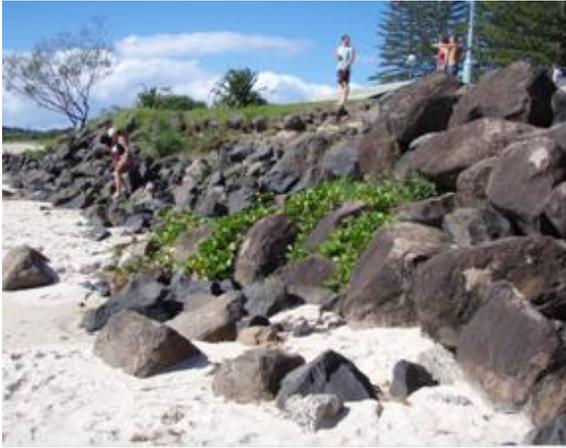
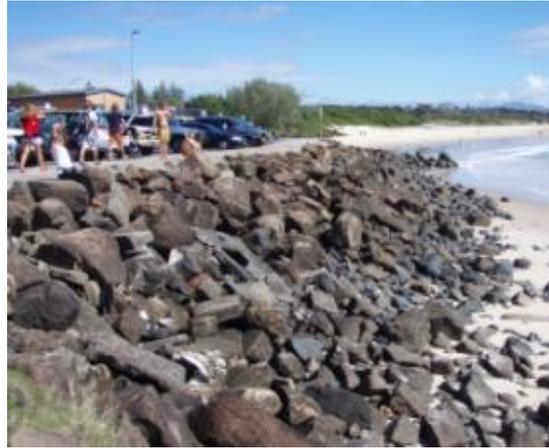
**Figure 2** – Jonson Street Protection Works – left – looking south; right – looking north from carpark.

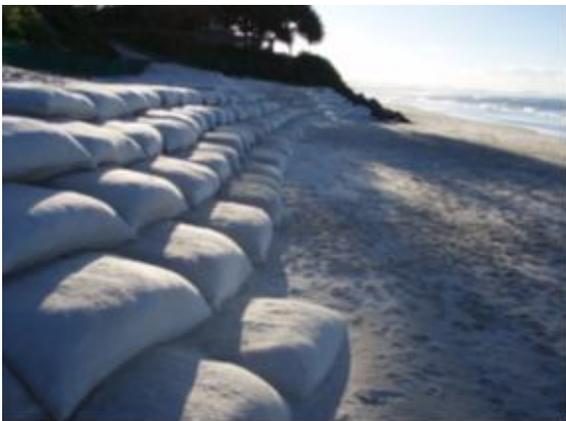
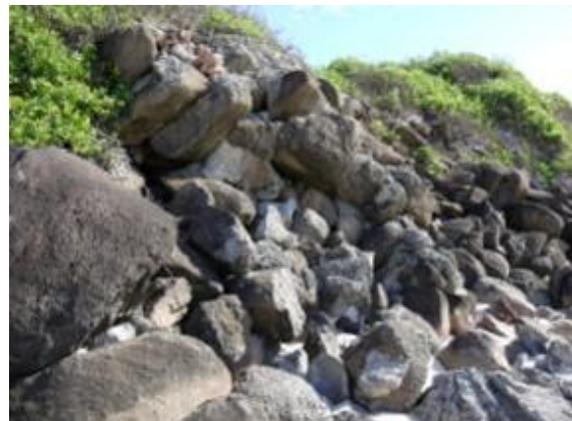
**Figure 3** – Left – Border Street interim protection works; Right – ad-hoc rock protection in Border Street area

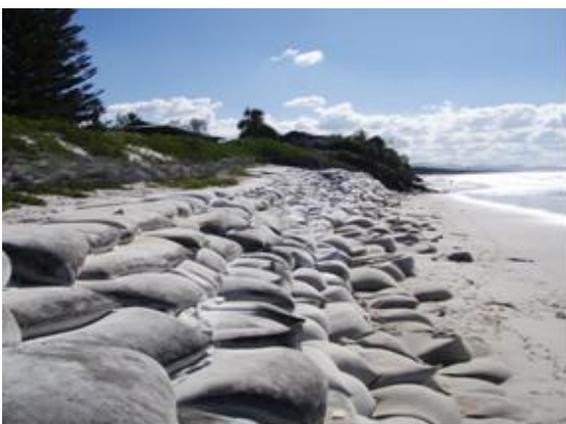
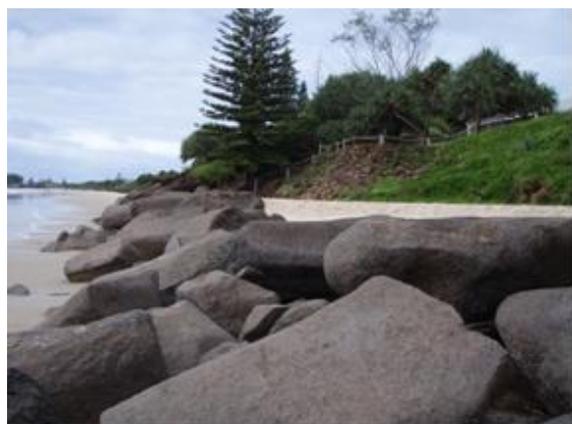
**Figure 4** – Left – Manfred Street interim protection works in July 2012 (prior to their collapse in January 2013); Right – rock protection near Manfred Street, looking south

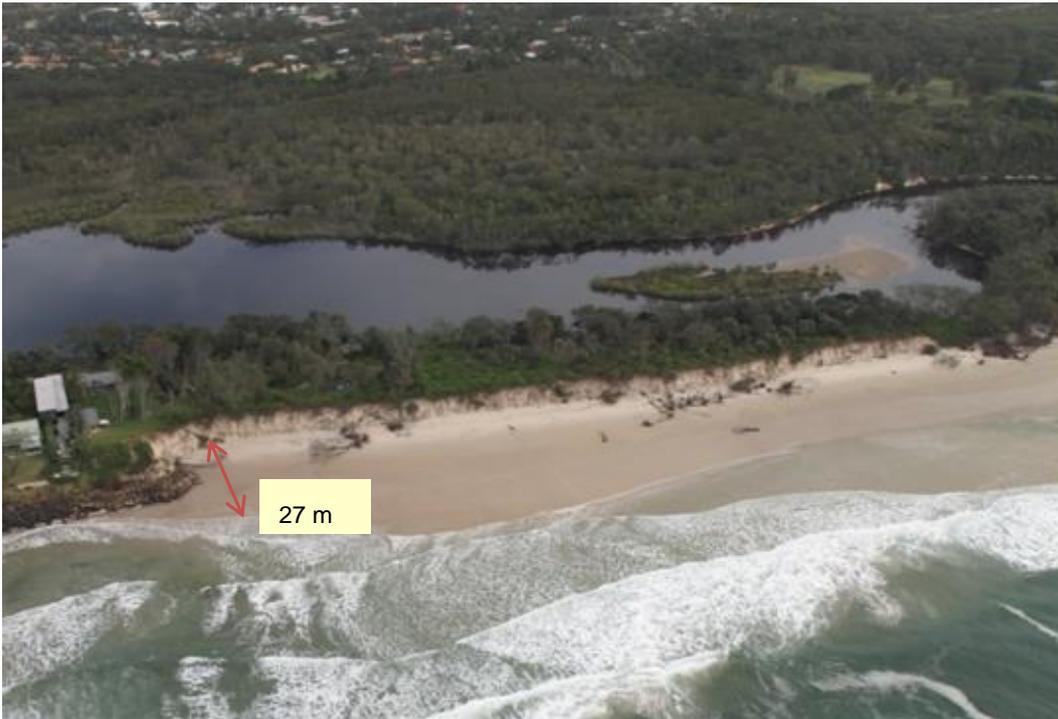
- The structure impact on foreshore alignment (refer Figure 12)
- The impact of the structures on beach width

**Figure 12** – Erosion of natural dune downdrift of Belongil erosion protection structures

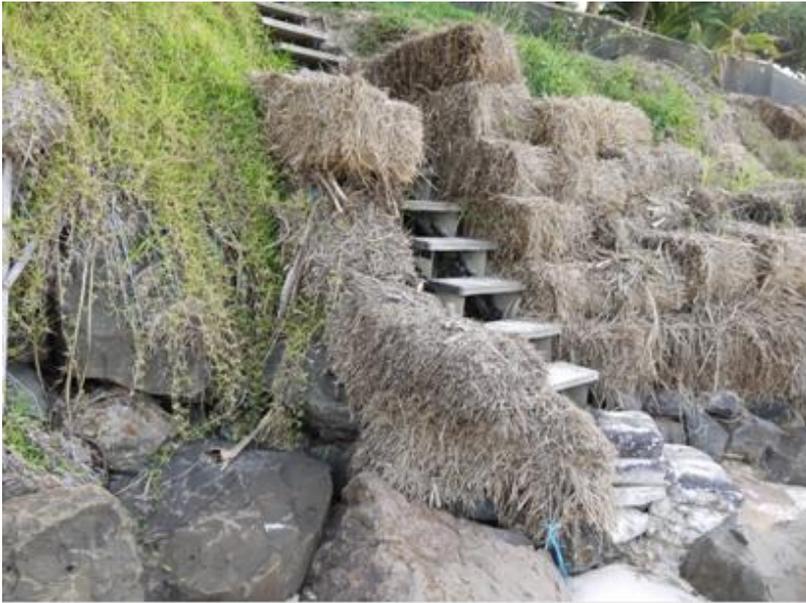
- Loss of sandy beach habitat caused by loss of beach width in front of the structure – this comes about through the location of the structure on the beach profile and how reflective the structure is to wave energy (which depends on the structure material and slope).
- Loss of natural dune habitat and vegetation as a result of the structure installation, structure footprint and degree of protection afforded to sandy dune habitat on the landward side
- The potential for the structure to create new foreshore habitat.
- Impact of the structure on marine pollution, e.g. whether foreign materials such as geotextile or twine are released from the structure into the marine environment (Figure 13).

**Figure 13** – Example of foreign materials that have potential to impact on marine environment

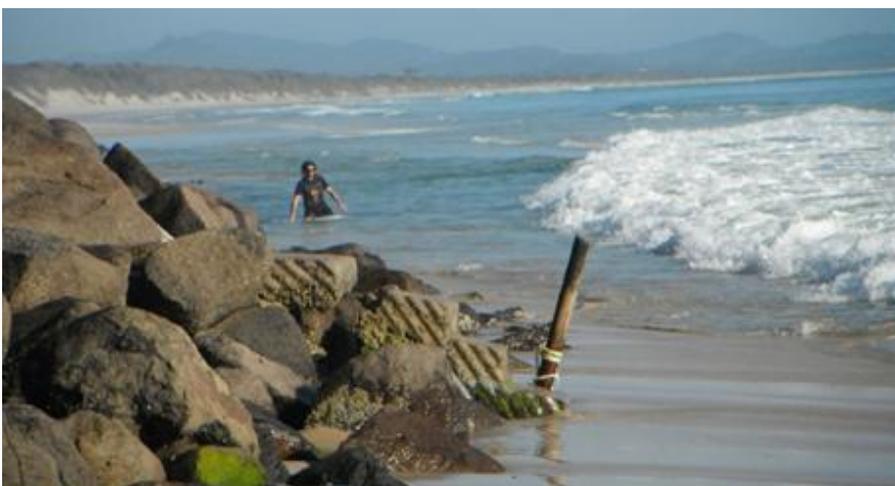
**Figure 14** – Difficulty of public access along beach at mid-high tide, near Manfred Street (photo Byron Shire Council)
