The "Tripper Wall" Managing the breakout of small lagoons and creeks across beaches

Angus D Gordon¹

¹ Principal Consultant, Coastal Zone Management and Planning, Sydney, sandgus@optusnet.com.au

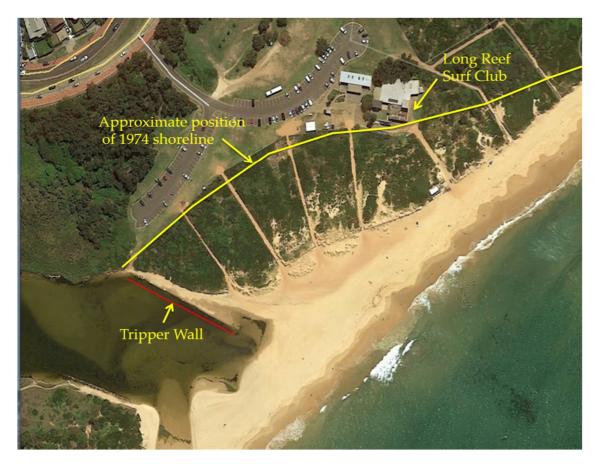
Figure 1 – Dee Why Lagoon Entrance showing 1974 shoreline and the location of the "Tripper Wall" that provided the environment to allow dune and beach recovery.
