# COMPARISON OF HARD AND SOFT ENGINEERING TECHNIQUES FOR EROSION CONTROL OF HISTORIC RUBBISH TIP SITES ON THE OPEN COASTLINE IN PORT FAIRY.

By Scott Elliott Department of Environment, Land, Water & Planning Warrnambool  
Victoria

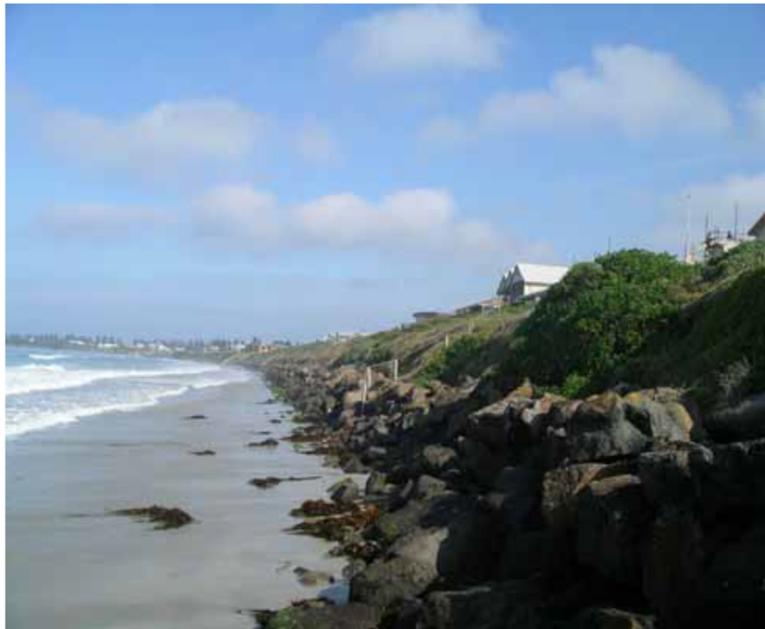
**Figure 9- Photo of rock revetment looking to the south west. This section of the revetment was repaired and upgraded in 2012 BMT WBM (2007)**

The revetment extends along the shoreline in front of the residential properties. The revetment has been damaged during recent storms and likely limited preventative maintenance at the eastern or terminal end. The damage is some rock displacement and outflanking by waves and subsequent erosion behind the wall causing collapse of a short section of wall. It is difficult to conclude that a single storm event has caused the damage, as some of the displaced rock is scattered along the beach and partly or completely buried, and therefore it is plausible that failure is caused by numerous/ongoing wave attack and storm events rather than a single event.

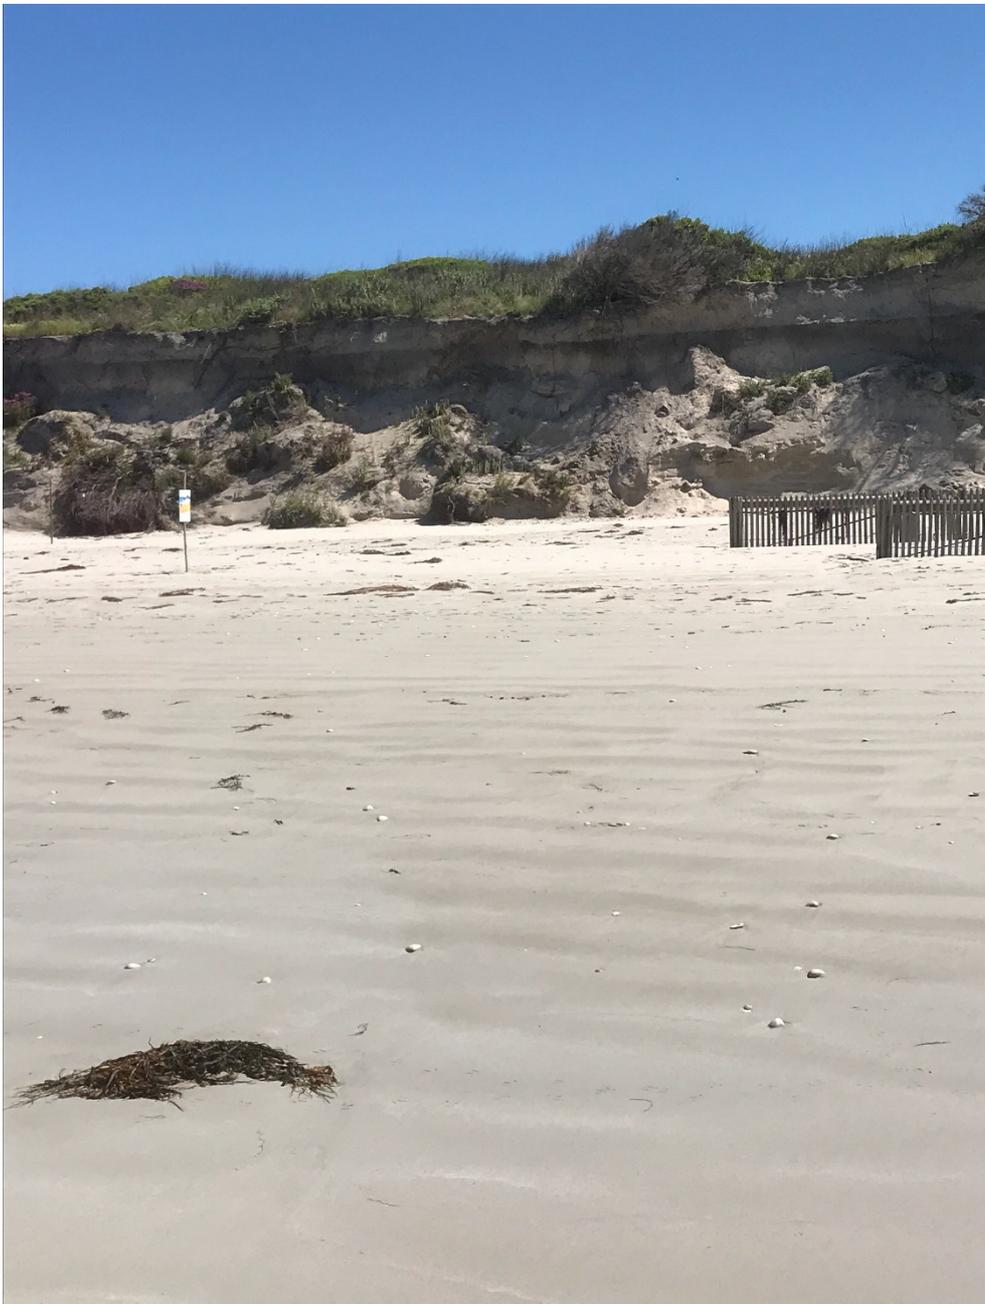
Rock revetment and breakwaters will have a large footprint on beach aesthetics and access. Any extension is highly likely to cause terminal scour erosion, similar to the existing revetment terminal scour erosion over time (i.e. months to years). Extending the revetment will transfer the terminal scour erosion further down drift to the northeast. Transferring erosion further towards the northeast may contribute to undermining of the Night Soil tip site (400 to 500 meters to the northeast) on DELWP managed land, which should be avoided if practicable.

**Figure 10- Photo showing end of wall effects at southern end of old Council landfill site**

being lost for considerable period. This is also likely to explain the end of wall effects evident at the old Council landfill site caused by the construction of the WEDS.

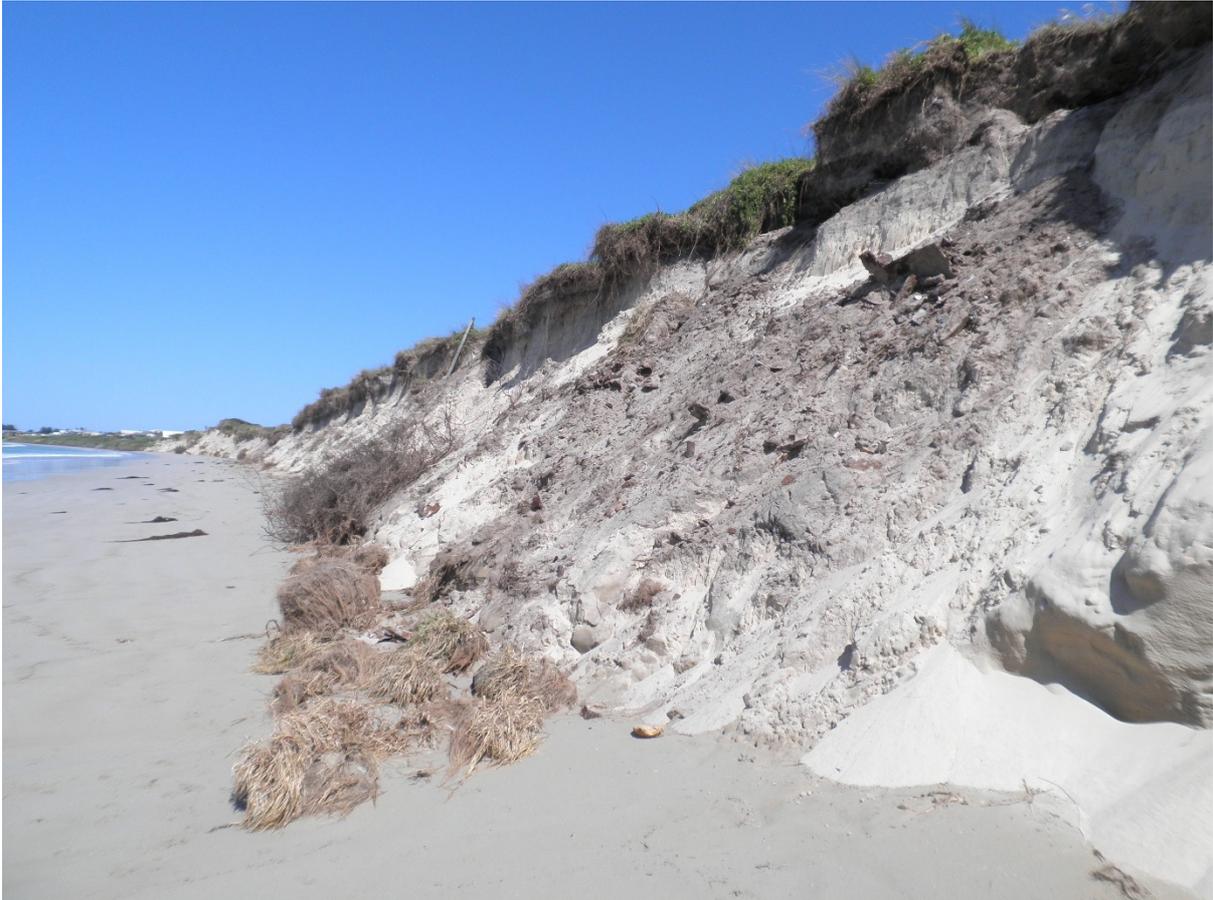
Because of storm events in 2011, the dune crest at the site was measured to be receding inland at an average rate of 1m per year since January 1996.

**Figure 11- View of active dune erosion to the south west of the DELWP landfill site in November 2011 after storm damage**

- Installation of two (2) rows of sand trap fencing for 205 metres along the beach in front of the site. The rows are separated 1.5 metres apart from each other with the row.
- Re-profiling of the dune face and installation of Geotech fabric and matting along with plantings of native vegetation to stabilize the dune face.

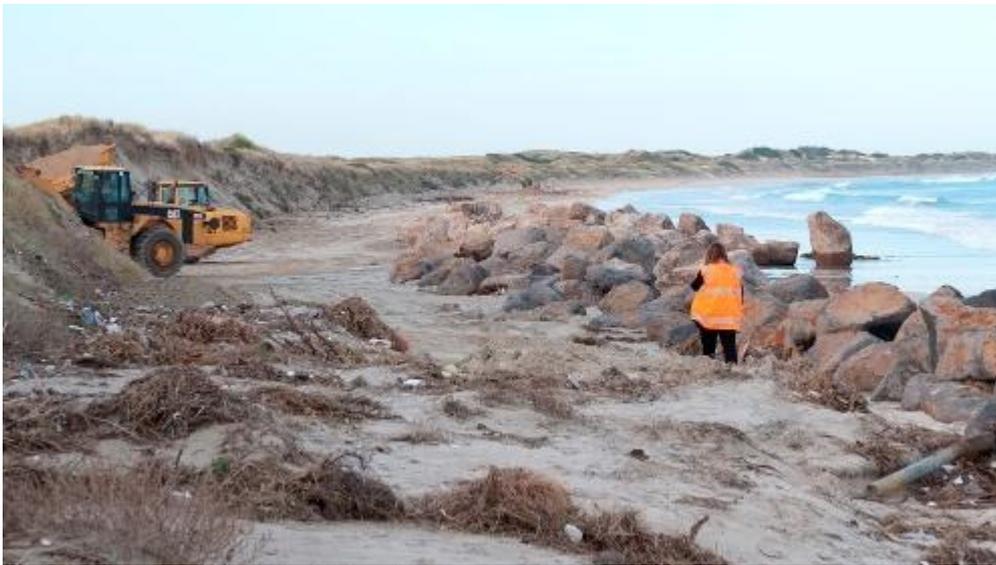
**Figure 12- Council landfill site looking to north east exposed due to dune erosion after 2015 storm event with WEDS in foreground**

- Between May-June, construction of a 235 metre rock wall (known also as 'WEDS' Wave Energy Dissipation Structure) along the beach about 4 metres in front of the landfill site.
- In November, the installation of 25 metres of sand-trap fencing at each end of the WEDS. These works did not occur until
- Re-profiling of the dune face and installation of Geotech fabric and matting along with plantings of native vegetation to stabilize the dune face

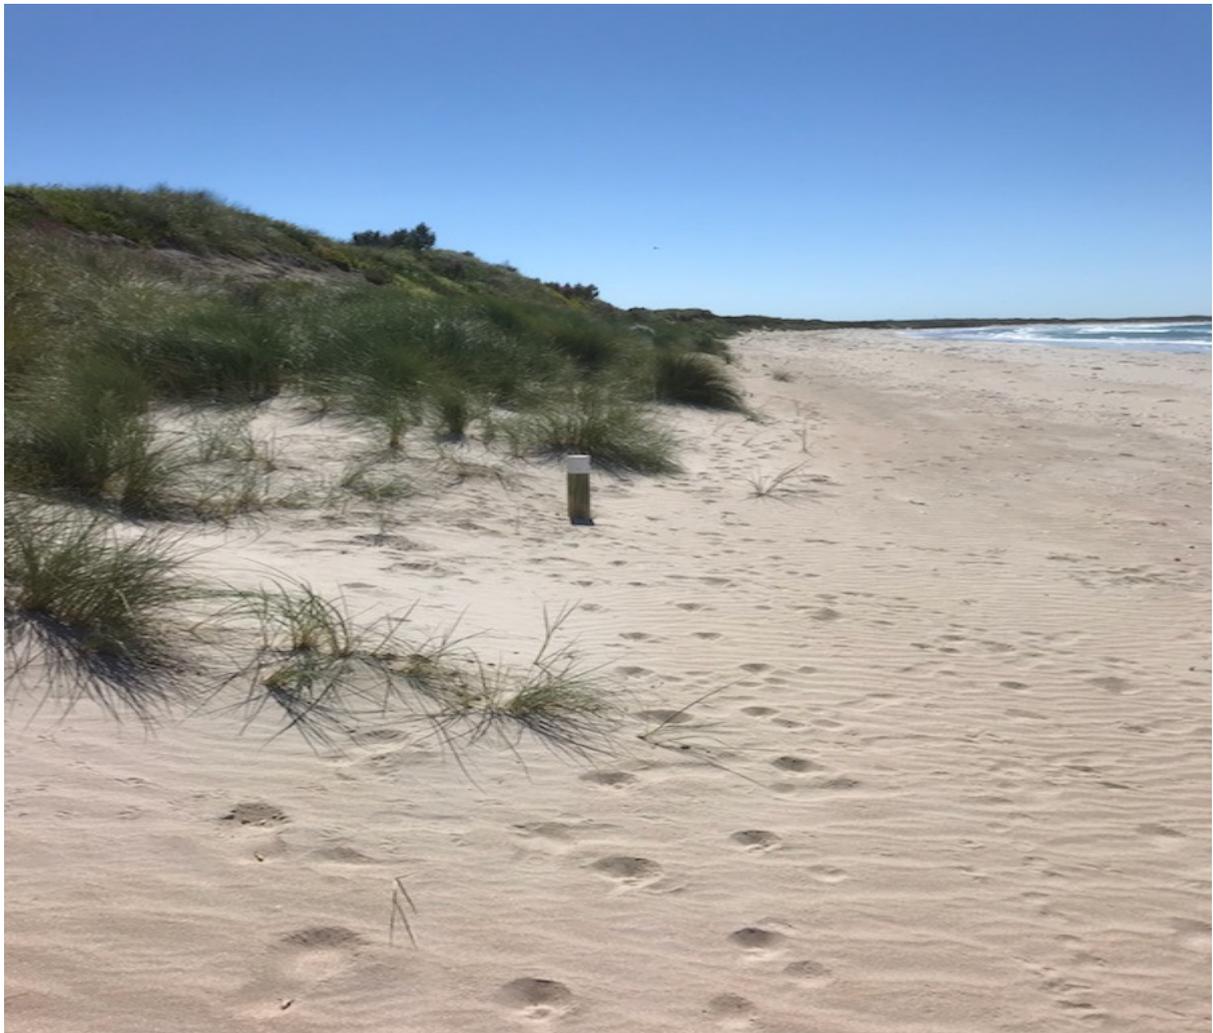
At the DELWP nightsoil site, reshaping of the dune crest and dune face, together with the geo tech matting and sand fence at the Night Soil site, have eliminated dune crest recession that has been a major concern in recent years. Further, both rows of sand trap fencing have been completely submerged by sand with vegetation now establishing there and therefore creating a tertiary dune in front of the primary dune. It is estimated that since these works took place that 1,000 to 2,000 cubic metres of sand has been trapped and maintained on the beach. This is likely to be due to aeolian (wind driven) processes and the mitigation works undertaken at the site.

**Figure 13- Photo taken 17 October of DELWP nightsoil site looking to the north east showing sand accretion and vegetation over**

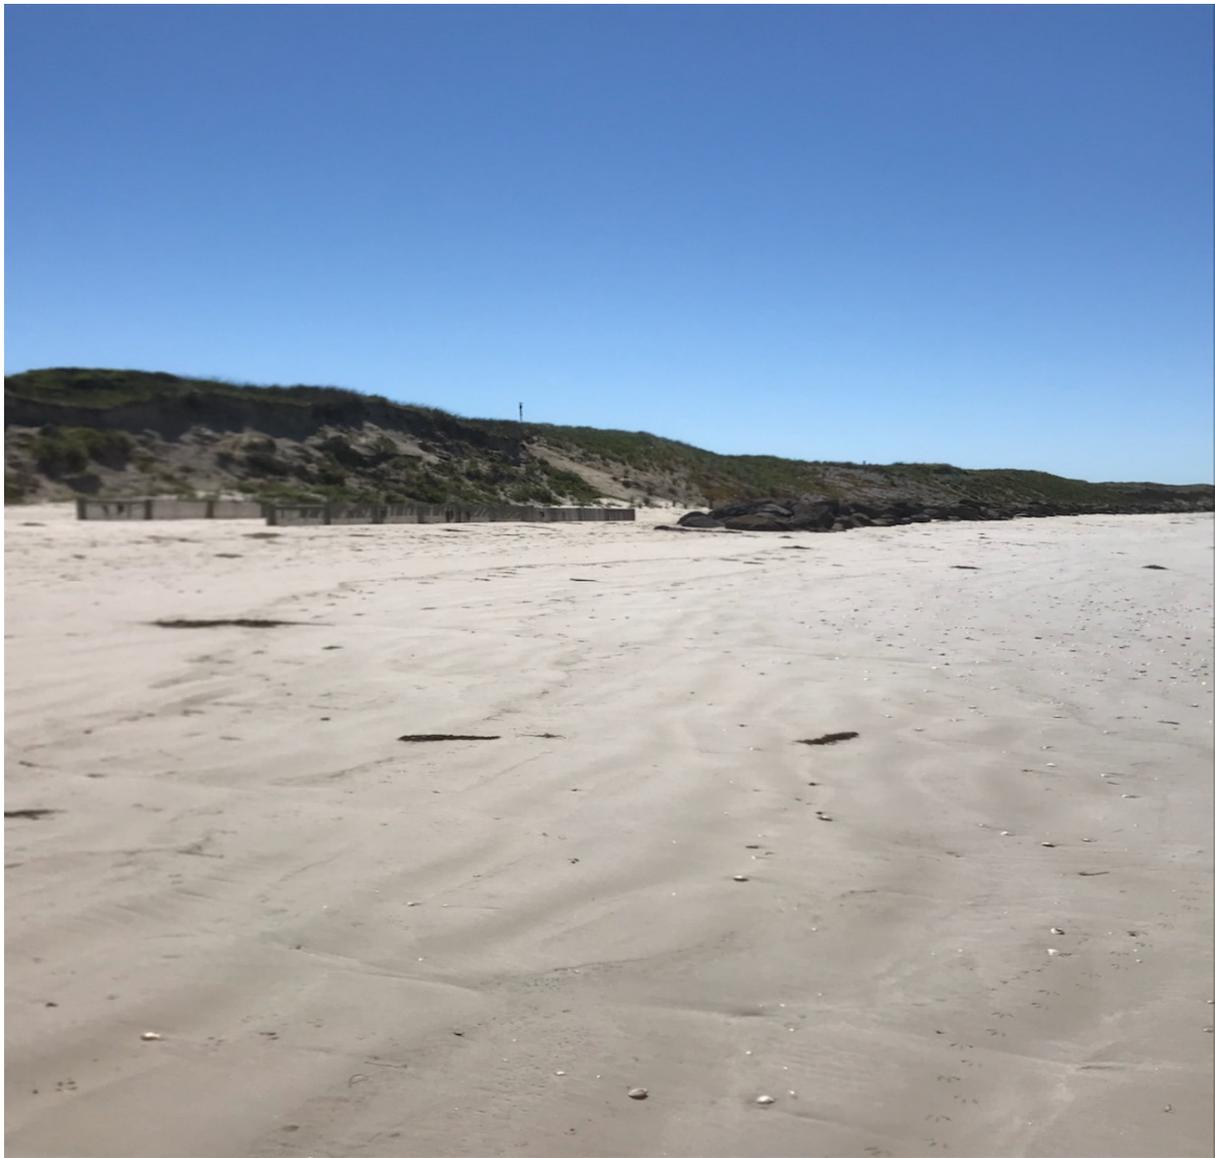
At the Council landfill site, the dunes behind the WEDS have stabilised considerably due to the works undertaken. However, it is noted at both ends of the WEDS where sand trap fencing has been installed that 'end of wall' impacts or scouring have occurred. This is likely to be due to the location and alignment of the sand trap fencing as well as the more exposed location of this site to the elements, particularly tides, swells and winds. The works were also impacted heavily by severe storm events over 5-6 months in 2015 with increased king tides and storm surges.

**Figure 14- Photo of the old Council landfill site looking to the north east. Note the smaller amount of sand on the beach compared to the DELWP landfill site**
