## 3D ASSET DATA CAPTURE TO EFFECTIVELY INFORM DAMAGE ASSESSMENT AND REPAIR DESIGN OF ROCK ARMOURED BREAKWATERS

## E Rowe<sup>1</sup>, D Dack<sup>1</sup>, J Hinschen<sup>2</sup>

<sup>1</sup>Arup, Sydney, NSW

<sup>2</sup>North Queensland Bulk Ports, Mackay, QLD

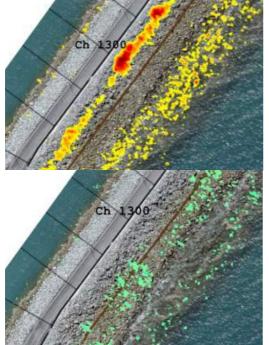
The pre- and post-event surface comparison maps (heat maps) as seen in Figure 1 were developed at the start of the project as a tool to assess the extent of damage to the assets. These heat maps assisted in defining the:

- magnitude of damage relative to values for volume loss/ gain and for surface area with elevation loss/ gain;
- likely mechanisms of failure;
- areas susceptible to damage, (particularly under TC Debbie conditions);
- trends in armour displacement and/or accretion along the structures; and
- definition of specific segments of the assets based on performance and extent of damages.

Figure 1 – Plan view excerpt from heat map of damaged breakwater showing example surface comparison maps with the top image showing elevation loss scaling from yellow (minor) through to red (major) and the bottom image showing elevation gain scaling from green (minor) through to blue (major)

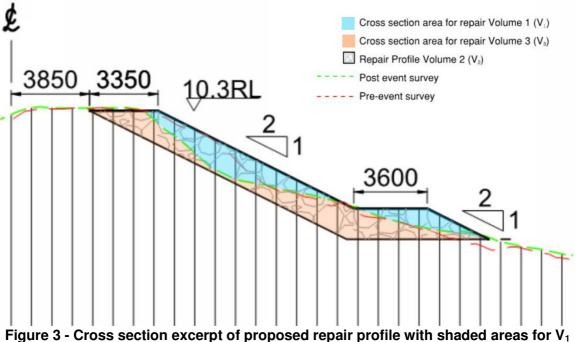
For all repair strategies where existing amour was to be incorporated into the repair profile, the following procedure was used to quantify the repairs (refer Figure 3, which provides a cross section of the volume analysis).

- The design surface was compared to the post-storm survey surface providing an initial volume estimate (V<sub>1</sub>).
- The volume for the whole repair profile was calculated (V<sub>2</sub>).
- The volume of the existing armour within the repair profile (V<sub>3</sub>) was calculated (V<sub>2</sub> minus V<sub>1</sub>).
- The volume of the existing armour that met the specification of the repairs (V<sub>4</sub>) was estimated by applying a percentage of retention (R) based on inspection of the existing profile (V<sub>3</sub>\*R).
- The final estimated volume for each segment of the breakwater was calculated by subtracting V<sub>4</sub> from V<sub>2</sub>.

While V<sub>1</sub> would logically provide an appropriate quantity estimate, if the existing armour within the design profile  $(V_3)$  is not of appropriate size or quality, this armour would be removed from the repaired profile. For the TC Debbie repairs, this value fluctuated based on site observations, but due to the wide grade and range of rock characteristics seen across the structures. the percentage of retention was typically approximately 40%.

(blue) and  $V_3$  (orange) as well as the pre- and post-event survey

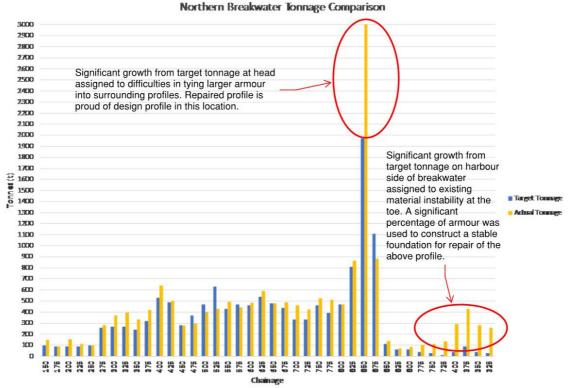
During the construction phase the targeted quantity estimates were used to track progress, provide continual revision of budgets and monitor the grading of placed rock armour. Quantities placed were tracked for every 25m (refer Figure 4) and allowed for controls to be placed on the Contractor by assigning hold and witness points for growth in placed volumes against targeted volumes. This led to an effective approach to monitoring the progress of the repairs and tracking contractor progress against budgets and the risks incorporated into the upper limit quantities. For this example, actual rock placed aligned well with pre-tender estimates (targeted quantities), which gave confidence in the approach taken and allowed the project to be delivered within budget

Figure 4 - Tracking spreadsheet for the Northern Breakwater repairs at the Port of Mackay showing target tonnages per 25m section (blue) against placed tonnages (yellow). Note the good correlation as well as outliers that were assigned to relevant risks determined during the design phase
