TRAMWAY SHARED PATH AND SEAWALL UPGRADE

L. Dean
Wollongong City Council

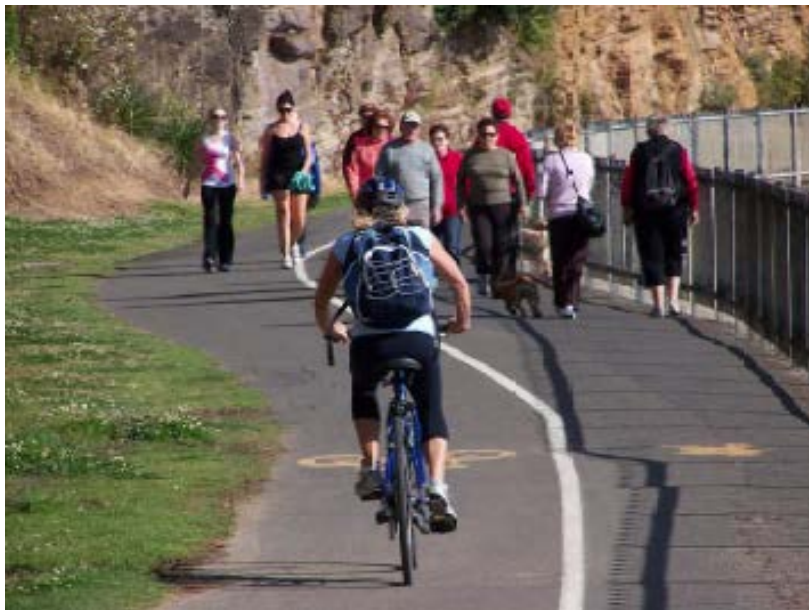
Figure 2 – Existing Path 1

The Tramway section of the Blue Mile sees around 14,900 pedestrians and 2,690 cyclists pass through the area every week. The existing asphalt path was narrow and split into a dedicated cycleway and footpath area. On a daily basis, this creates conflicts between high volumes of pedestrians and, at times, fast moving cyclists trying to navigate the narrow space.

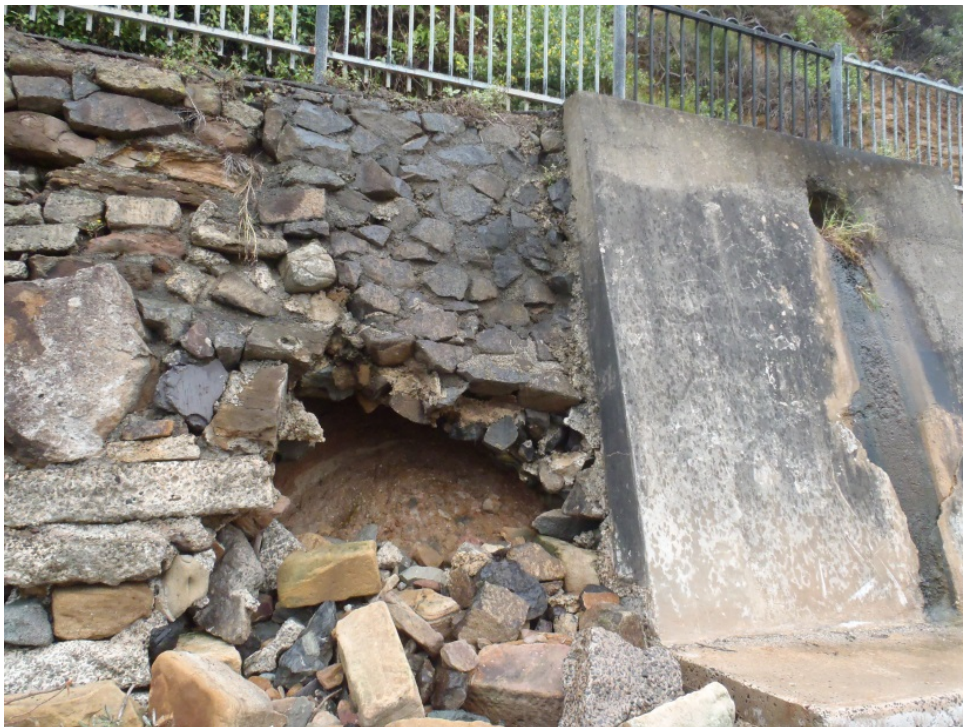
Figure 4 – Voids in Seawall 1

The existing seawall was a stacked stone wall which was built around 1862 to support the creation of a tramline between the Mt Pleasant Mine and the coal loading terminals at Belmore Basin. Due to the tidal and wave action on the wall over time, rocks have been washed away and large voids created behind the wall. These voids created structural issues for the seawall and path above.

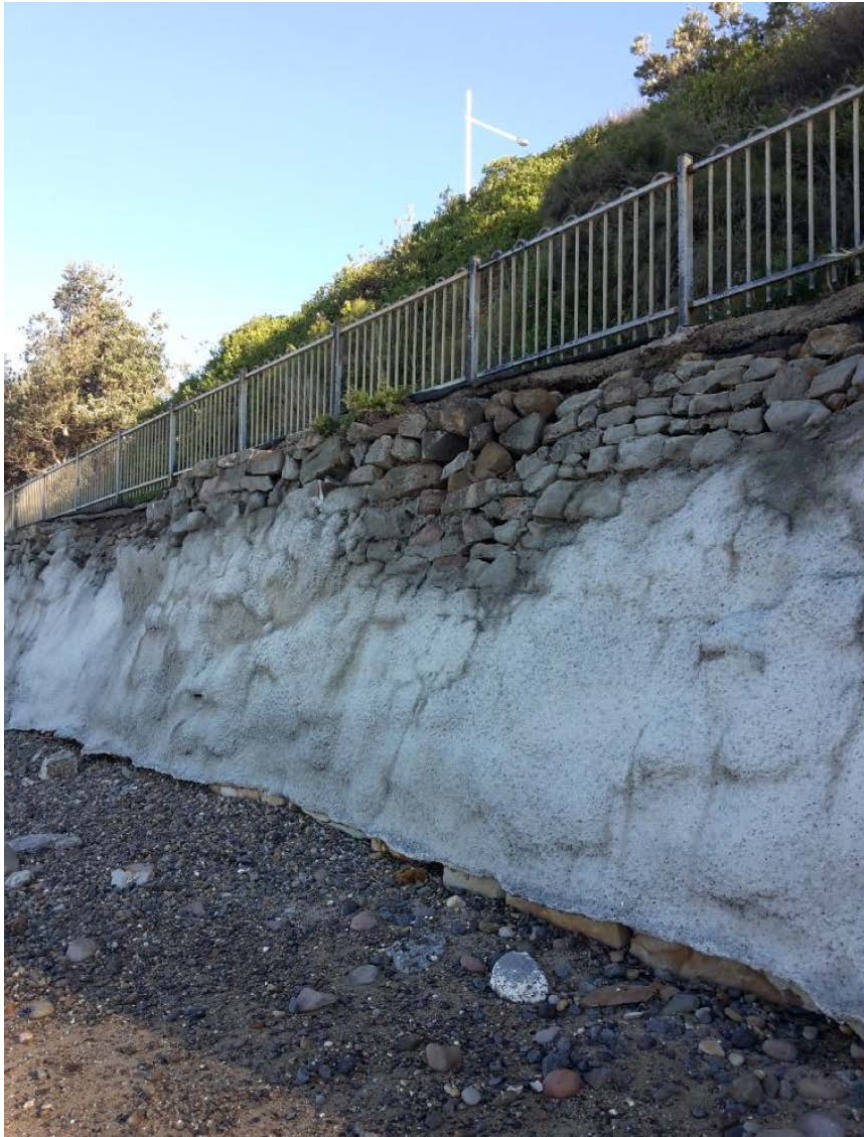
Figure 6 – Shotcrete Wall Repair

Council has a long history of repairing the sea wall by filling voids with concrete and applying shotcrete to the surface of the wall to avoid further void creation.

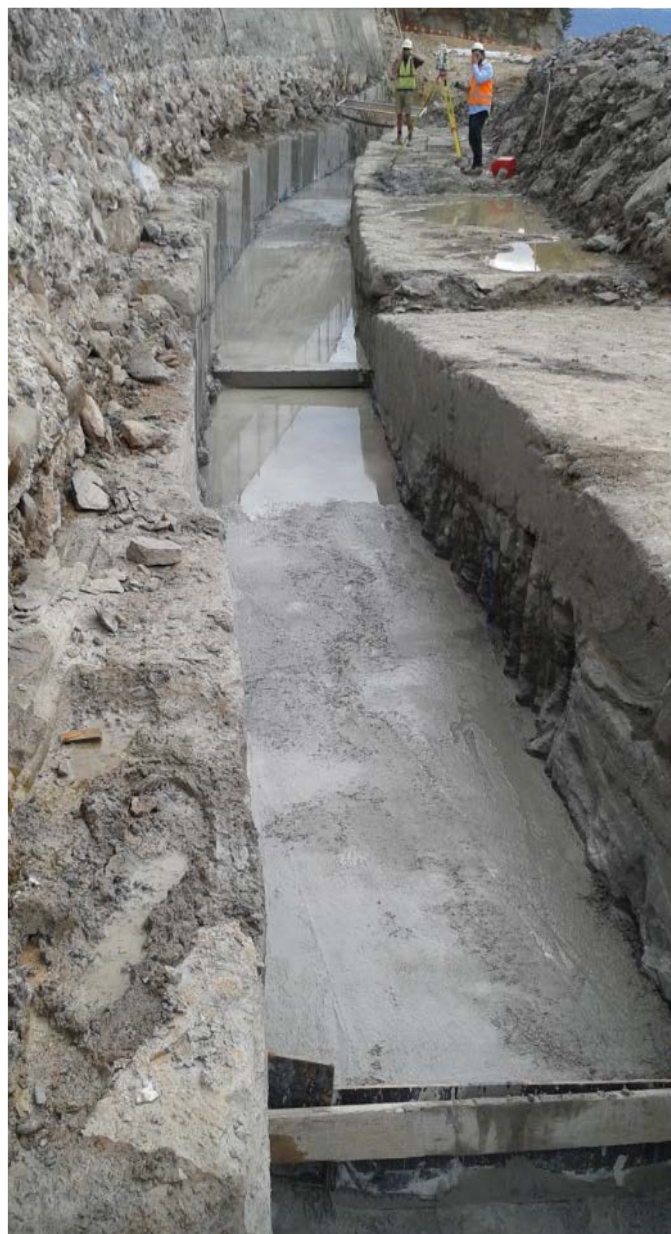
Figure 11 – Rock Trench with Bedding

Options to connect the new sea wall to the existing rock shelf were investigated. The rock shelf along the length of the wall is made up of a low strength Bulga sandstone. The surface of the rock was uneven, this made using dowels and placing the wall directly on the surface very difficult and susceptible to water access under the panels through voids create in the grout over time.

To avoid this risk and ensure the panels could not be undermined before the end of their design life a trench was cut into the rock shelf. This provided a flat base for the

panels, consistency of grouting and additional toe support to help long term stability under wave action.

The outcome of the trial was to specify that the contractor use a 10mm diamond blade to cut the trench. This method provided the least amount of fines on site and created larger rock from the trench which could then be used as toe protection for the new wall. It also ensured the works stayed within noise and vibration limits for the adjacent buildings. With noise and vibration within allowable limits Council was able to provide approval to work longer hours so the contractor onsite could better schedule around the tides whilst digging the trench and building the sea wall.
