## Managing Beach Accessways – A Rational Approach

Chris Adamantidis  
NSW Coastal Conference May 31 2022

## Coastal Accessway Management Tool (CAM)

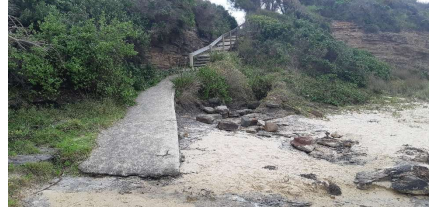
Nelson Beach – slope stability, stormwater outflow

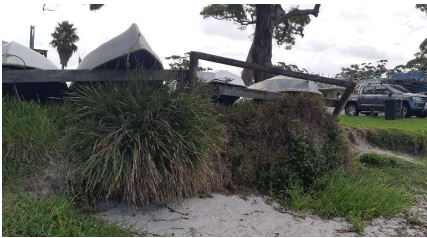
Berrara - Erosion due to runoff
