## Managing Beach Accessways – A Rational Approach

Christopher A Adamantidis<sup>1\*</sup>, Nigel Smith<sup>2\*</sup>, Danny Wiecek<sup>3\*</sup>

Shoalhaven City Council manages 40 beach compartments with over 220 beach access points exposed to a wide variety of coastal impacts. As part of an update of Council's Coastal Asset Management Plan, a beach access strategy has been devised that includes a methodology for rationalisation of beach accesses based on environmental, social and economic risks. The methodology includes development of a pro-forma to allow rapid assessment of each asset in the field. A specialised multi-criteria analysis tool has been developed to provide a beach-by-beach rationalisation of accessways that can be adapted for use by any coastal council.

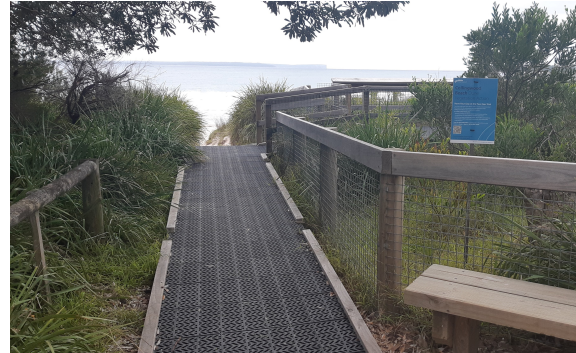
**Figure 1:** Example of recently upgraded beach accessway at Collingwood Beach

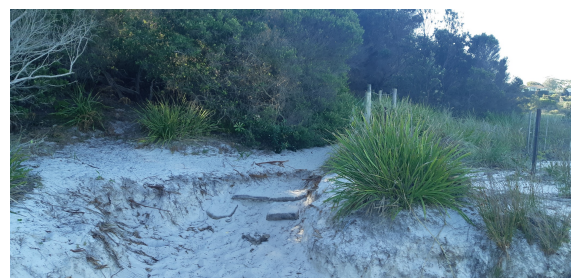
**Erosion at the base of the accessways** – this is exacerbated where there are steep slopes and stormwater overflows onto the accessways (see example in Figure 4). A proposed solution for this type of erosion is to extend timber steps to the base of the track, where these are used on upper portions. Re-orienting the seaward ends of the accessways away from the prevailing wind direction may also help prevent the problem from recurring, particularly for those accessways that face south at their seaward end.

Figure 4: Example of erosion at accessway base

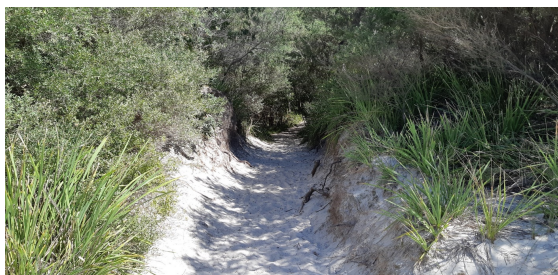
**Lowering of the base of the accessways relative to the surrounding dune** (see example in Figure 5) – these can be treated by topping up with sand to restore the accessway elevation relative to the dune, and placement of timber sleepers to maintain the accessway level.

**Figure 5:** Example of lowering of accessway level relative to dune
