“Carrying Many Small Stones” – A Story of Foreshore Stabilisation in Lake Macquarie

S Walpole¹, J Parsons¹, J Jansson²

¹Lake Macquarie City Council, NSW

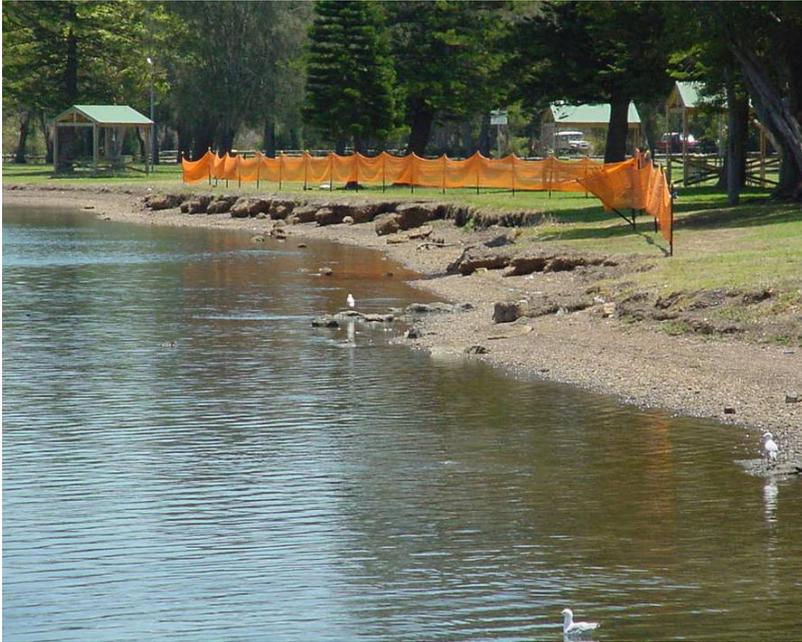
Figure 2 - Speers Point Reserve foreshore (before). Note degradation of foreshore, lack of littoral vegetation, seagrass wrack accumulation and general lack of amenity.

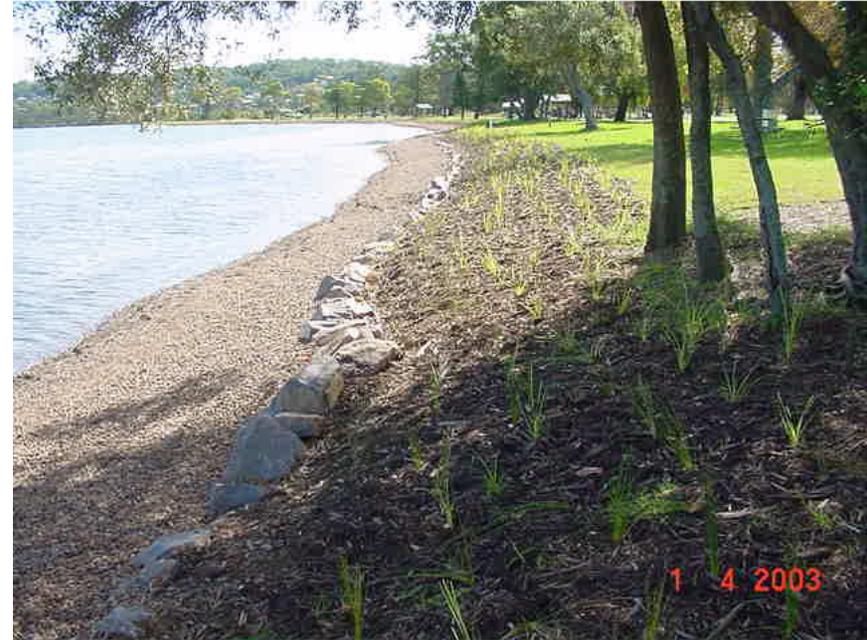
Figure 1 - Speers Point (after). Note sloping beach installation, protection of foreshore bank toe, native plants, and improved amenity.

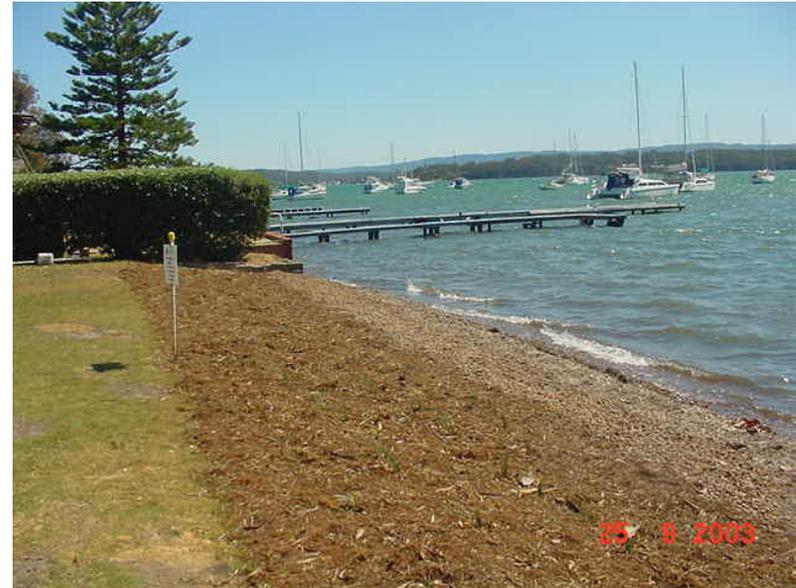
Figure 3 - Valentine foreshore (after). Note improved foreshore slope angle designed to facilitate wave energy dissipation to prevent 'mini-escarpment' development.

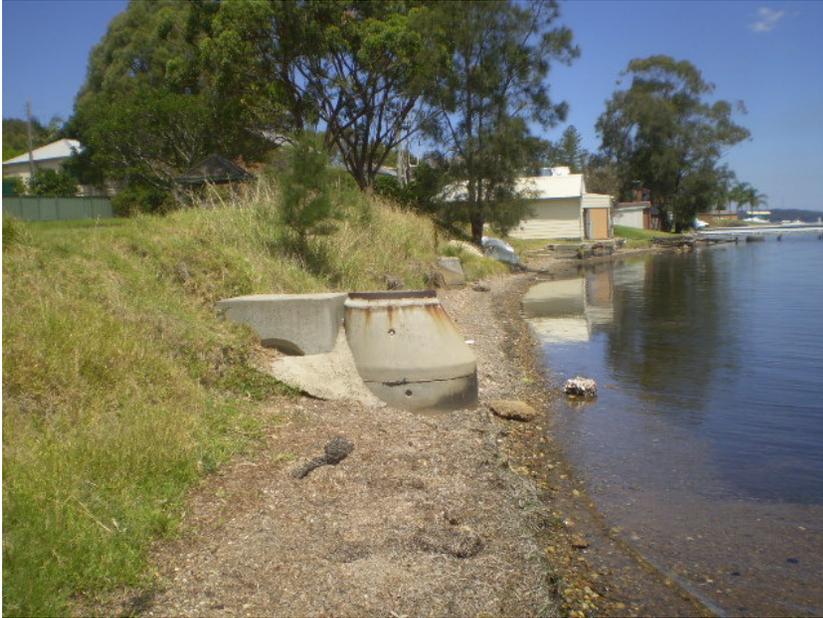
Figure 6 - Wippi Reserve, Coal Point. Note height of upper bank and lack of foreshore area.

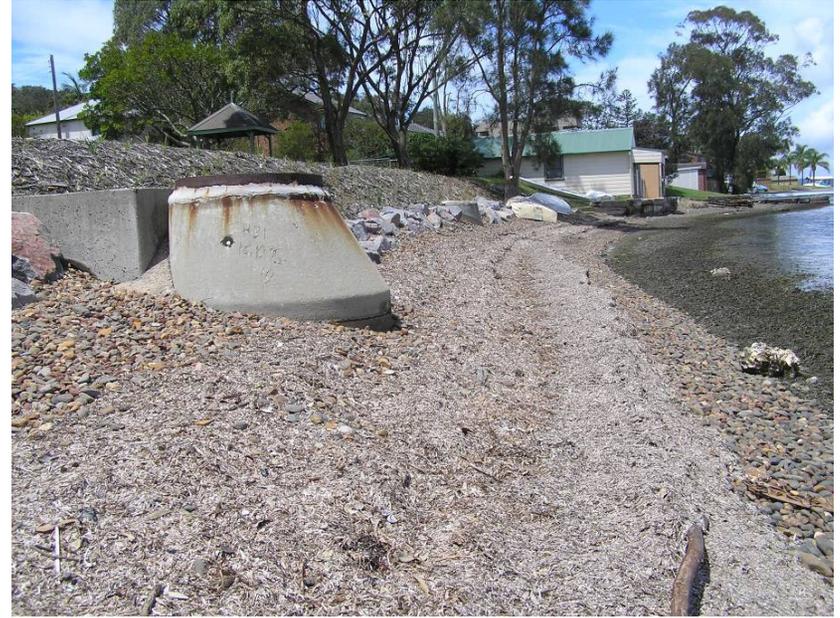
Figure 5 - Wippi Reserve, Coal Point (after). Note foot of bank stabilised with rock, extended foreshore run & accumulation of wrack on foreshore out of the water.

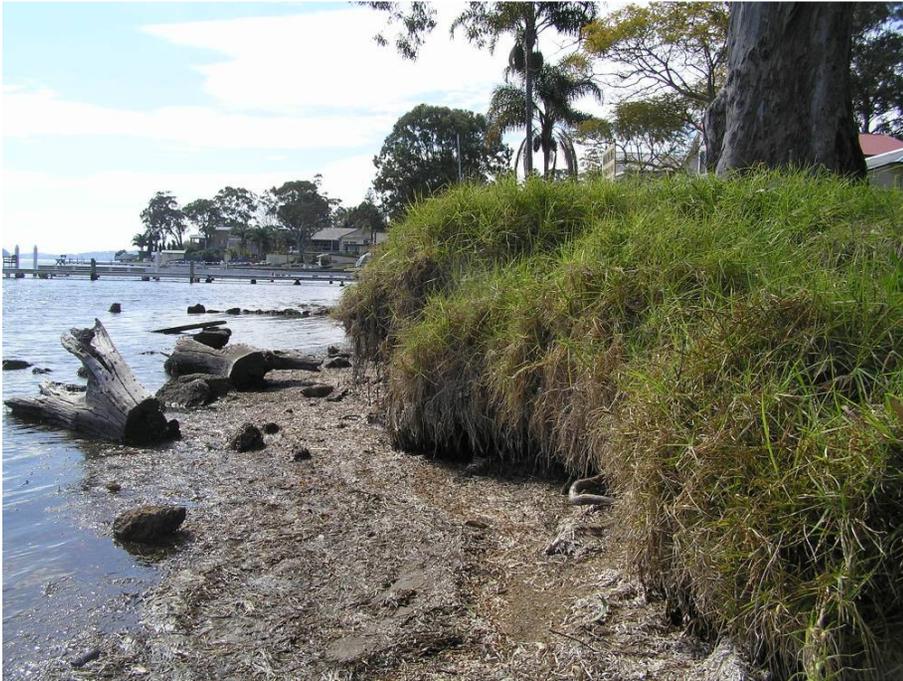
Figure 8 - Nords Wharf Reserve (before). Note height of foreshore, undercutting of bank and accumulation of seagrass wrack.

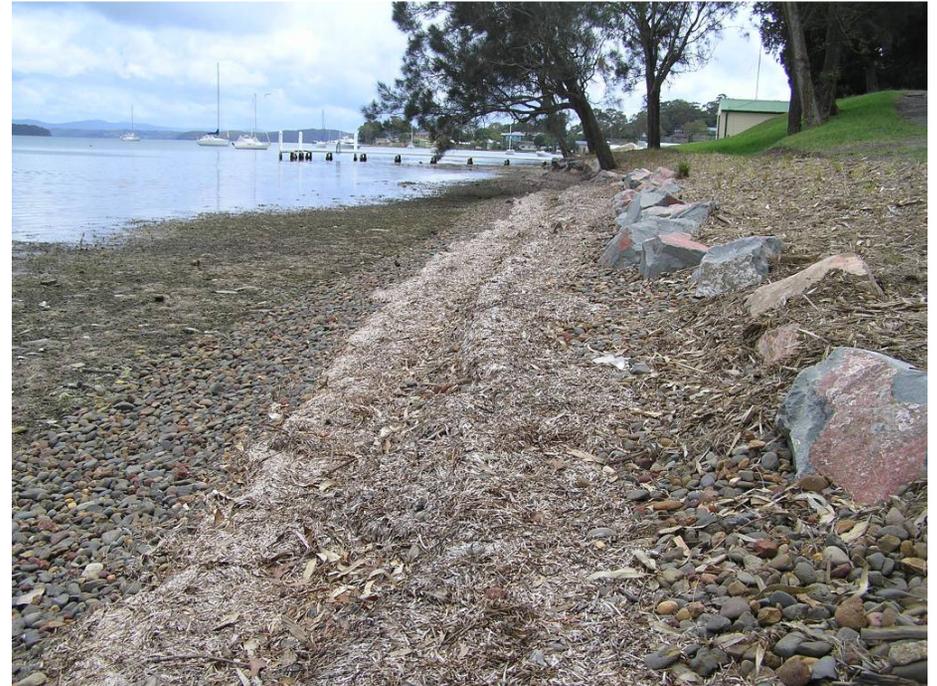
Figure 7 - Nords Wharf Reserve (after). Note return of foreshore slope, protection of toe of bank and seagrass wrack on the cobble beach.

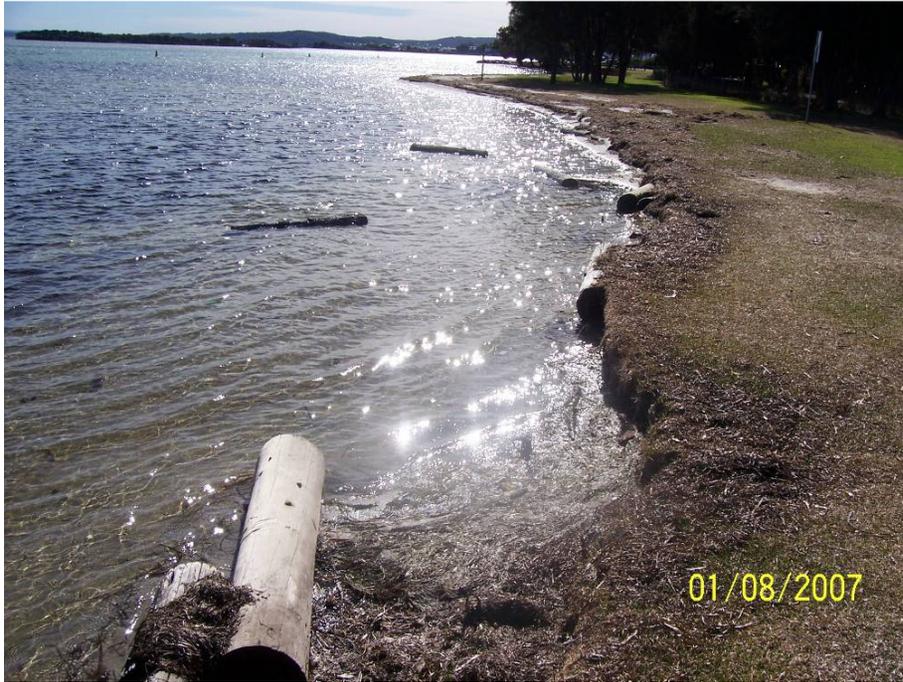
Figure 10 - Swansea Channel (before). Note 'mini-escarpment' along foreshore edge, accumulation of sea grass and failing foreshore revetment (logs).

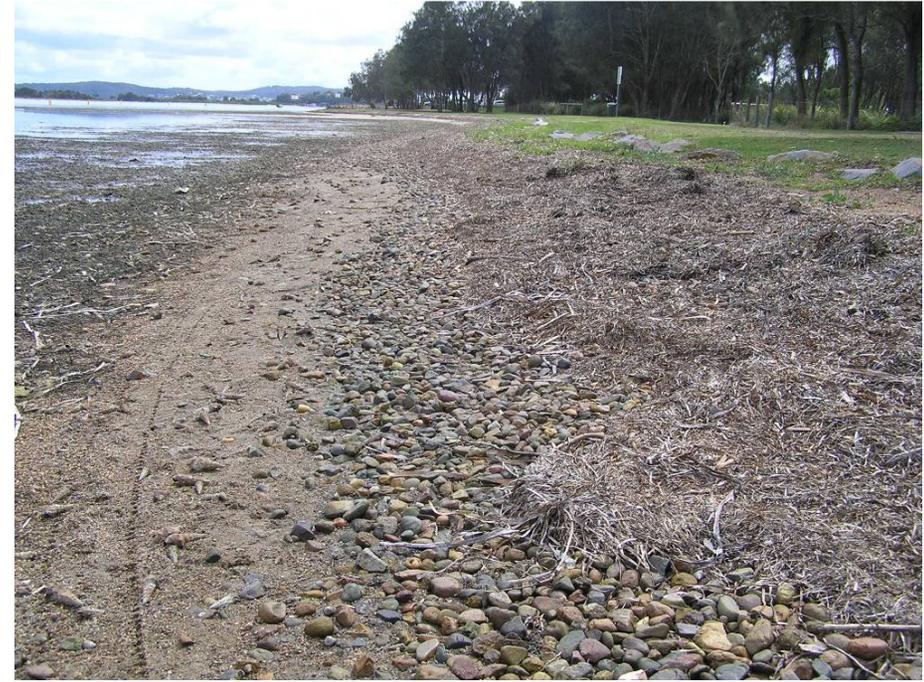
Figure 9 -Swansea Channel foreshore (after). Note removal of 'mini-escarpment', return of foreshore profile and movement of wrack onto cobble beach.

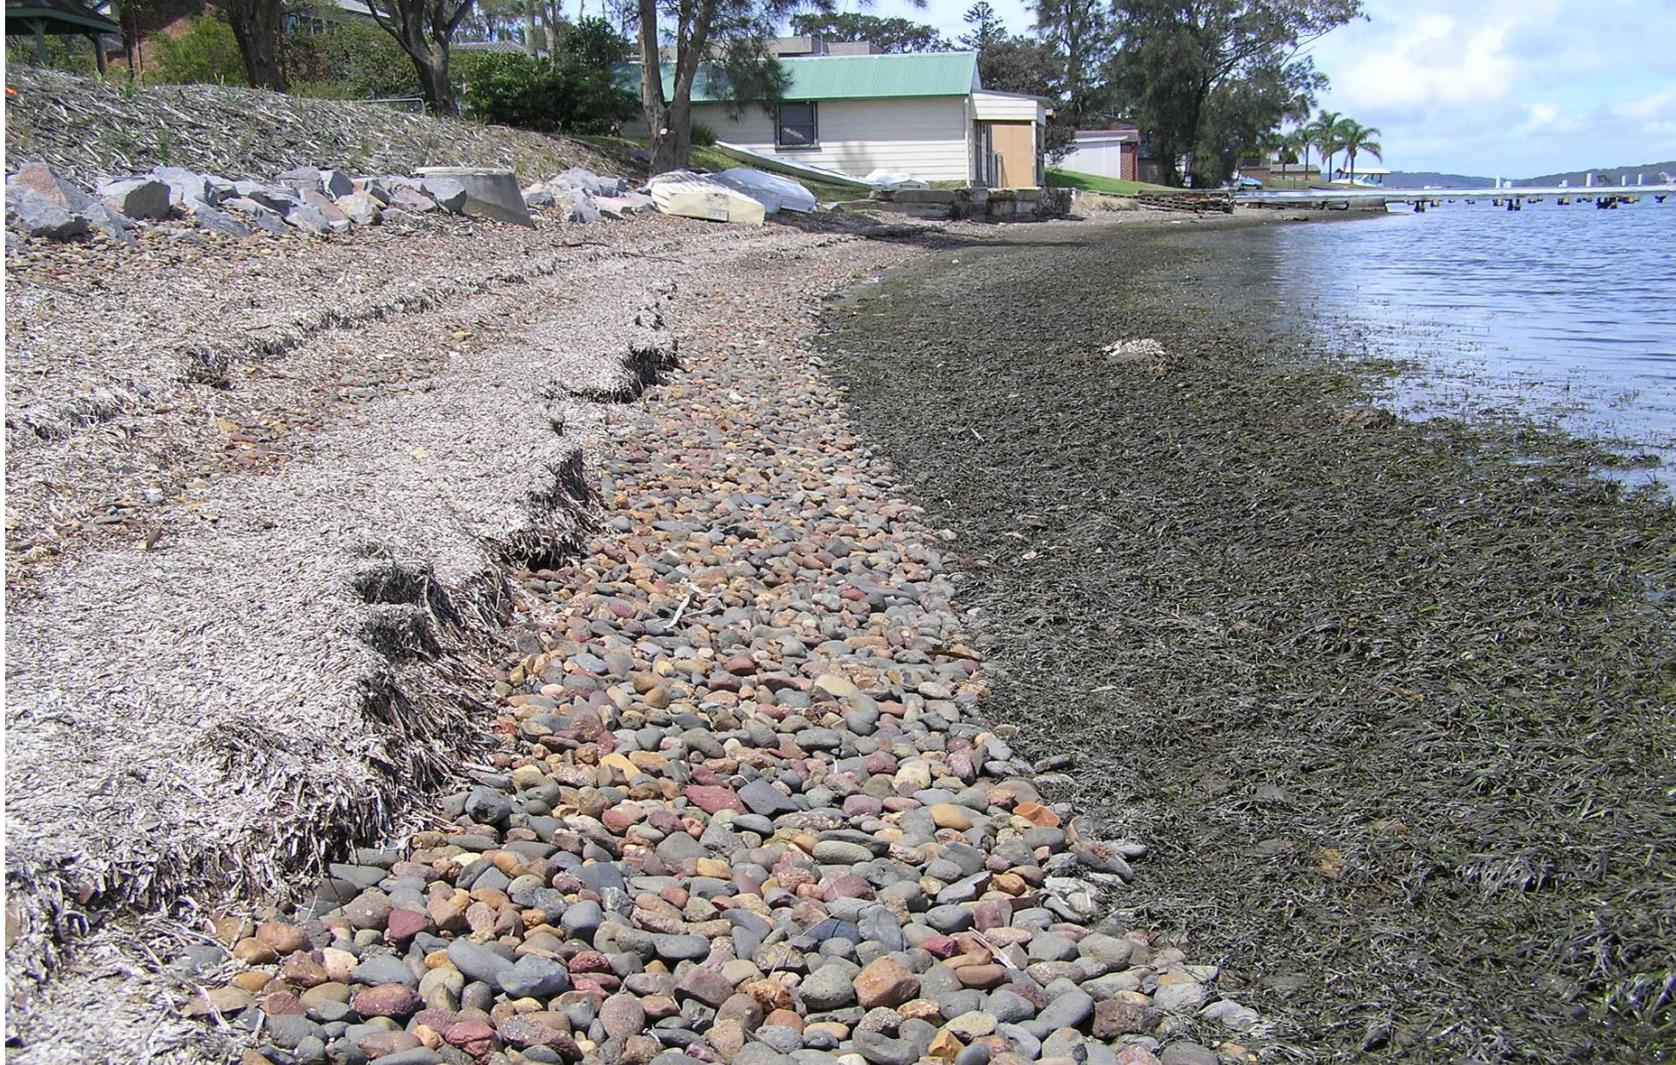
Figure 11 - Side view of Wippi Reserve foreshore profile after restoration. Note the effect the cobble beach has on moving sea grass wrack up the foreshore. Prior to installation of the cobble beach the 'mini-escarpment' would trap the wrack in the Lake water limiting the breakdown of the wrack. The cobble beach has created a zonation of stages of wrack decomposition from the near shore to upper foreshore. (Note this photograph was taken at a time of low lake level exposing sea grass beds usually inundated by Lake water.

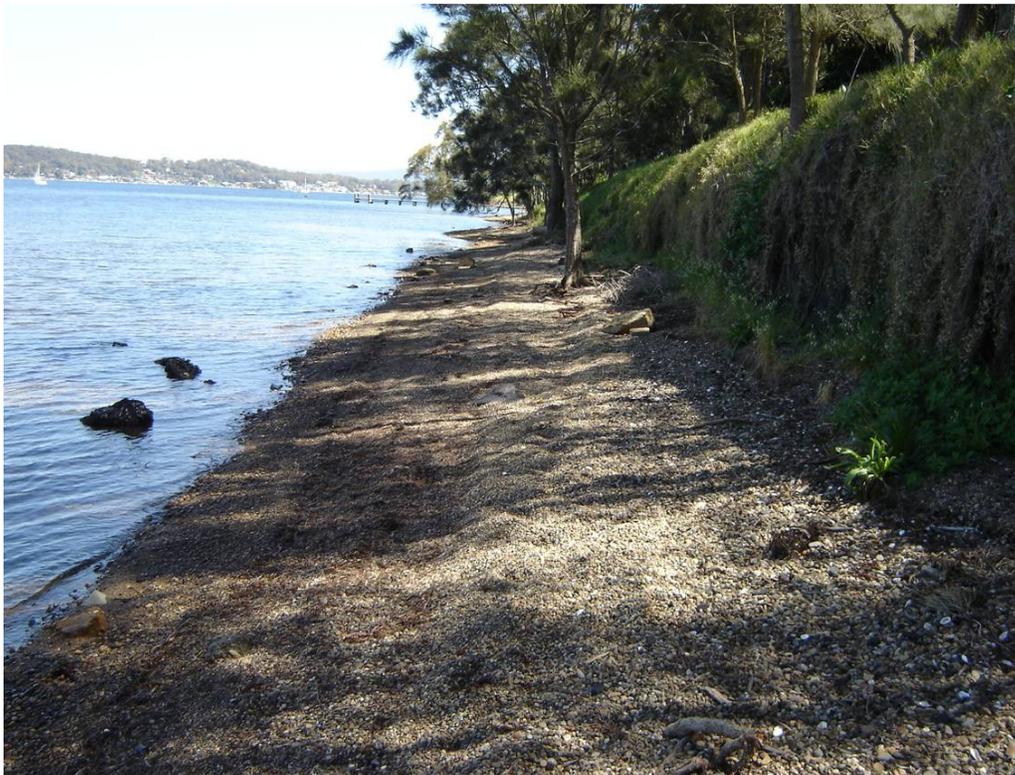
Figure 12 - Green Point foreshore (before). Note height of bank due to historic deposition of fill material.

As shown above, the modified morphology of the Green Point foreshore (due to historical placement of fill) has created an environment prone to the effects of high-energy events. The abrupt change in angle to an almost vertical face does not provide adequate foreshore distance for the foreshore to sufficiently dissipate wave energy in storm events. Subsequently the toe of the bank receives energy from the waves and as a result, experiences accelerated erosion.

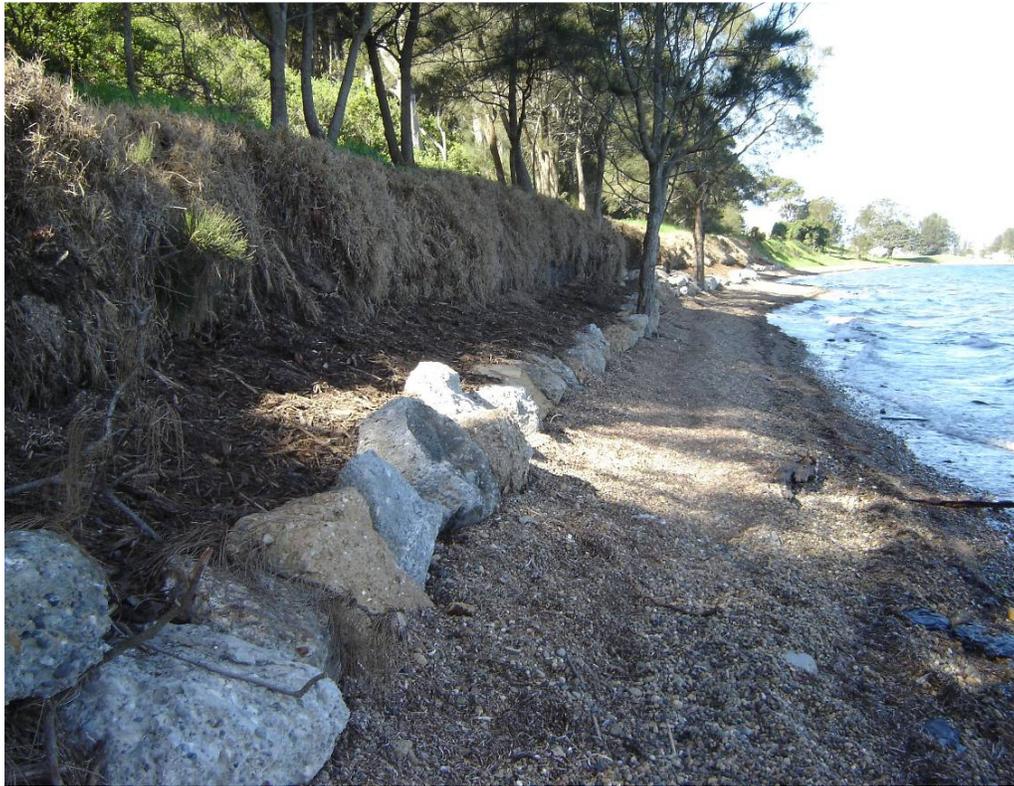
Figure 13 - Green Point foreshore (after). Note installation of toe protection.

In this situation, the armour rock placed to protect the toe has not performed well, as the waves have penetrated behind the rock causing them to move, exposing the toe of the bank. During construction, the toe armour was not keyed into the foreshore therefore reducing the ability of the rock to withstand the wave energy. In retrospect this site may not have been an ideal site for the sloping beach technique due to the extremely altered condition of the foreshore (the vertical face so close to the lakes edge).

To protect this bank from further erosion (during storm events) a greater investment in infrastructure may be required to construct a revetment wall several rocks high and wide to provide adequate protection from storm events.

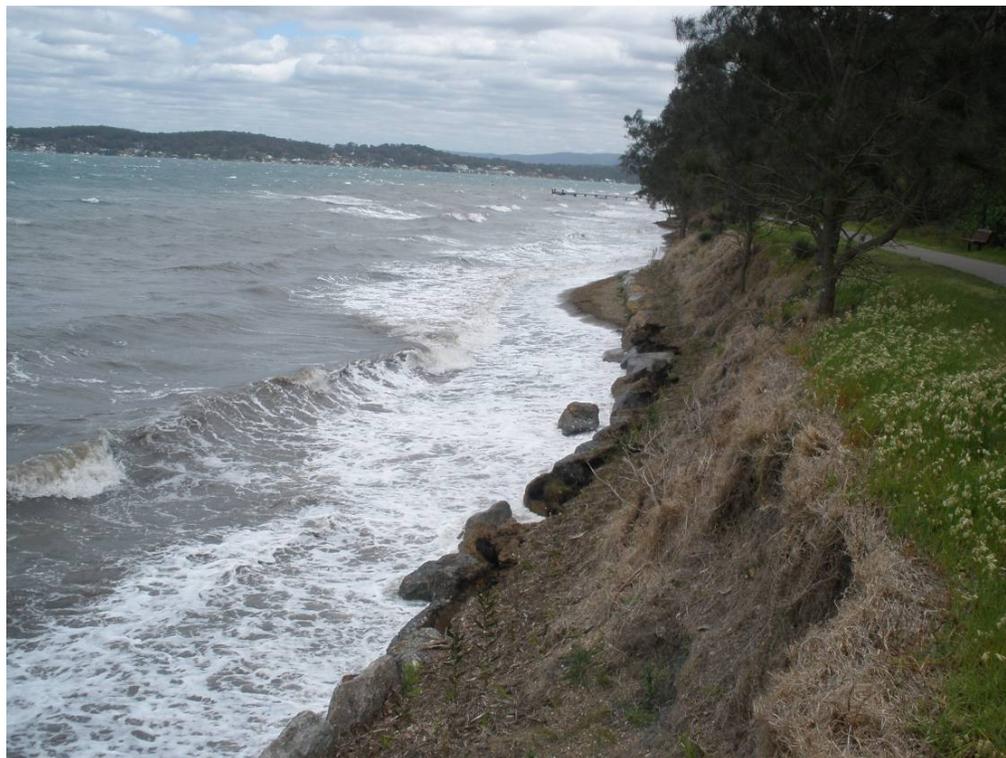
Figure 14 -Green Point foreshore during large storm event. Note change in lake level and waves breaking directly on toe protection rocks.
