CONSTRUCTION OF A TOE DRAINAGE STRUCTURE AT CABBAGE TREE HARBOUR

Andrew Pearce, Tim Burch (Wyang Shire Council), Lex Nielsen (WorleyParsons)

Abstract

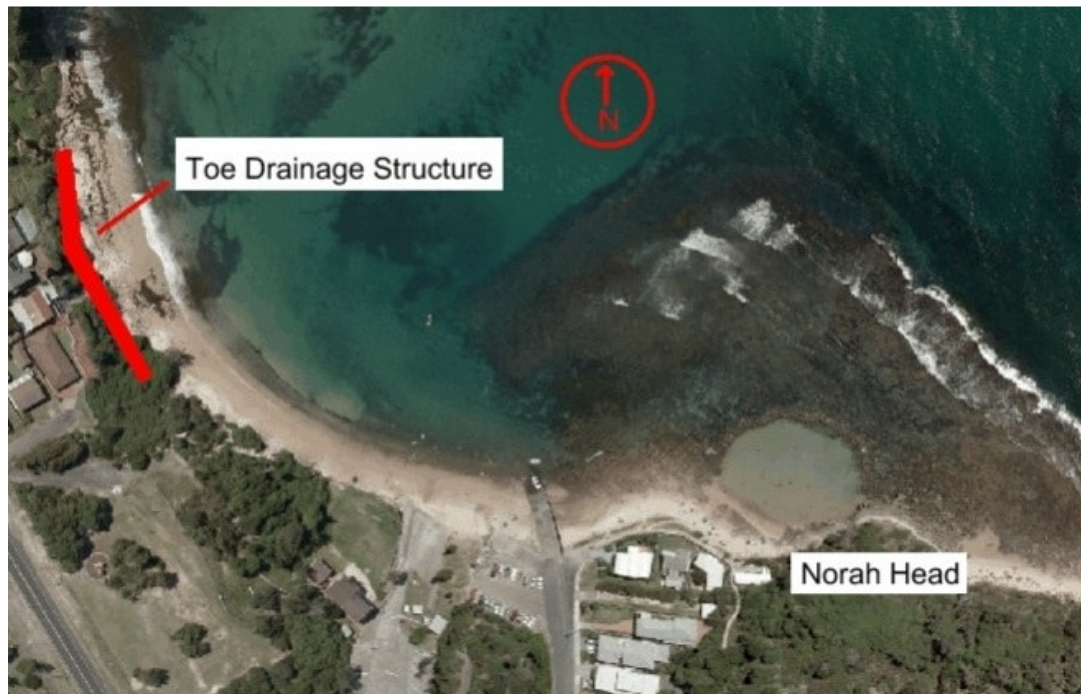
Figure 1: Cabbage Tree Harbour and the Toe Drainage Structure

Cabbage Tree Harbour (CTH) is located north of Norah Head on the Central Coast of NSW (Figure 1). The small pocket beach is popular with swimmers, surfers and boat users, but its northerly aspect provides exposure to seasonal storm activity from the east and north-east which has historically resulted in ongoing beach erosion.

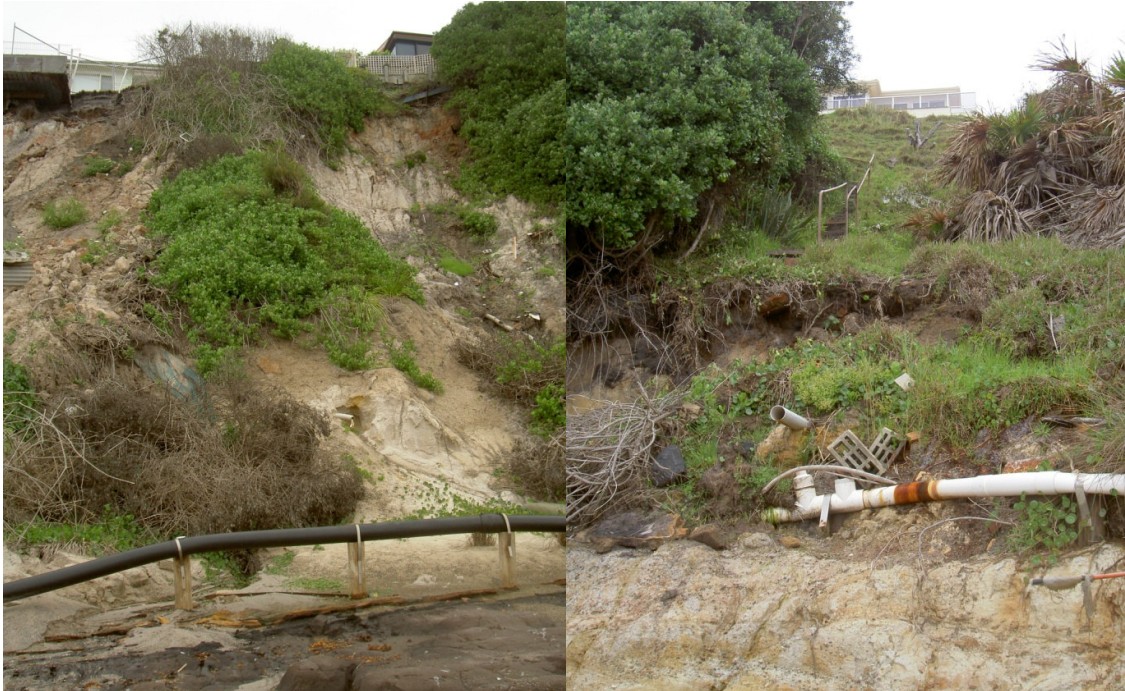
Figure 2: A photo of the original sub-horizontal drainage scheme installed in 2001 destroyed by wave erosion and embankment slippage

In 2001 Wyong Shire Council (WSC) installed a sub-horizontal drainage scheme at the north-western end of CTH to relieve ground water flows through the indurated sand dune, to improve stability of the bank and reduce the incidence of landslip. The scheme however was subjected to continuous damage during storms, required frequent maintenance, and was purported to have contributed to the undermining of the slope (Figure 2).

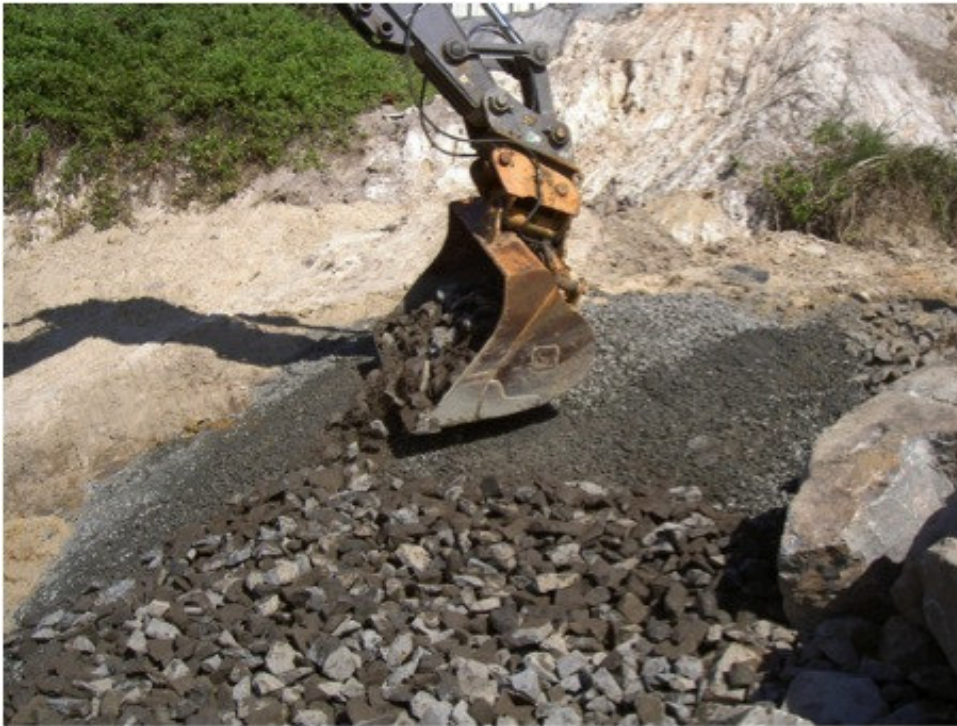
Figure 4: A photo of the placement of the graded filter layers (July 2011)

In total 780 tonnes of gravel filter materials were used, 365 tonne of under layer armour rock (500 – 600 mm diameter) and 1535 tonnes of outer armour rock (1000 – 1200 mm diameter) Graded filter materials were delivered separately and blended on site in Mazlin Reserve. The blending process and placement of the graded filter layers was undertaken seamlessly and eliminated the need for placement of an additional geotextile layer which expedited construction and eliminated a potential slip plane, which was considered important given the history of slip failures at the site (Figure 4).

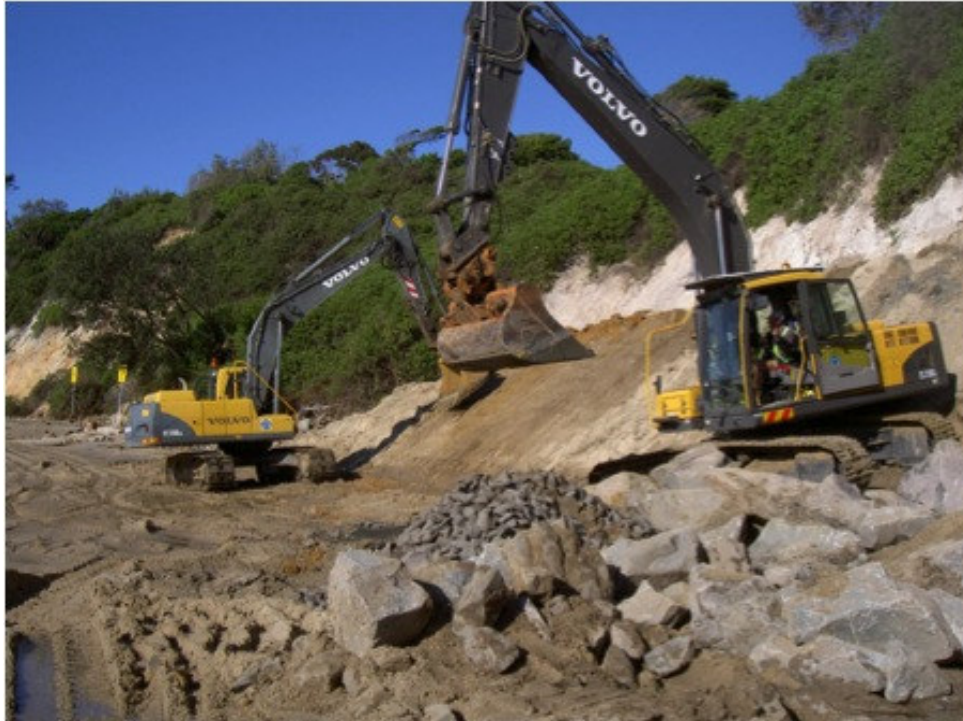
Figure 5: A photo of the 20T excavators working in tandem on the beach in CTH (July 2011)

Machinery used to construct Stage 1 of the TDS included two 20 tonne excavators working on the beach in CTH to place materials, a 12 tonne excavator receiving and loading materials from a stockpile site nearby in Mazlin Reserve, and three THWAITES 9 tonne power swivel dump trucks which transported the materials from Mazlin Reserve to the beach in CTH as required. The all-terrain trucks were able to work through mid-high tides and proved to be a key factor in delivering the project ahead of schedule and under budget.

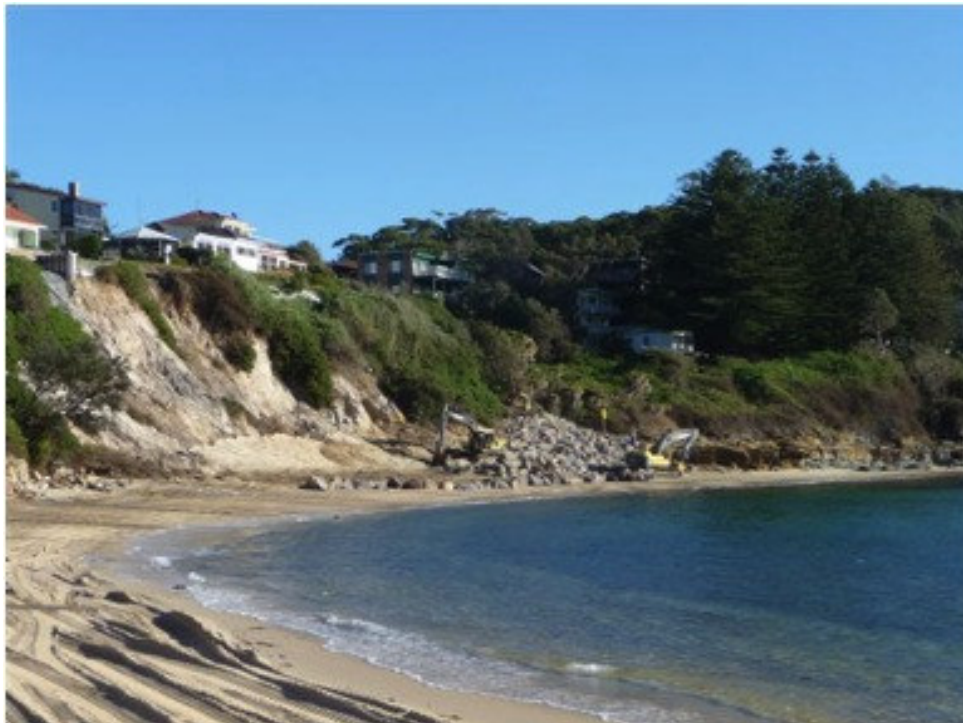
Figure 6: A progress photo of the construction of the TDS at north end of CTH (July 2011)

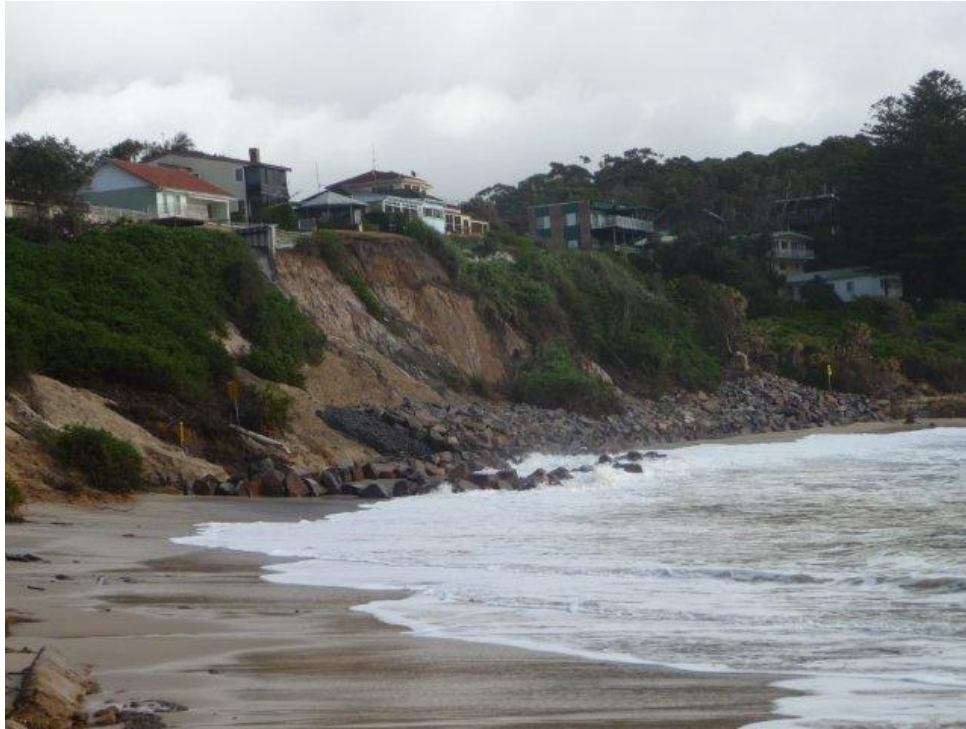
Figure 7: A progress photo taken during one of the few days lost to adverse weather. Note the armour rock used to form a temporary barrier to protect the work (July 2011)

Initial cost estimates and work programs assumed construction staff might be restricted to as few as four hours per day working normal business hours and around tides. Planning for extended work days and out of normal business work hours was made, however staff found once the work progressed they were able to work much longer hours each day than anticipated due to the use of specialized machinery adopted for the works and limited storm activity experienced throughout. Staff also found utilizing the large armour rock to temporarily line the lower section of the beach effective in retarding wave run-up and tidal activity (Figure 7)

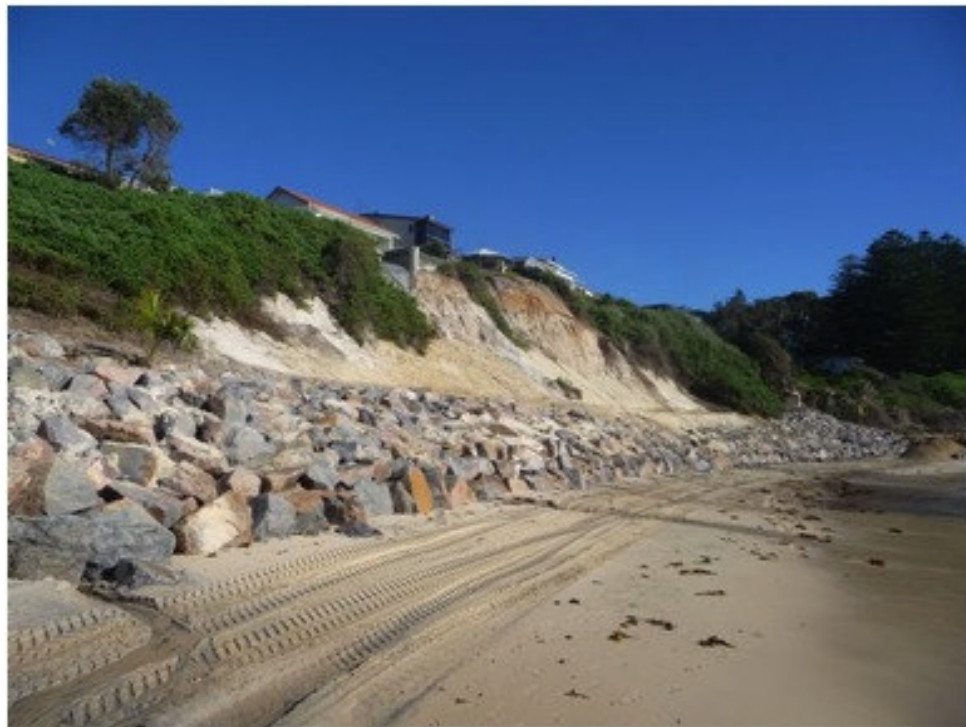
Figure 8: A photo of the completed TDS from beach level looking north (September 2011)

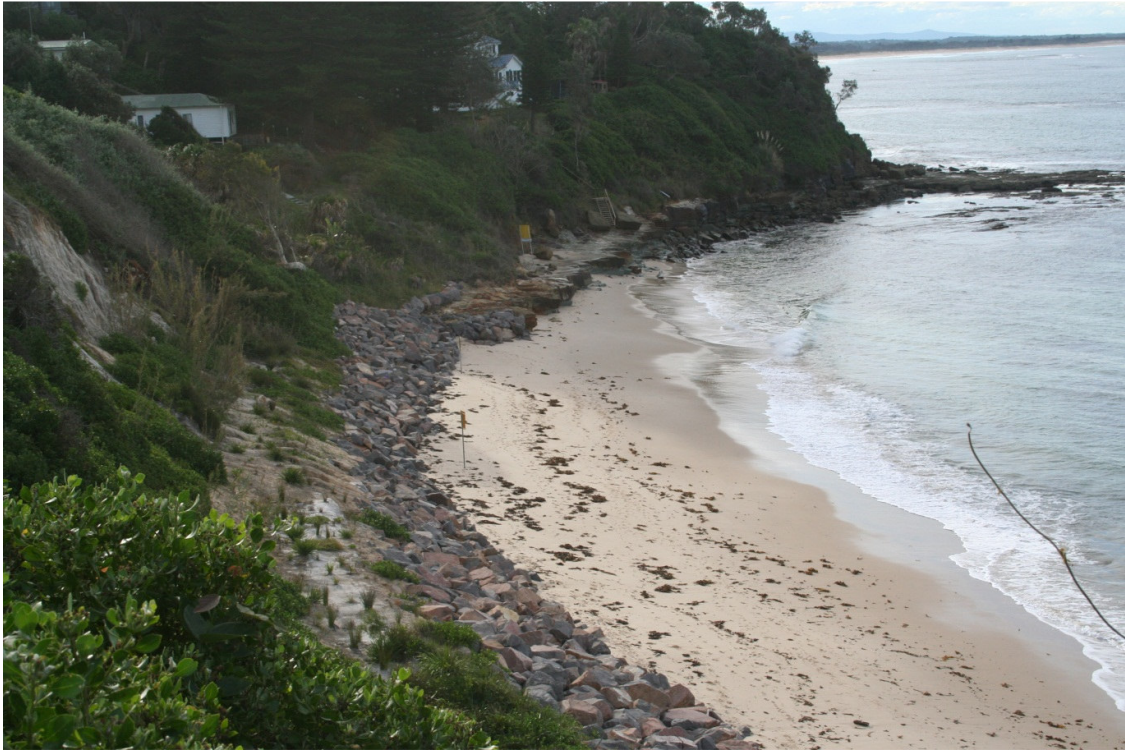
Figure 9: A photo of the completed TDS looking north (June 2013)

In September 2012 a follow-up survey was undertaken. In the 12 months prior there had been moderate storms and Council was interested in confirming whether the large armour stone had moved considerably. The results of the survey confirmed that the structure had only moved a maximum horizontal distance of 26 mm and a maximum vertical distance of 33 mm. This was considered a tremendous result and proof that the structure had been designed and constructed to a high standard.
