CONCEPT DESIGNS FOR A GROYNE FIELD ON THE FAR NORTH NSW COAST

I Coghlan¹, J Carley¹, R Cox¹, E Davey¹, M Blacka¹, J Lofthouse² ¹ Water Research Laboratory (WRL), School of Civil and Environmental Engineering, The University of New South Wales, Manly Vale, NSW ²Tweed Shire Council (TSC), Murwillumbah, NSW

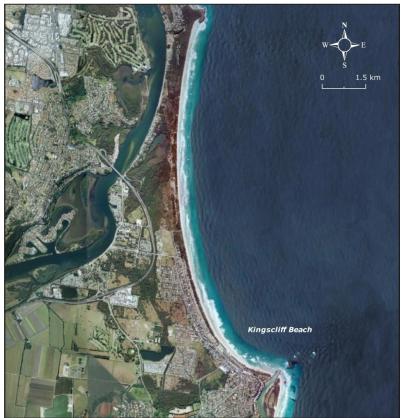
Figure 1: Location (Aerial Photo 23/06/2008)

Kingscliff Beach, located at the southern end of Wommin Bay on the far north coast of NSW (Figure 1), is a section of the Tweed coastline with built assets at immediate risk from coastal hazards. Ongoing erosion in the last few years has resulted in substantial loss of beach amenity and community land. Storm erosion episodes between 2009 and 2012 severely impacted the Kingscliff Beach Holiday Park (KBHP). This section is also affected by moderate ongoing underlying shoreline recession (WBM, 2001).

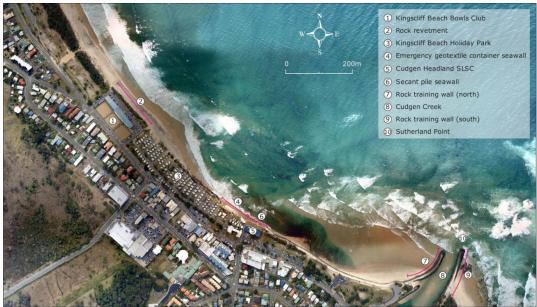
Figure 2: Site Details (Aerial Photo 21/07/2011)

To manage the Kingscliff Beach foreshore (Figure 2) in the longer term, Tweed Shire Council (TSC) is considering a combination of several of the following options:

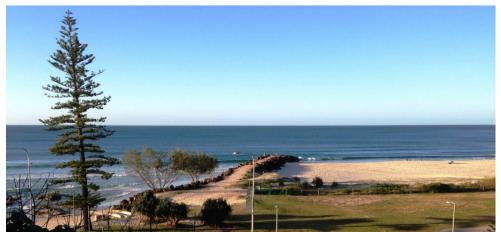
Figure 5: Kirra Point Groyne, Qld (Photo 07/07/2013, Prior to 2013 Restoration)

Kirra Point Groyne was originally constructed in 1972 extending seaward to -5 m AHD (Robinson and Patterson, 1975) with an approximate length of 180 m, but was then shortened by 30 m in 1996 (WorleyParsons, 2009). The groyne currently extends to approximately -3 m AHD (WorleyParsons, 2009) and is generally considered to be fulfilling its function of protecting Coolangatta/Greenmount Beach. At the time of writing, approvals were being sought to lengthen the groyne by 30 m to improve downdrift recreational surfing amenity, which would effectively return the structure to its original length. Miles Street Groyne, located approximately 500 m west of the Kirra Point Groyne, originally had a length of 120 m which was also shortened by 30 m in 1996 (WorleyParsons, 2009). Design parameters for the original Kirra Point Groyne (1972) are reproduced in Table 2.

On the basis that the shortened Kirra Point Groyne (1996-2013) is fulfilling its protective function and that the conditions experienced at this site are broadly similar to those at the southern end of Kingscliff Beach, the key properties of this structure were adopted for the concept design of the long term groyne field layout for Kingscliff Beach.

As discussed earlier, the nearby Kirra Point Groyne presently extends to the -3 m AHD contour and is generally considered to be fulfilling its function of protecting Coolangatta/Greenmount Beach. Note, however, that the bed level at the head of the Kirra Point Groyne is substantially modified by sand bypassing of the Tweed River training walls. Following consideration of the preceding information, it was assumed that the groynes would extend seaward to the -3 m AHD contour for concept design of the long term groyne field. On this basis, it is expected that approximately 50% of the net annual longshore sediment transport would bypass each groyne head (259,000 m³/year).

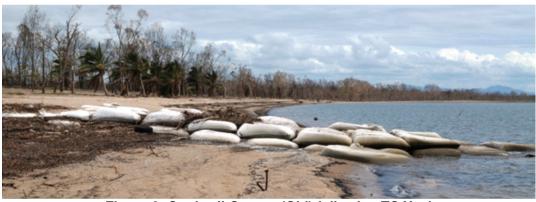
Figure 6: Cardwell Groyne (Qld) following TC Yasi

A short groyne (extending to -0.5 m AHD) composed of 2.5 m³ sand-filled geotextile containers exists at Cardwell in northern Queensland (Figure 6). As discussed in Carley et al (2011), Tropical Cyclone (TC) Yasi passed within 45 km of this structure in February 2011. While the structure was largely still in place following TC Yasi with minor displacement of some geocontainers, it does not have full exposure to the open ocean. The Cardwell Groyne has a crest level of 1 m AHD at the seaward end and 2.9 m AHD at the landward end. The toe level of the head of the groyne is -1 m AHD with a typical bed level at the head of approximately -0.5 m AHD.

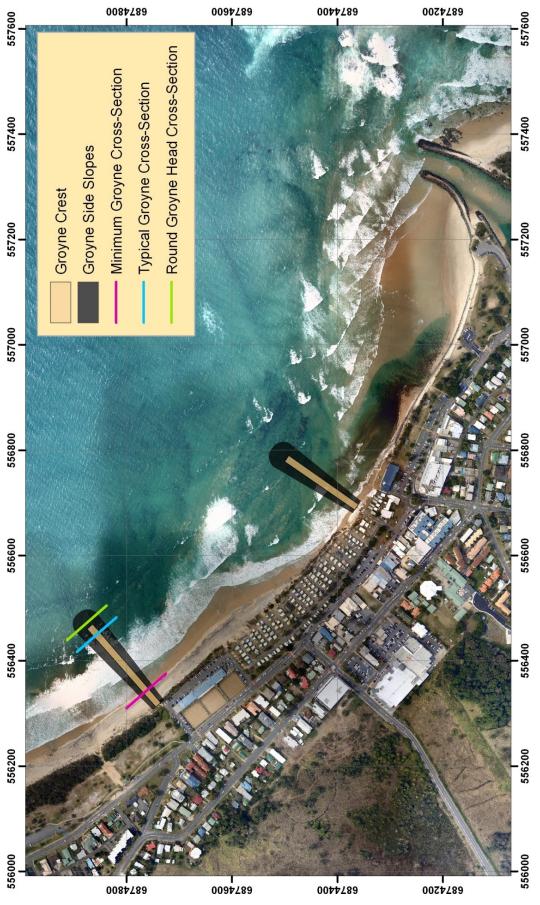
The target criterion of the groyne spacing not being more than four times the effective length has been complied with for both groyne field layouts (Table 4). Note that the two groynes for Layout 1 (with large scale beach nourishment) are longer than those for layout 2 (with a terminal seawall). This is because the nourished -3 m AHD contour is located approximately 50 m further seaward than the un-nourished -3 m AHD contour. Groyne Field Layout 1 is shown in Figure 9. Note that approximate positions of three typical groyne cross-sections (which are discussed in the following section) are also shown on Figure 9. Groyne Field Layout 2 has not been shown for brevity.

Groyne locations were determined through consideration of the location of existing structures. For both groyne field layouts, one groyne would be located at the northern end of the KBBC rock revetment. As such, down drift erosion/recession effects would impact the unprotected section of Kingscliff Beach to the north of Kingscliff Beach Bowls Club. A second groyne would be located approximately co-linear with the entrance road to Kingscliff Beach Holiday Park at the southern end of the park.

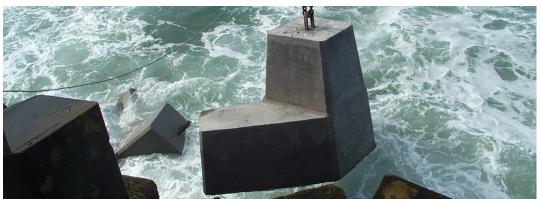
Figure 12: Placement of a Hanbar Armour Unit at Coffs Harbour, NSW

Enquiries with several quarries indicated that there was an abundance of greywacke rock but that the supply of basalt was more limited. However, it was not possible to acquire greywacke rock in sufficient quantities for construction with a median mass greater than 7.0 t. On the basis of hydraulic stability (Carley et al, 2011), sand-filled geotextile containers were found to be unsuitable for the groyne field if the design working life is 50 years. Since no evidence was found of long-lasting impermeable pile structures made from timber or concrete during the literature review, they were not considered further as construction materials. Hanbars are three-legged, pre-cast unreinforced concrete armour units (Figure 12) which provide a non-proprietary means of gaining stable armour on coastal structures where it is impractical to use quarry rock and are more economical than concrete cubes providing the same degree of protection. These armour units have been widely used in NSW.
