MANAGING WAMBERAL BEACH – THE FORGOTTEN TWIN

D Lord¹, T Macdonald²

¹Coastal Environment Pty Ltd, Newcastle, NSW.

²Central Coast Council, Gosford, NSW.

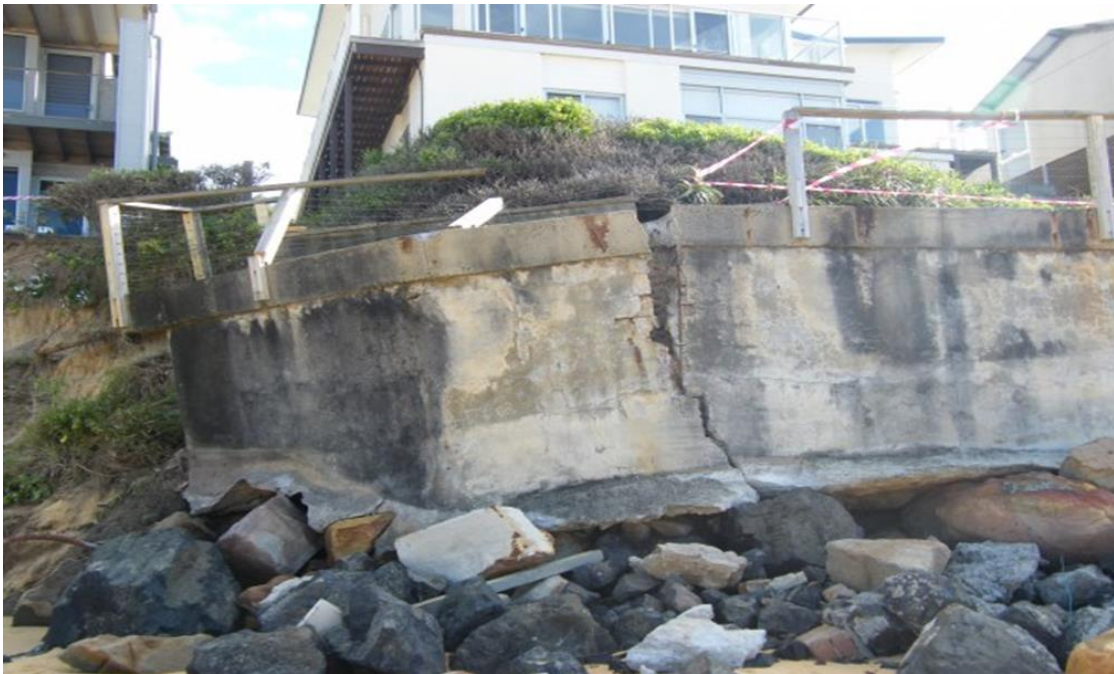
Plate 1 – Concrete seawall on Wamberal Beach undermined and damaged following June 2016 storms Photo: Coastal Environment, June 15th 2016.

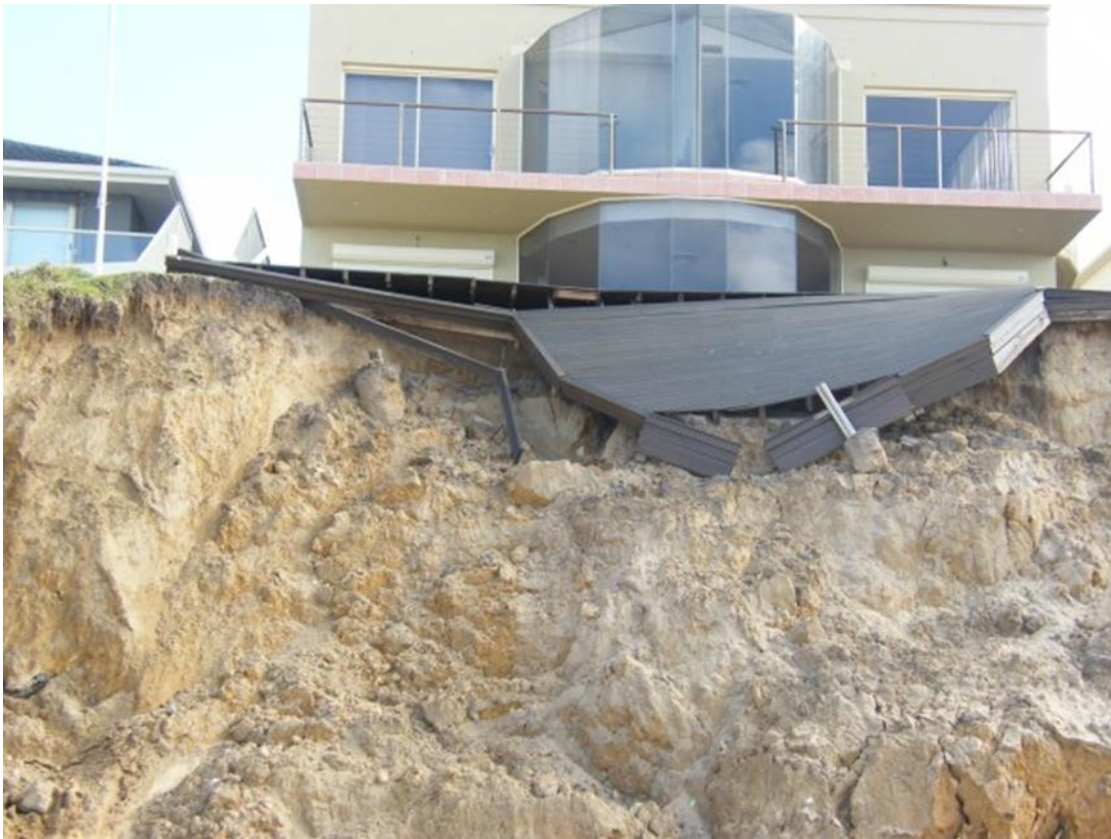
Plate 2 – Five metre high storm erosion escarpment undermined fencing and timber deck on Wamberal Beach. Photo: Coastal Environment, June 15th 2016.

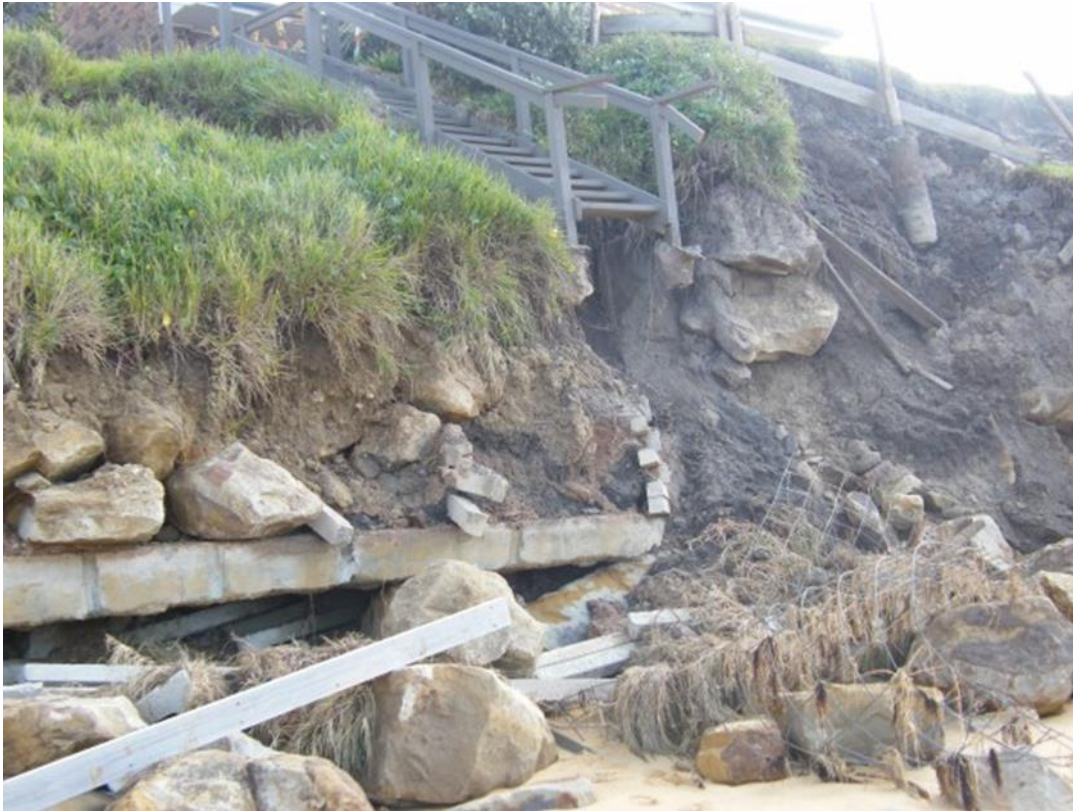
Plate 3 – Eroded escarpment on Wamberal Beach with collapsing structures, voids and suspended rock posed an immediate hazard following June 2016 storms. Photo: Coastal Environment, June 15th 2016.

The erosion escarpment fronting 12 properties was identified as posing a high risk to public safety, in some cases having a steep and unstable slope exposed to a height of 6 metres. Again at these locations a further geotechnical and coastal engineering assessment was recommended prior to remediation works being commenced. A further 24 erosion scarps were classed as a medium risk and requiring some rehabilitation.

For those scarps identified as “high” risk at Wamberal, care was essential when working in close proximity to the base of the slopes. For those 12 properties designated high risk, it was recommended that a further detailed geotechnical and coastal engineering assessment should be undertaken prior to rubbish removal from the face of the slope or any slope stabilisation being commenced.

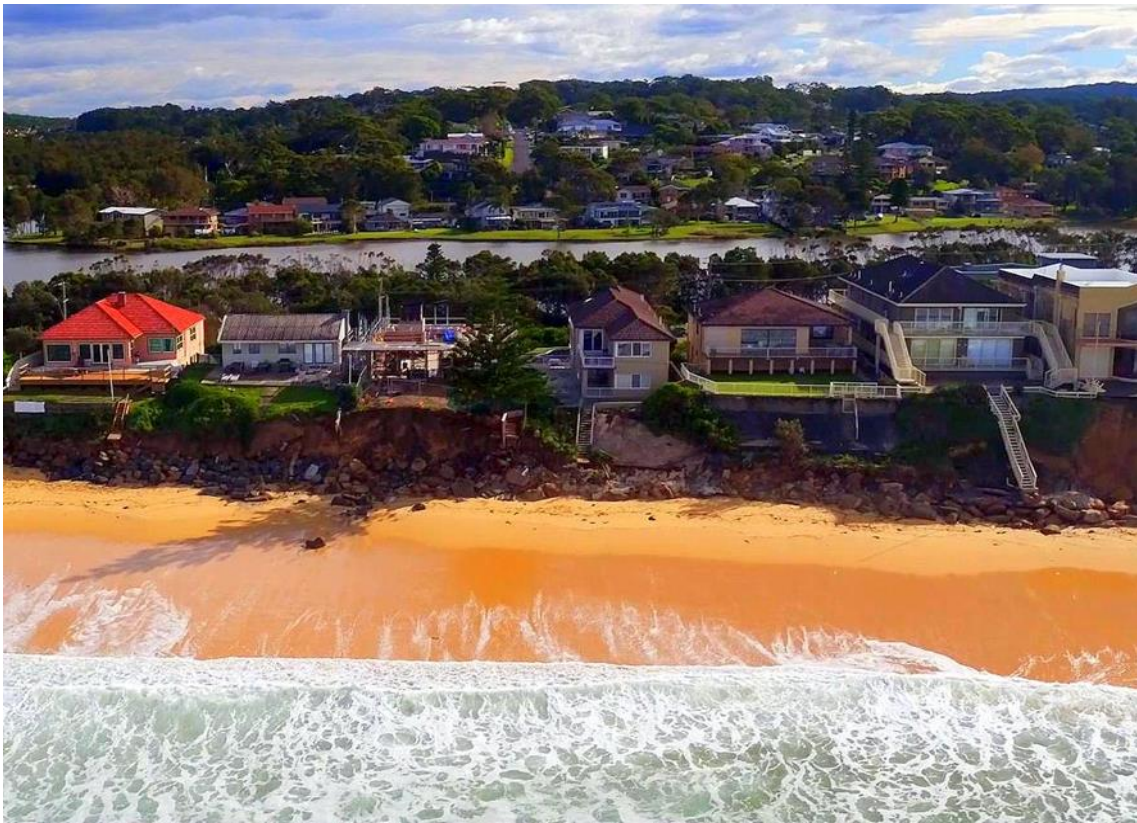
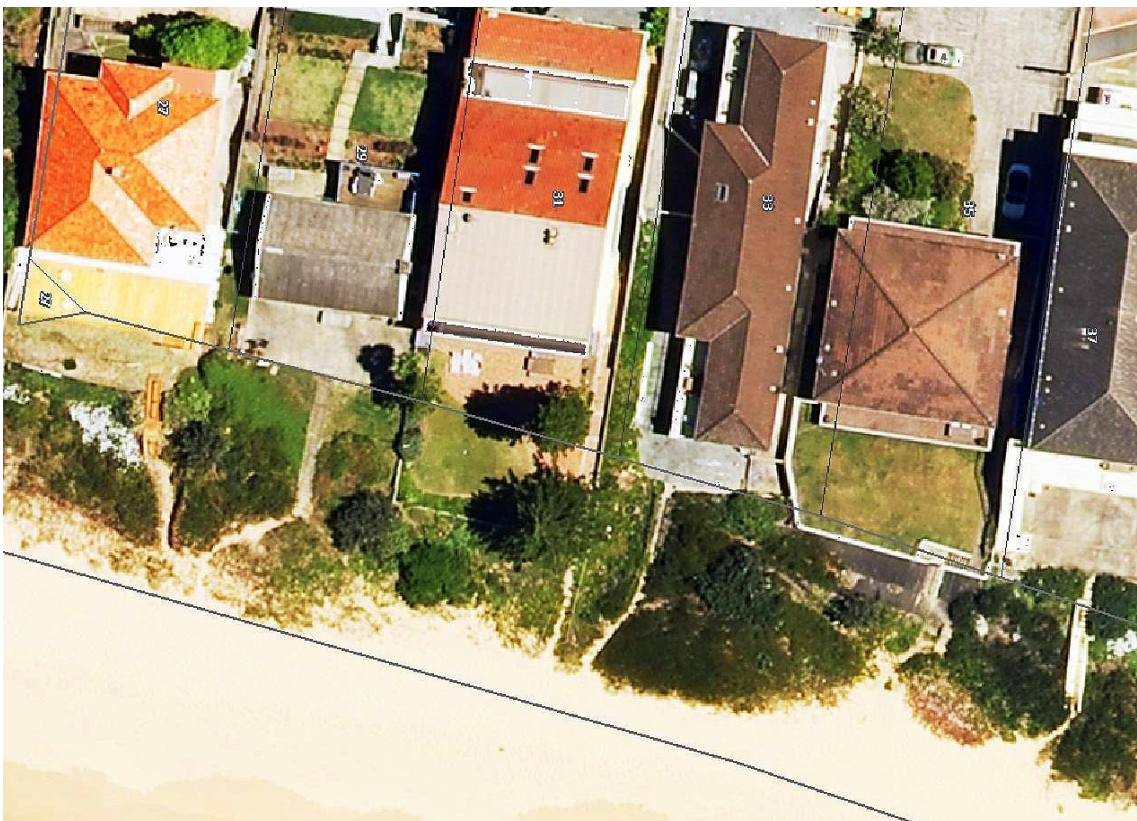
**Plate 4A Top: A section of Wamberal Beach erosion post storms, 5/6/2016.
Plate 4B Bottom: Same section of Wamberal Beach pre-storm with seaward cadastral boundary shown.**

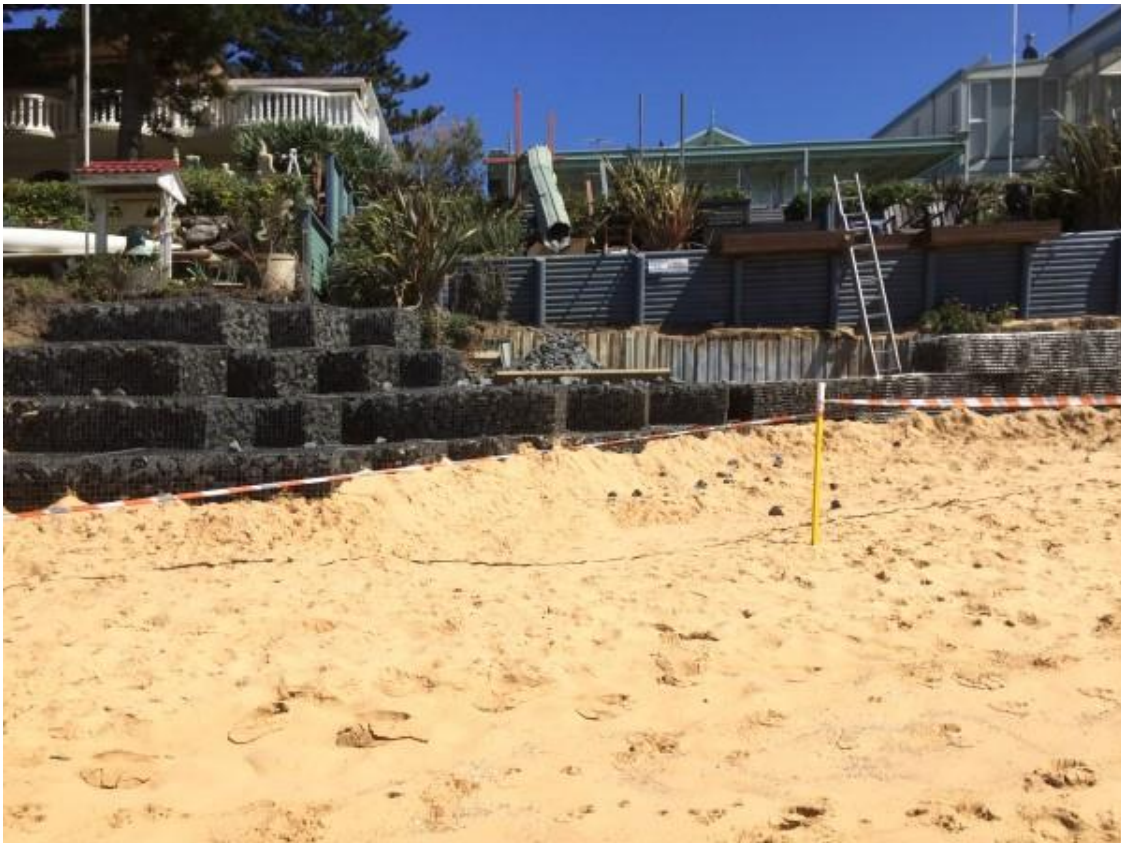
Some works currently being constructed are substantial. This is of great concern as many:

- are being erected without prior development consent of the consent authority in cases where prior development consent is required;
- are unlikely to meet the requirements of Chapter 6.2 of the Gosford Development Control Plan 2013. Some ancillary structures are seaward of the Coastal Building Line mapped with the DCP. For example, one Gabion revetment is unlikely to comply with normal engineering requirements for a coastal protection structure in this location; and
- are likely to increase risk to the public and neighbours due to design deficiencies.

Plate 5 - Gabion revetment under construction at Wamberal Beach following June 2016 storm erosion.

Photo: T Macdonald, Central Coast Council. September 26th 2016.
