BREAKWATERS AND TRAINING WALLS THE GOOD, THE BAD AND THE UGLY

A F Nielsen¹, A D Gordon²

¹Advisian WorleyParsons

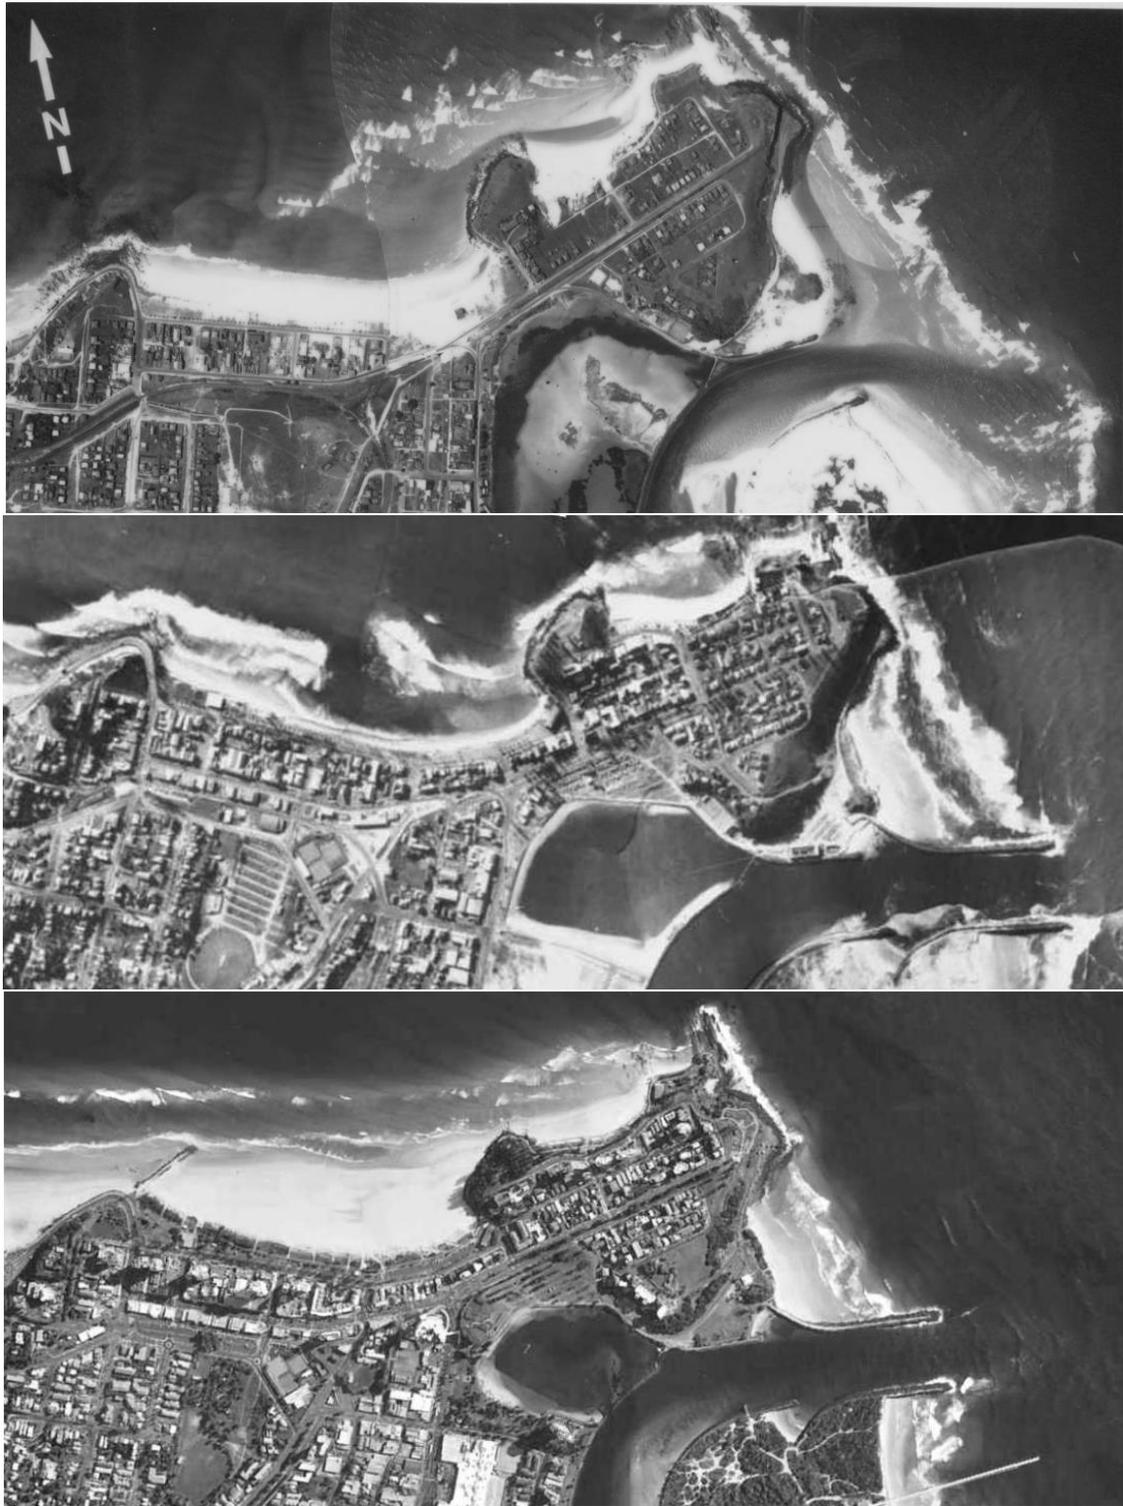
Figure 1. Top: Tweed River entrance in 1935 prior to breakwater extension. Centre: Tweed River entrance in 1967 following breakwater extension. Note improvements to channel navigation and the depletion of Coolangatta Beach. Bottom: Tweed River entrance in 2004 following installation of sand bypassing system. Note accretion of Coolangatta Beach. (from Ackworth & Lawson, 2011)

Safe passage into the Tweed River has long been hindered by the periodic formation of sand shoals at the river entrance. River training works and dredging have been undertaken since the late 19th century in attempts to improve navigability. These works culminated in the extension of the training walls at the river entrance to form breakwaters during 1962-65. Although this improved navigation for a period, the entrance bar reformed and again created difficulties for navigation. The Tweed breakwaters have trapped sand, taking it out of the littoral system through the accretion of Letitia Spit, causing coastal erosion on the Gold Coast (Figure 1), requiring the construction of expensive sand-bypassing systems (Figure 2) and revetments (Figure 3) to offset their impacts.

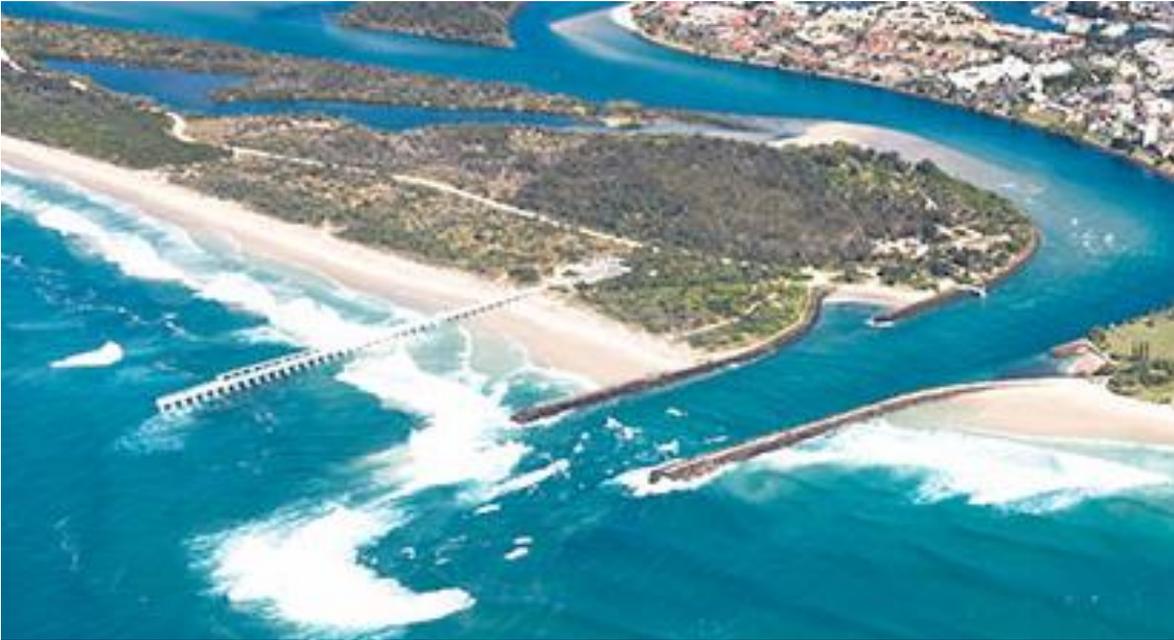
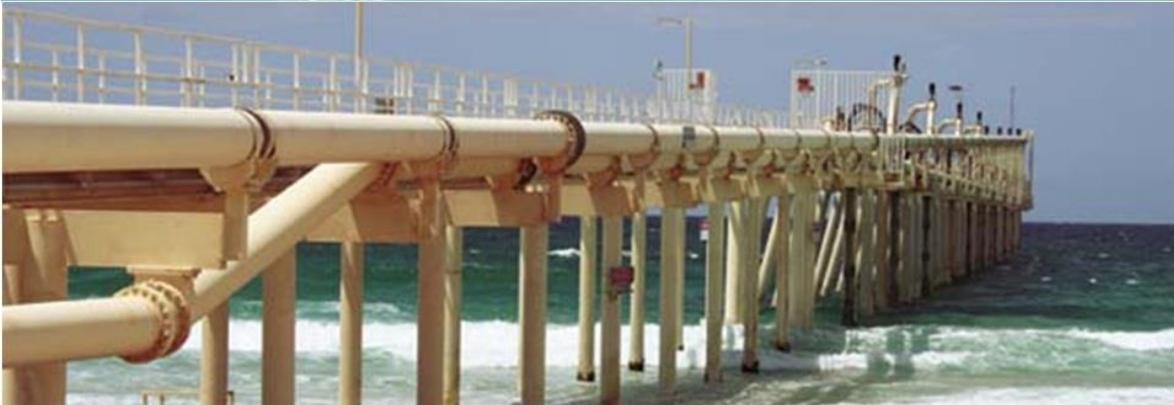
Figure 2. Tweed River entrance and sand-bypassing system comprising trestle, sand pumps and pipelines (©Tweed River Entrance Sand Bypassing Project (TRESBP))

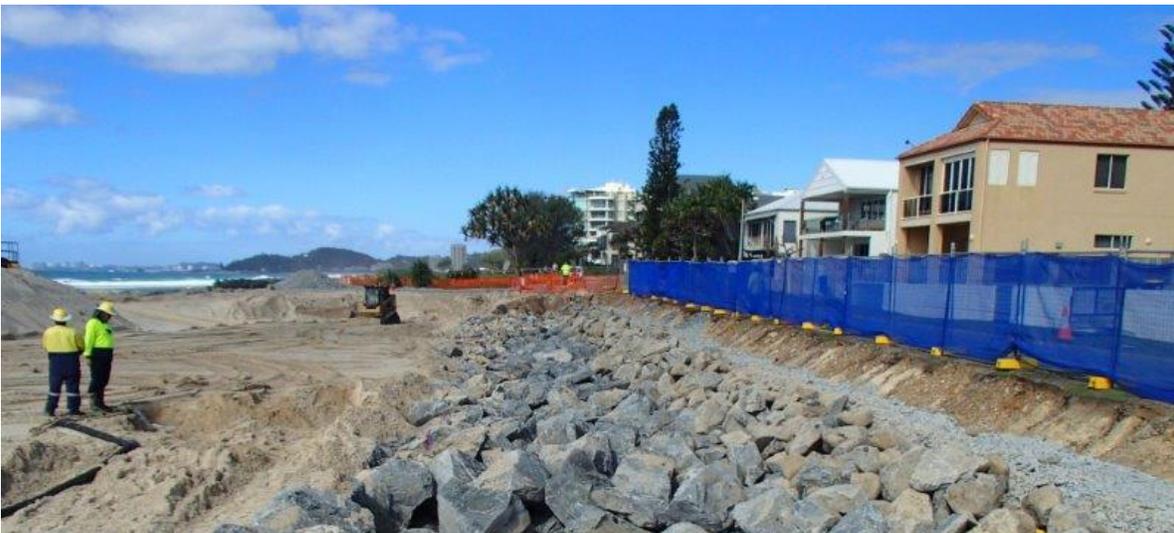
Figure 3. Revetment under construction, Palm Beach, Gold Coast

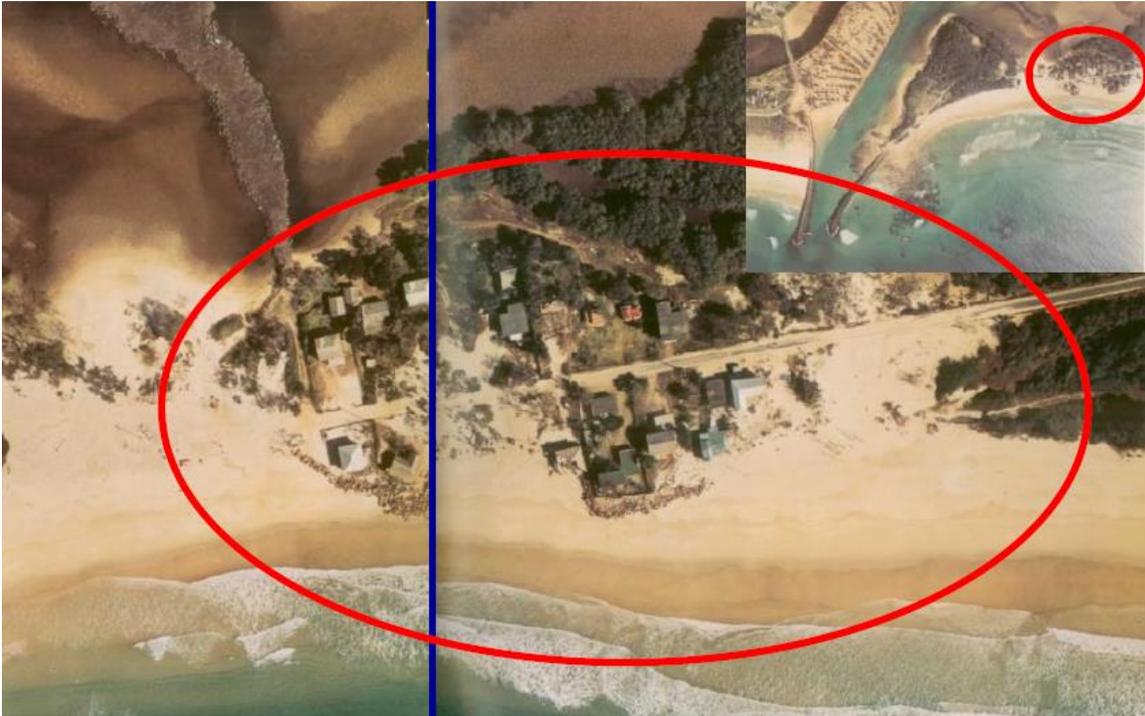
Figure 5. The destruction of Sheltering Palms village to the north of the entrance breakwaters on the Brunswick River

Between 1960 and 1962 twin breakwaters were constructed at the entrance to the Brunswick River. Up until that time a small rock outcrop on the northern side of the river created a slight deflection of the long beach between Byron Bay and Hastings Point. However, the breakwaters effectively created a new headland resulting in significant accretion and re-alignment of the beach to the south and erosion and formation of a crenulated shoreline to the north. Initially, the impact of the sand trapping to the south was sufficient that, within 10 years, the small village of Sheltering Palms, on the northern side, was devastated completely with cyclone waves breaking through the village into the North Arm of the Brunswick River. After natural by-passing was established and with the assistance of beach scraping, dunes and a beach were re-established to the north. However, the new alignment of the overall embayment reflects the imposition of the artificial “headland” of the Brunswick breakwaters.

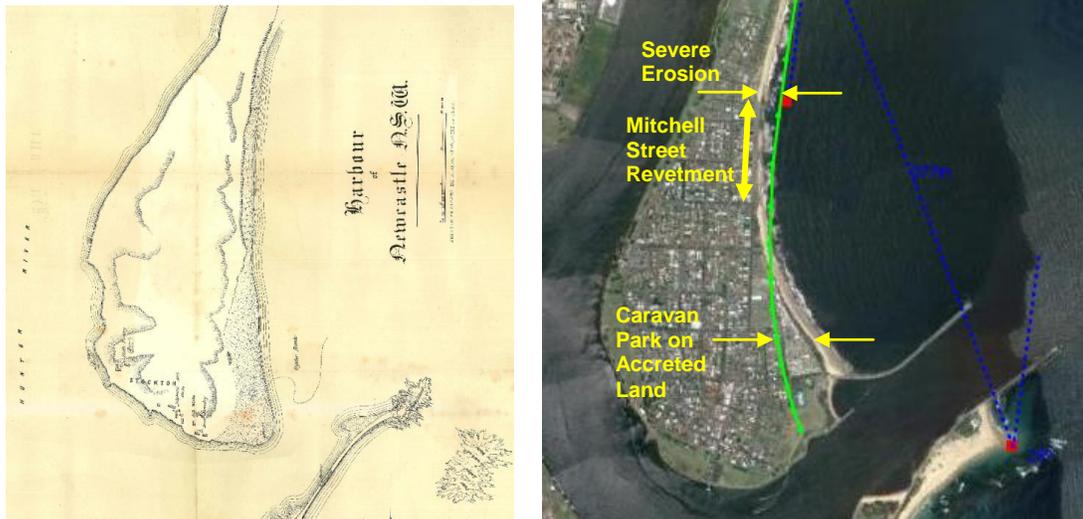
Figure 6. Left: Entrance to Newcastle Harbour (circa 1850). Right: Present-day entrance with MEPBAY 1850 predicted shoreline superimposed indicating foreshore re-alignment and severe erosion and accretion.

In between 1818 and 1856 a breakwater was constructed on the south side of the Hunter river entrance to connect the rock outcrop at Nobbys to the mainland. Between 1875 and 1915 this was extended offshore from Nobbys to provide further protection to the harbour entrance. Effectively, this extended the “headland” at the entrance. But it was the northern breakwater constructed between 1898 and 1912 that had the most significant impact on the shoreline at Stockton. This breakwater cut off the flood tide channel that had run along the beach and into the entrance. The result was the effective removal of the entrance bar and a significant accretion of sand on the northern side of the north breakwater. This accretion moved the shoreline approximately 300 metres seaward at the breakwater and resulted in a build up estimated to be of the order of two million cubic metres of beach sand at Stockton. However, it also induced erosion to the north as the shoreline responded to the changed tidal flow and wave conditions. A software package called *Model for Equilibrium Planform of Bay Beaches* (MEPBAY; Klein *et al.* 2003) was used to calculate the shoreline planform of Stockton Beach prior to breakwater construction (Figure 6 right). This modelled shoreline was verified by reference to historical surveys (Figure 6 left) and indicated both the accretion that has occurred on the northern side of the breakwater and the severe erosion that has occurred on Stockton Beach following breakwater construction as a result of the formation of a crenulated embayment. The erosion has continued as a result of both the realignment of the beach and the net loss of sand into the dunes of Newcastle Bight (Gordon and Roy, 1977). This has resulted in the requirement to construct a rock revetment to protect Mitchell Street and the village.

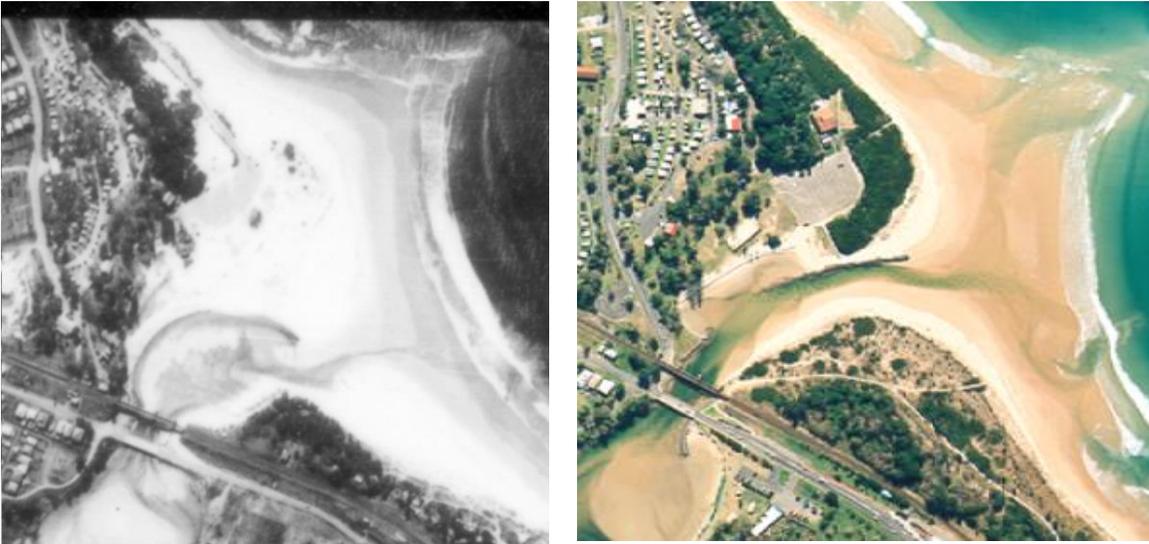
Figure 8. Coffs Creek entrance 1969 (left) and 1996 (right) © NSW Land Information Centre

Training walls in tidal channels increase hydraulic conveyance and channel velocities (Nielsen 2002; Nielsen & Gordon 2016 in press). In 1987 a rock training wall was constructed on the northern bank of the Coffs Creek entrance. As indicated in Figure 8, this changed an ICOLL to a permanently open estuary. The deepened channel discharged spring ebb tides at speeds over 1 m/s and the creek bed portrayed current-related bedforms over 0.5 m high (Nielsen 2002). These fast-flowing, undulating conditions are attractive to swimmers who like to use the creek as a water slide. On 23rd January 1999, one such enthusiast was sporting in the creek when his head hit a bedform as he dived into the fast-flowing turbid waters of unknown and variable depth, rendering him quadriplegic. After the trial the Council erected four signs at access points: three on the northern bank of the creek and one on the southern side. Under a heading "GENERAL WARNINGS", there appeared under pictorial devices the words "SUBMERGED OBJECTS", "DANGEROUS CURRENT", "SLIPPERY ROCKS" and "NO LIFEGUARD OR LIFESAVING SERVICE HERE TODAY" (Gummow 2005).

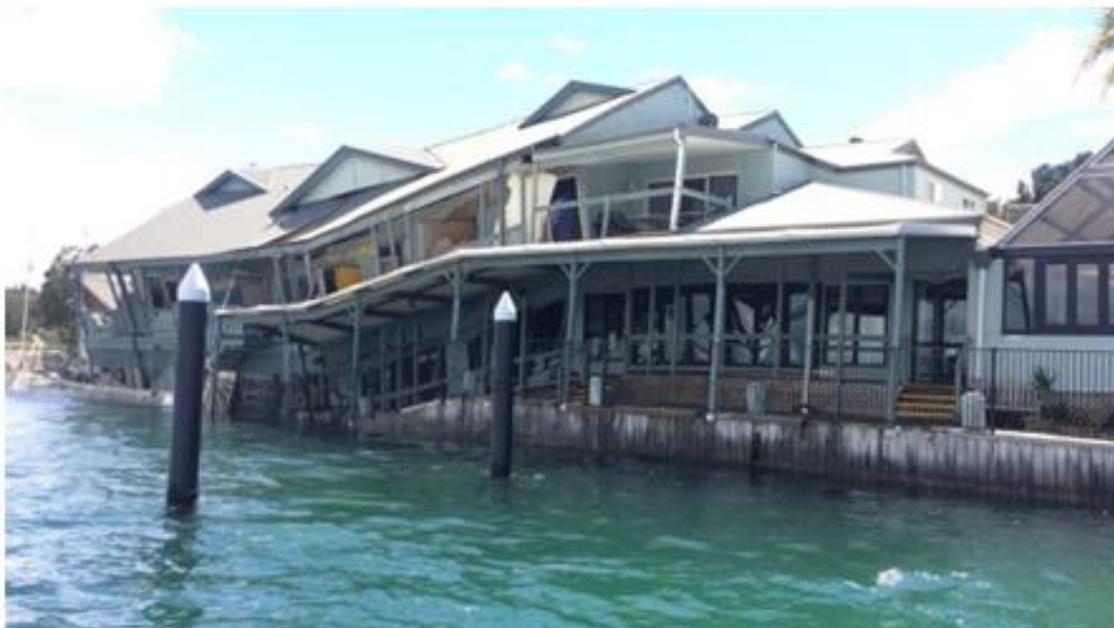
Figure 9. At Lake Macquarie, the collapse of a Swansea Channel foreshore building comprising restaurant, offices and residences on 8 February 2016 (Photo: Fire & Rescue NSW).

- Channel scour has resulted in the total collapse of some foreshore buildings and undermined bridge foundations as well as undermining river training works (e.g., Swansea Channel Lake Macquarie Figure 9).
- Breakwaters have re-aligned the foreshore causing beach erosion, loss of residential development and other infrastructure (e.g., Brunswick Heads Figure 5;).
- Breakwaters causing erosion have sometimes necessitated revetment construction to limit erosion thereby destroying beach amenity (e.g., Stockton Beach at Hunter River Newcastle Figure 10).
- Training walls in tidal channels can create dangerous conditions that may cause serious injury to swimmers (e.g., Coffs Creek).
- High ebb tide velocities on the ocean bars have presented challenges to recreational boating and have seen boating fatalities (e.g., Foster; Lake Wagonga Narooma Figure 11).

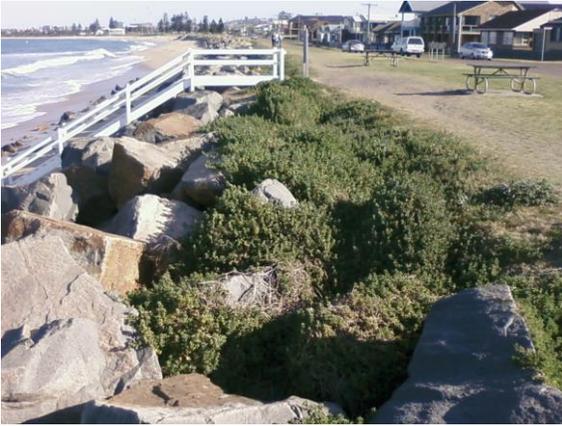
Figure 10. Left: Rock revetment to protect Mitchell Street. Right: Severe erosion north of the rock revetment

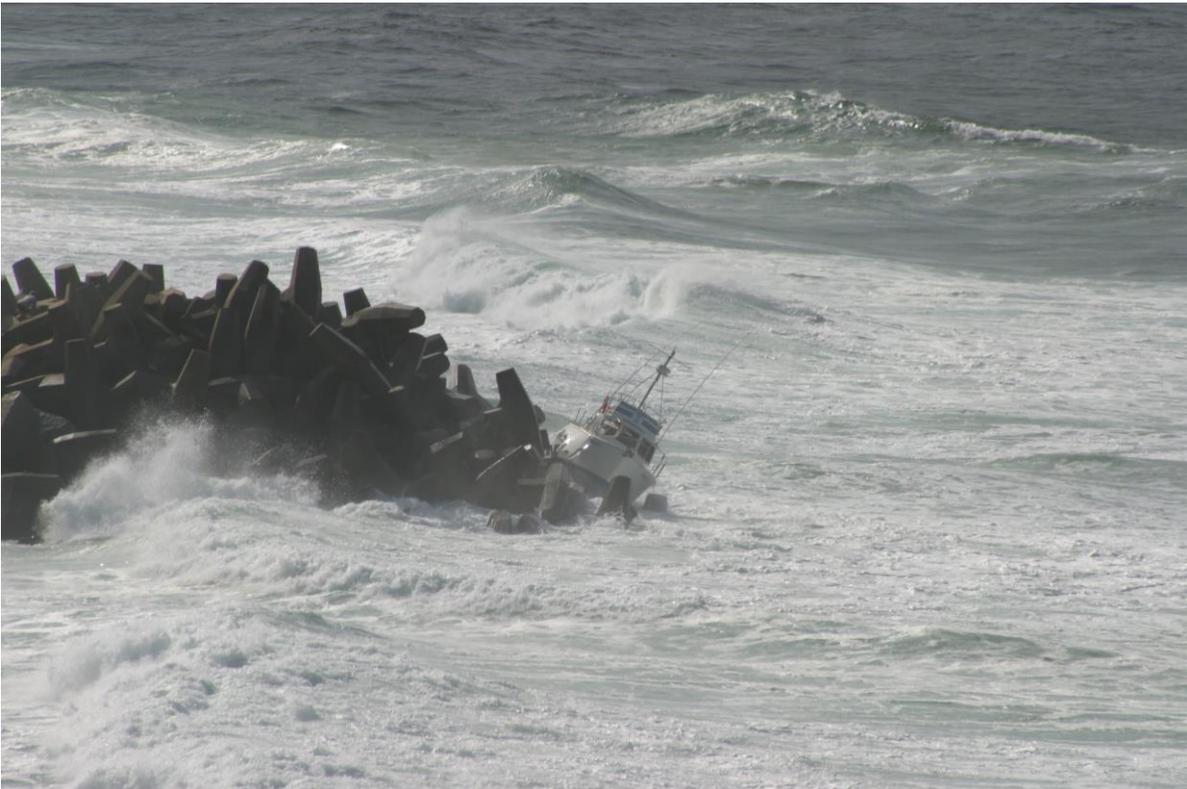
Figure 11. Charter boat smashed on the end of the Narooma Breakwater (Photo Batemans Bay Post). Since 1970 there have been more than 11 deaths and 100 rescued.
