# **The long and short of responding to East Coast Lows: Actions and policy response from two coastal erosion hotspots**

**C Morrison**<sup>1</sup>, T Macdonald<sup>2</sup>, T Dickinson<sup>1</sup>

<sup>1</sup>Northern Beaches Council, NSW

<sup>2</sup>Central Coast Council, NSW

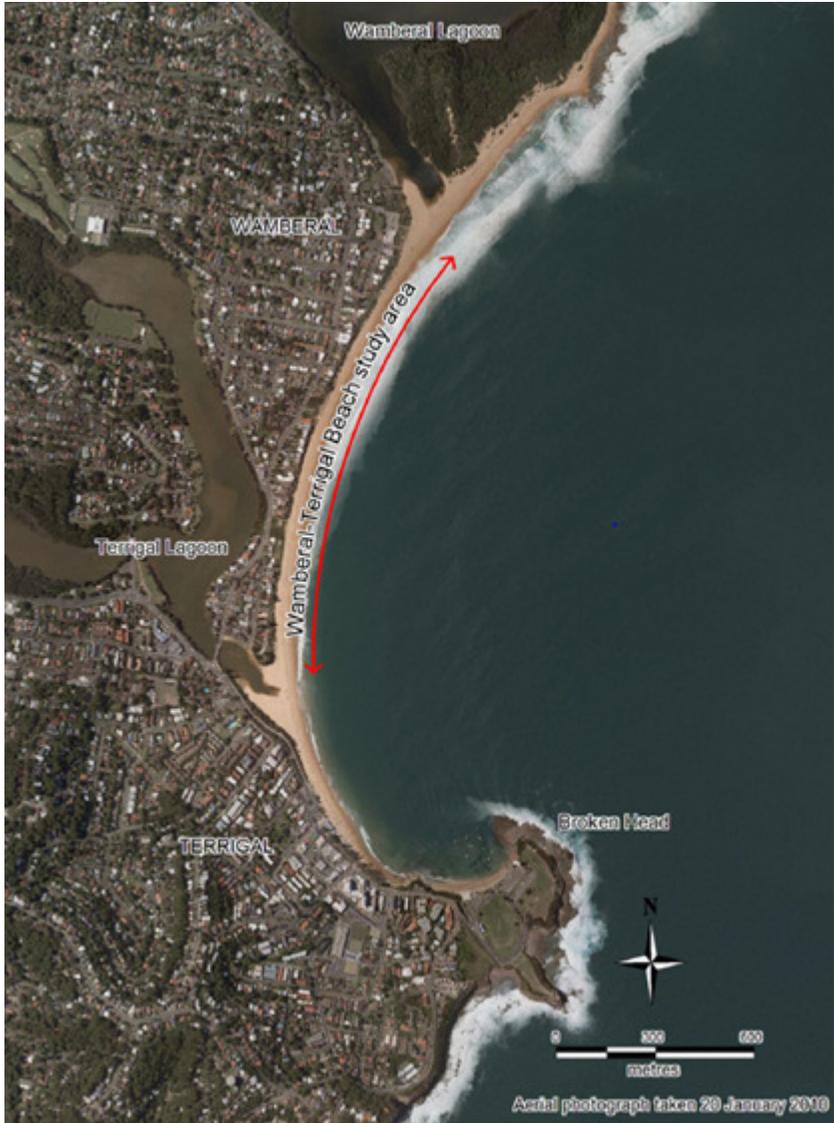
**Figure 1:** Wamberal/ Terrigal Beach embayment

Wamberal Beach located within the Local Government Area of the Central Coast between Broken Head and Wamberal Point on the Central Coast of NSW, approximately 10km east of the Gosford City CBD.

Coastal investigations show that the foreshores of the Terrigal/Wamberal embayment have experienced a gradual recession over a period of at least sixty years, interspersed with more severe episodes of storm erosion. The identified shoreline recession is ongoing and is gradually exposing the fore dune (and development thereon) to more frequent storm erosion events.

An aerial view of both beaches is provided in Figures 1 and 2.

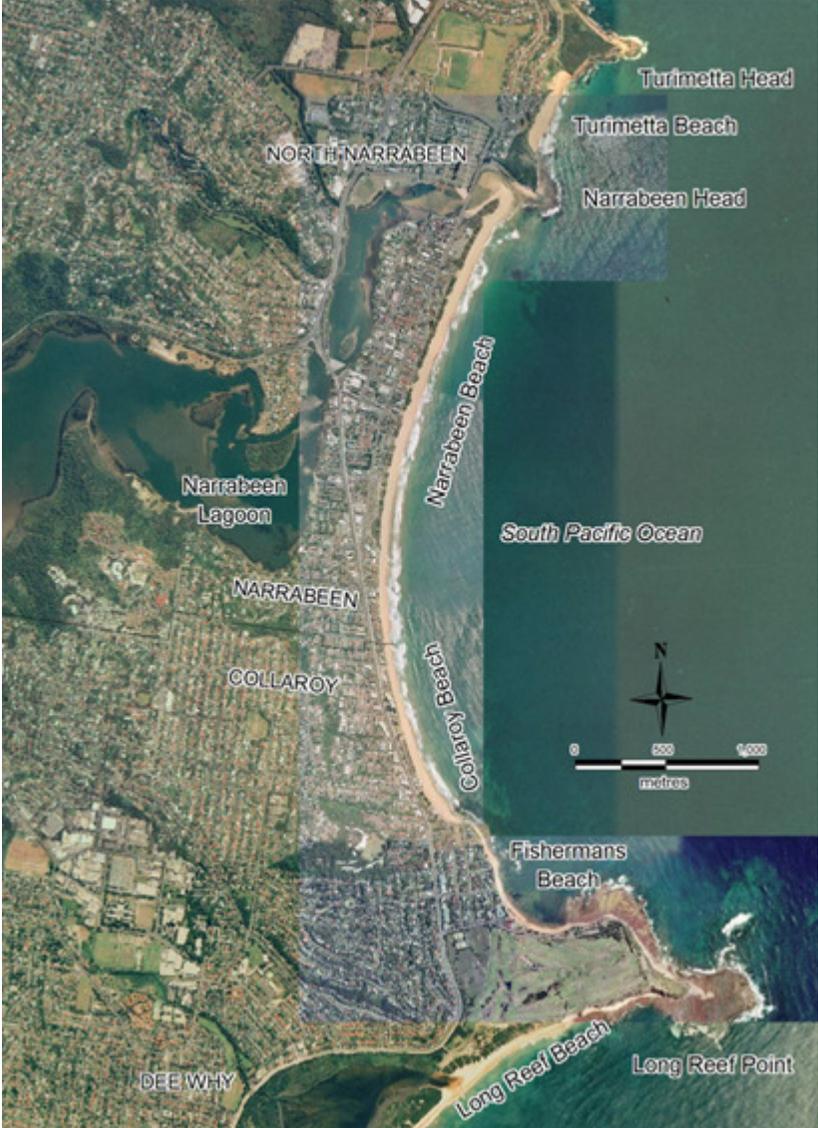
**Figure 2:** Collaroy-Narrabeen Beach embayment

Collaroy-Narrabeen Beach is located within the Local Government Area of the Northern Beaches Council in Sydney's north between Narrabeen Head and Long Reef Headland. Like Wamberal Beach the prevailing offshore wave climate is predominantly from the south-east with wave exposure along the beach increasing to the north.

The Shoreline recession at Collaroy-Narrabeen is considered minor compared to that at Wamberal, with the Collaroy-Narrabeen embayment considered to be a closed sediment compartment. Extensive monitoring over the beach of the last 40 years indicates that the volume of sand in the embayment at any time has remained constant. (PWD 1987)

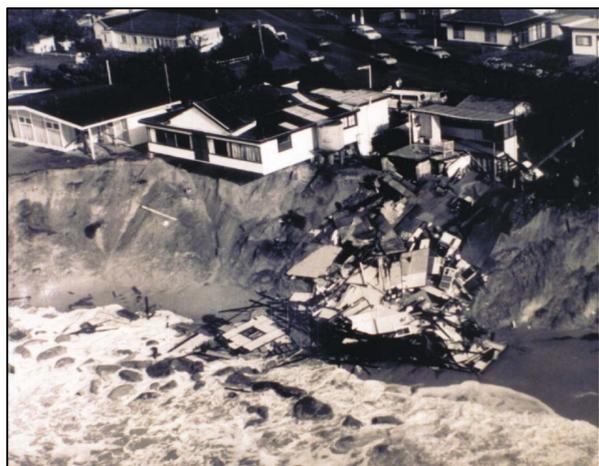
**Figure 3:** House collapse at Wamberal-Terrigal beach 1978

Figures 3 and 4 depict the impacts of historic storm events.

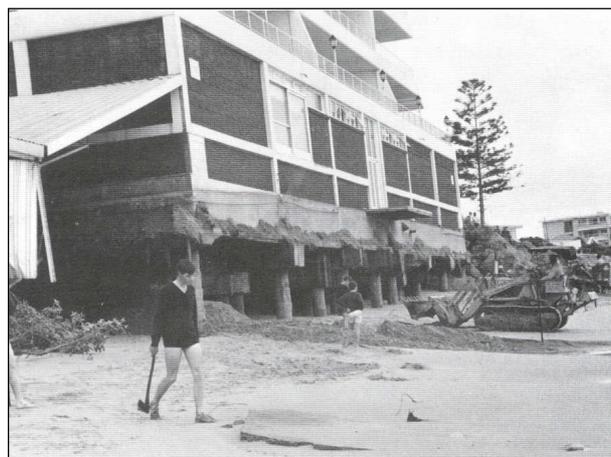
**Figure 4:** Exposure of "Flight Deck" foundations at Collaroy as a result of 1967 storms

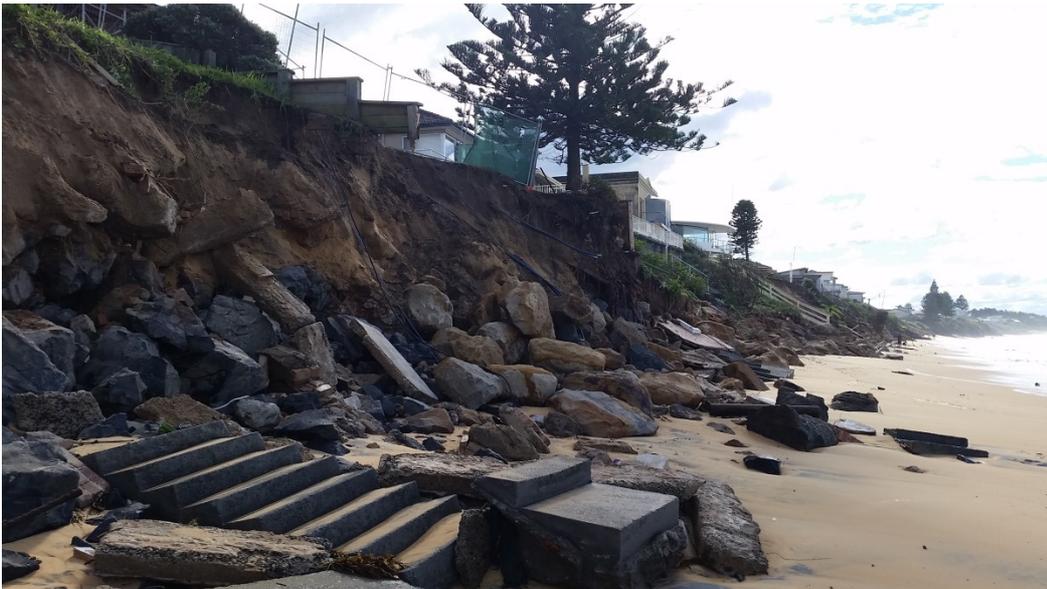
**Figure 5:** Exposed informal works at Wamberal Beach

At Wamberal beach this informal protection was placed primarily the 1960's, 1974 and 1978. While at Collaroy-Narrabeen Beach placement of rocks began in the 1920's, with extensive rock being added in the 1960's, 1970's and up to the late 1990's.

Figures 5 and 6 depict the works as exposed during the June 2016 storm at Wamberal and Collaroy-Narrabeen beaches.

At both locations, the quality of these protection works is variable and generally does not satisfy current design standards. Therefore they cannot be certified by a qualified coastal engineer as providing protection from coastal storms.

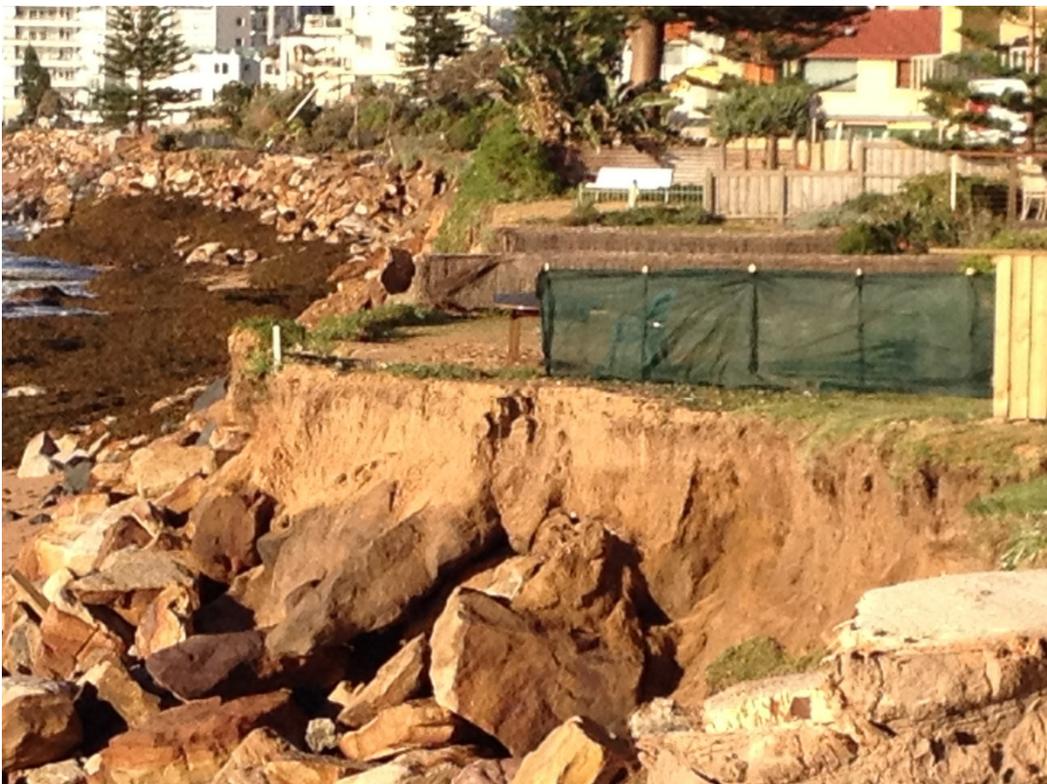
**Figure 6:** Exposed informal works at Collaroy-Narrabeen Beach

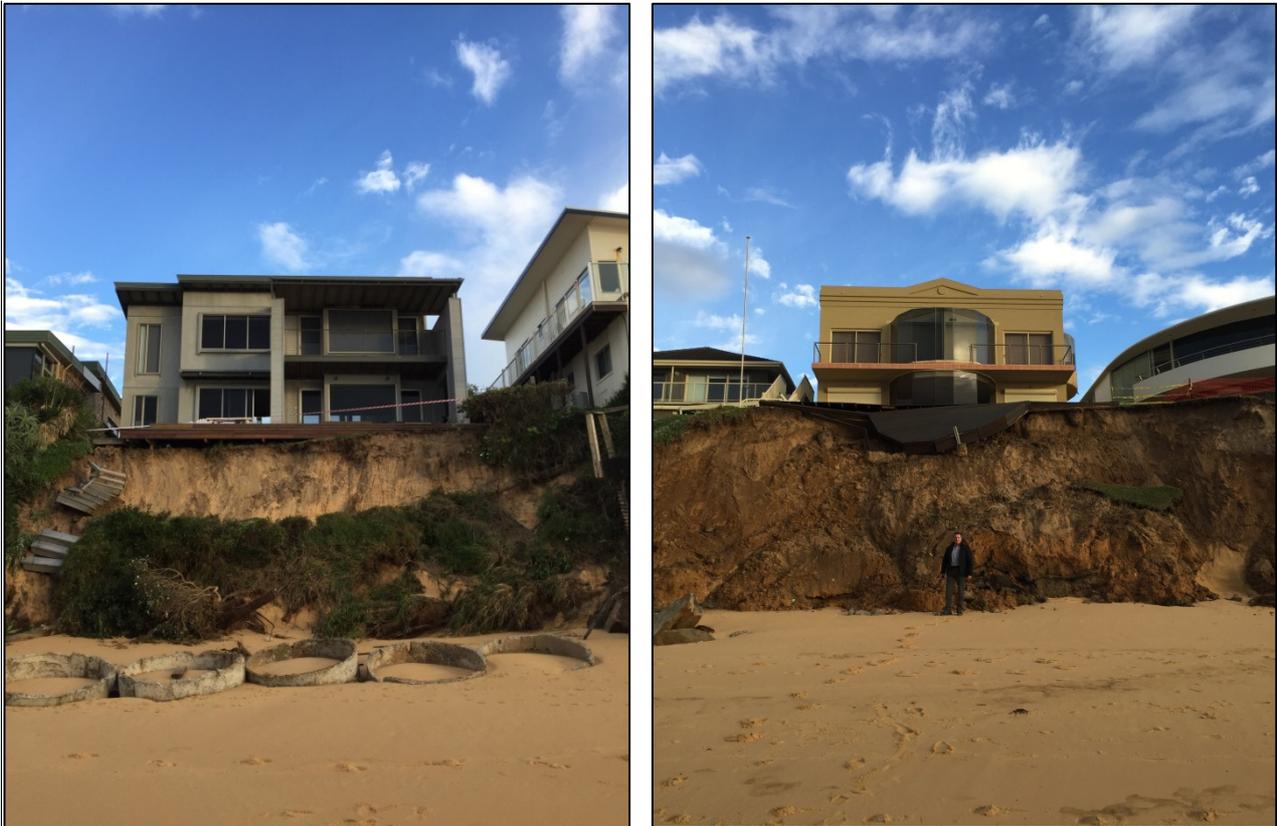
**Figures 7 and 8:** Erosion impacts at Wamberal Beach June 2016

Analysis undertaken following the storm estimates that 260,000m<sup>3</sup> of sand was lost from Wamberal beach profile (up to 184 m<sup>3</sup>/m) at Wamberal beach 404,000m<sup>3</sup> of sand was lost from the beach profile (up to 228m<sup>3</sup>/m) at Collaroy-Narrabeen Beach. (Harley 2016)

This loss of sand buffer left an increasing risk that the dune may be eroded should more storms occur at Wamberal Beach. The storm also completely removed all sand in front of the existing protection works at Collaroy-Narrabeen beach exposing the cemented sand layer for extensive sections at South Narrabeen and Collaroy. During and closely after the storm, Central Coast and Northern Beaches Councils had to monitor these situations to ensure that they were not further exacerbated by subsequent high spring tides, even in the absence of severe waves.

Significant sections of the exposed informal protection existing at both had beaches had become displaced during the storm and added further debris to the beach along with other structures such as fences, deck, outdoor furniture and pathways that were destroyed during the storm.

Figures 7,8 and 9 depict impacts of the June 2016 storm event.

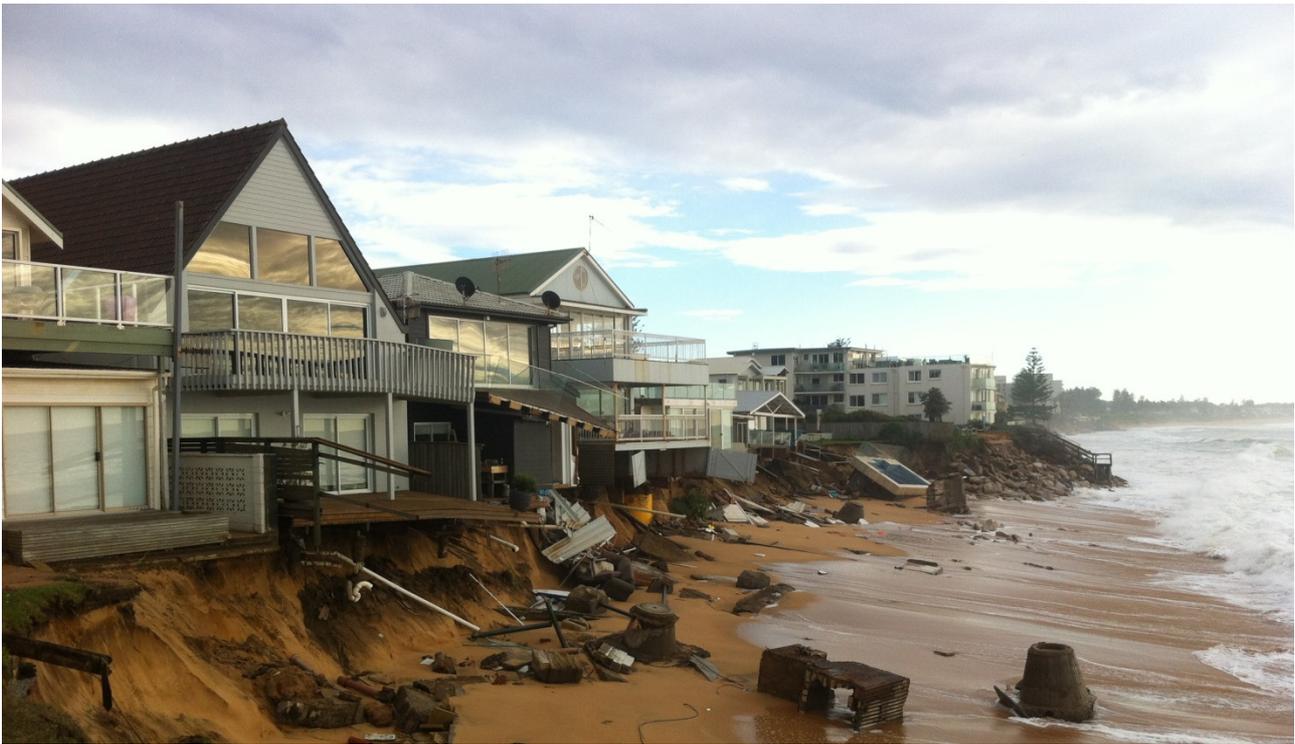
**Figure 9:** Erosion impacts at Collaroy-Narrabeen June 2016

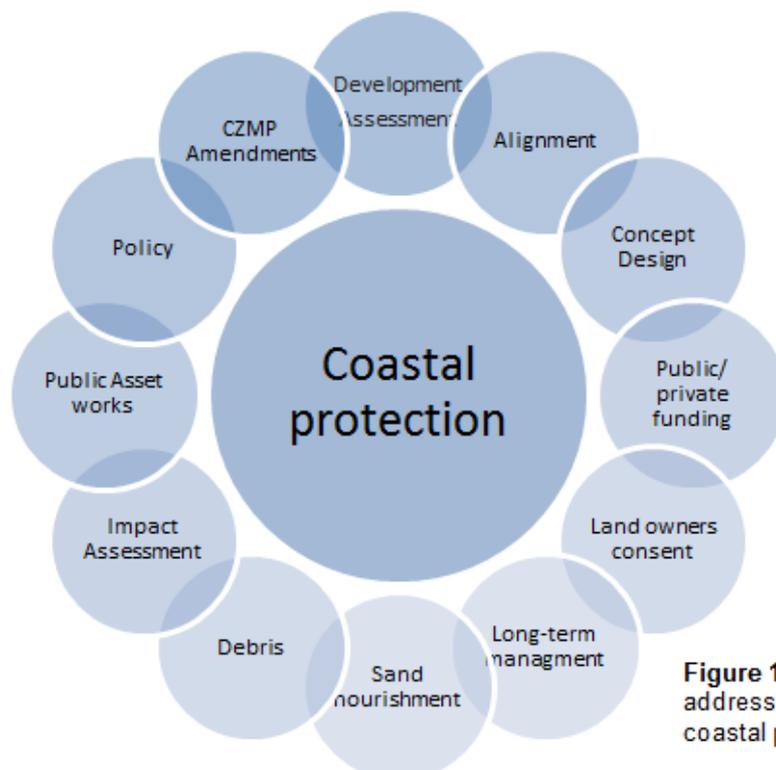
**Figure 10:** Issues to be addressed when implementing coastal protection.

Figure 10 outlines the range considerations Councils have in driving the implementation of coastal protection works for private property.
