# Quantifying change and impacts to Lake Illawarra from a permanent opening

## Abstract

Lake Illawarra is a large coastal lake located on the NSW south coast, 85km south of Sydney. A number of changes have occurred to Lake Illawarra since the finalisation of works to create a permanent entrance opening in 2007 through training walls/breakwaters and associated entrance dredging. Lake Illawarra previously functioned as an ICOLL, and during drought would close off to the ocean for extended periods. Significant community pressure regarding concerns with poor water quality and estuary health during periods of closure culminated in the NSW Government (the now disbanded Lake Illawarra Authority) implementing a staged process of construction to create the permanently opened entrance.

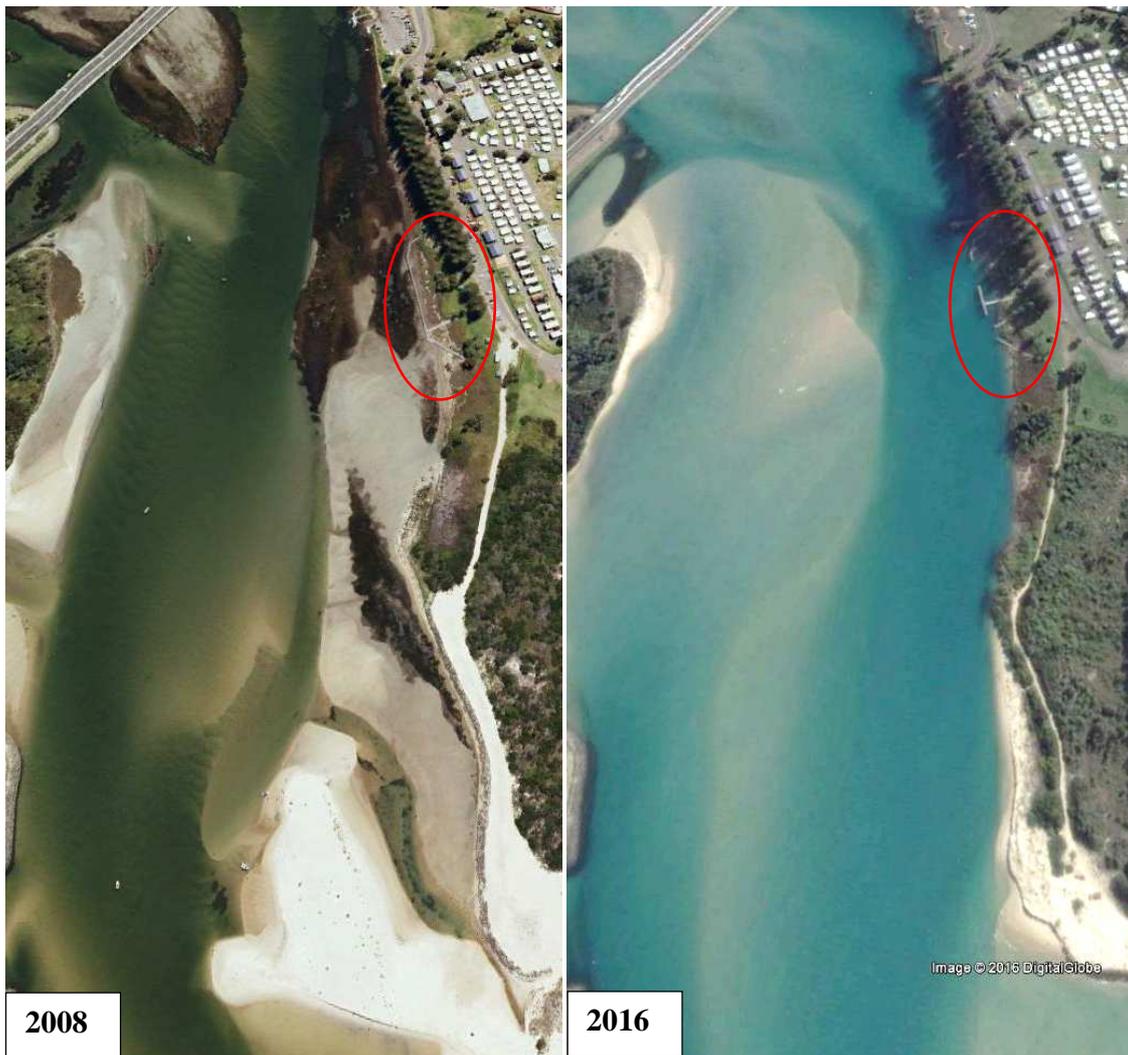
**Figure 5: Aerial image of the shoals and shoreline downstream of Windang Bridge in 31/3/2008 (left) and 5/6/2016 (right), showing the complete loss of the shoals attached to the eastern shoreline, and a boardwalk (circled in above images) that extended over intertidal flats in 2008 which by 2016 has been undermined and partially lost.**

Changes to the pattern and scale of scouring and accretion in the entrance channel as a result of tidal prism and velocity increases have also led to increased foreshore erosion. For example, channel expansion and migration due to enhanced tidal prism and tidal flow velocities have resulted in the complete loss of a large shoal attached to the NE side of the entrance channel downstream of Windang Bridge (Figure 5). This shoal lined the foreshore for a distance of ~800m and was over 100m at it widest. This scouring has resulted in the loss of sections of boardwalk through undermining of their pilings (Figure 6), and is continuing to erode the foreshore and impact on other assets.

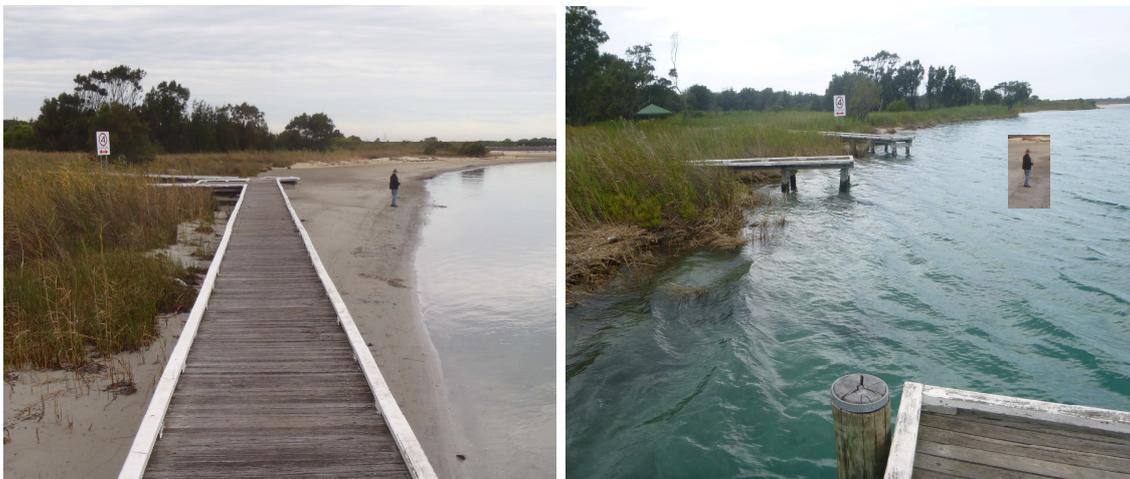
**Figure 6: Shots of the northern entrance channel foreshore downstream of Windang Bridge taken on the 14-6-2012 (left) and 12-3-2015 (right), showing the loss of intertidal shoals and sections of boardwalk lost through scouring of the pilings.**

As a result of this scouring and foreshore erosion impacting on assets including the boardwalk, sections of footpath, lighting and other park infrastructure, the LIA constructed three groynes and sections of seawall to halt further erosion in 2012. While these engineering solutions have maintained the shoreline over their footprint, protection of the shoreline both upstream and downstream has not occurred, and extensive erosion is continuing to threaten assets. This highlights how unexpected consequences of training an estuary can lead to ongoing costs associated with managing entrance channel erosion and scour as a result of channel adjustments to accommodate an increased tidal prism and velocities. The Lake Illawarra CZMP will need to look at long term engineering management options for the whole length of this foreshore to manage further erosion and future impacts to assets.

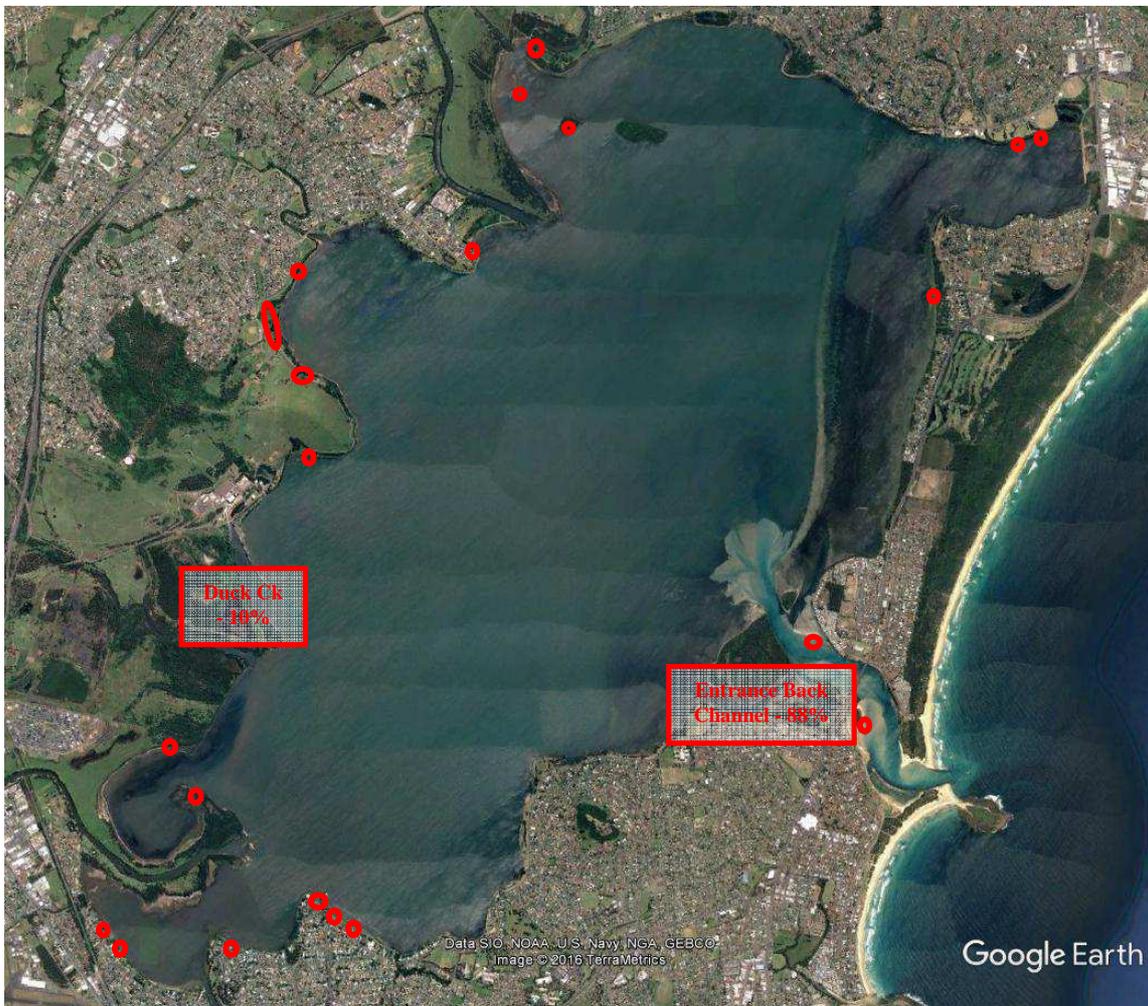
**Figure 10: Generalised location of mangroves within Lake Illawarra identified from intensive field survey in 2016. Small circles represent individual mangroves, or small clumps of mangroves and represent 2% of total mangrove area in the lake.**

The 2016 mangrove cover mapping (Regina 2016) shows they are concentrated within two distinct locations: entrance back channel, with 88% of the total cover, and Duck Creek and the adjoining foreshore (stretching to the Yallah Bay power station cooling

water outlet canal) containing 10% of the total (Figure 10). Only single trees, or small patches of trees and seedlings, were identified at other locations around the Lake (2% of cover). Both of the major areas had one or more mangroves mapped prior to 2007, highlighting how they have only flourished in areas where they were present prior to 2007 and where environmental conditions are favourable. These favourable conditions are likely to include the shallowness and sheltered nature of both locations, enabling mangrove propagules from the existing parent stock to settle and establish, coupled with enhanced tidal exchange since the 2007 permanent opening.

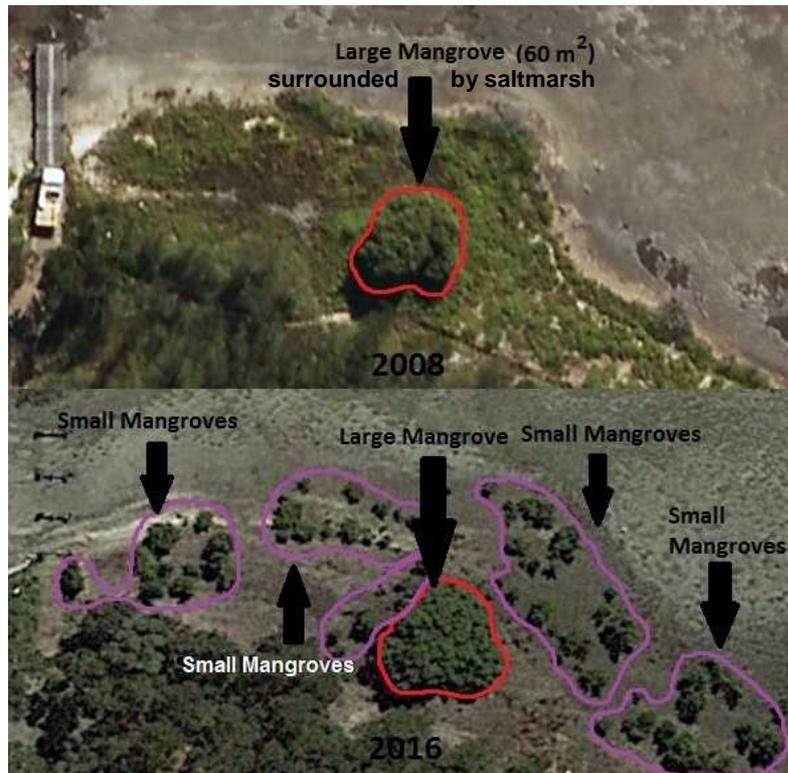
**Figure 11: An example of mangrove encroachment of saltmarsh in the entrance back channel of Lake Illawarra (adapted from Regina 2016).**

While no assessments of cover of saltmarsh analogous to those completed for mangroves have taken place, comparisons of aerial photos and landscape photos suggest a decline in saltmarsh due to the mangrove expansion in the entrance back channel of the Lake (Figure 11).
