Understanding the complex ebb tide delta at Ettalong using advances in remote sensing

Chris Drummond, James Carley, Gabriela Lumiatti, Kilian Vos

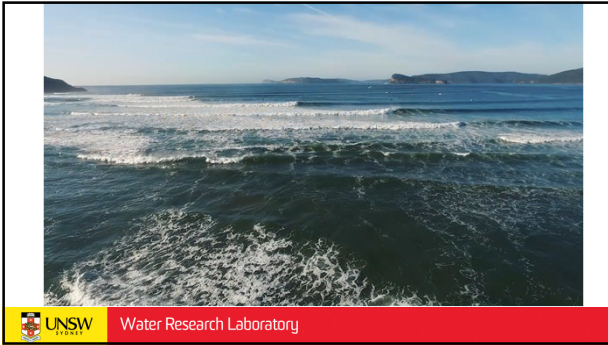
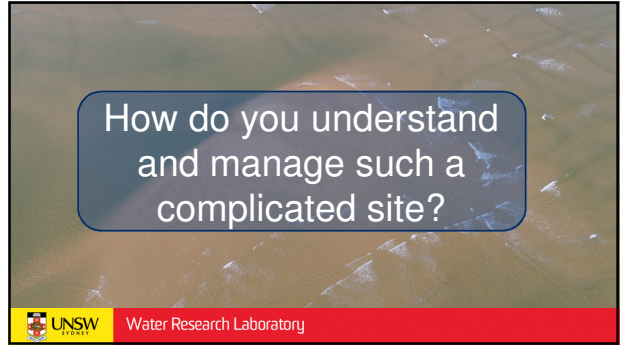
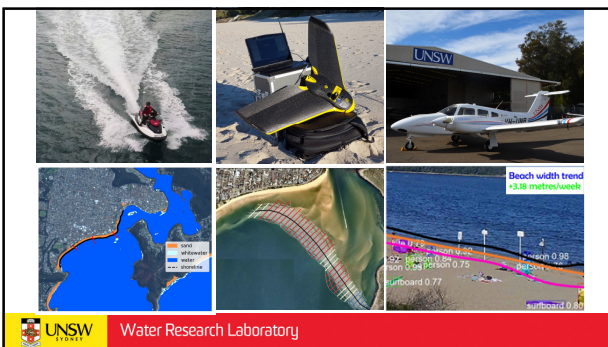
Data driven framework!

1. **Capture of a 'digital twin' of the system**
Drone survey, jetski bathymetry and sediment sampling
2. **Compile 80 year visual timeline of site:**
~200 photos from historical aeriels, satellites, Nearmaps, drone surveys
3. **Track key morphological features**
Shoreline, shoal properties, channel properties
4. **Link past changes in the system to environmental forcing**
Waves, water levels, rainfall, artificial modifications

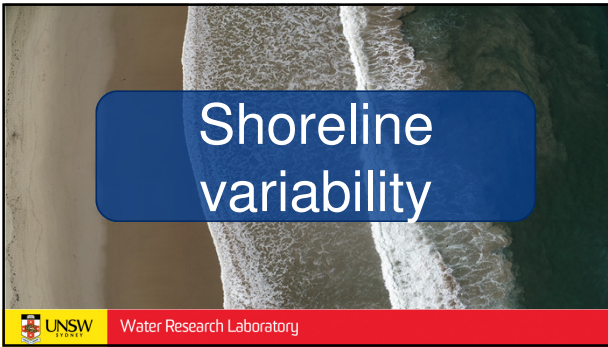
CoastSat

- Open source toolkit in python
- Produces timeseries of shoreline position
- 30 + years of shorelines from 1987- present
- Validated shoreline accuracy of 10 m

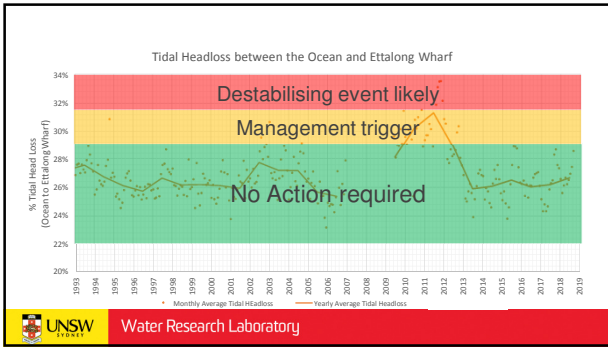
- ### Processes disrupted by blowout
1. Recession of Ocean Beach due to reduced sediment feed
 2. Increase in tidal planes upstream of ebb tide shoal
 3. Increase in SE bedform migration rate causing channel siltation
 4. Change in shape of outer shoal edge → wave focusing feature in 2015 storm
 5. Reduction in surf quality at 'The Box'
- UNSW Water Research Laboratory

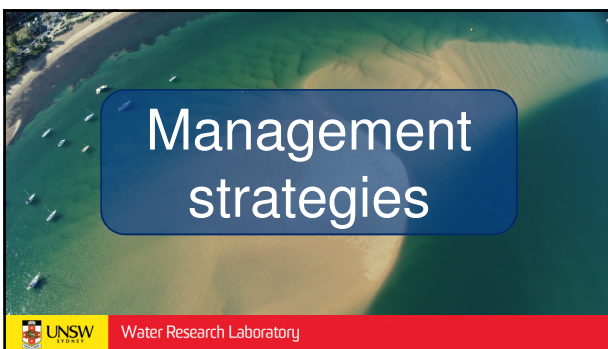
- ### Management strategies
- Avoid blowout at all costs
 - Monitor beach width
 - Possible interventions:
 - Nav channel dredging
 - Enhance permanency of Ettalong Pt
 - Avoiding blowout is win-win for coastal management and maintaining surfing amenity
-
