EXPERIMENTAL SALTMARSH RESTORATION IN THE HUNTER RIVER: VEGETATION FINDINGS TWO YEARS ON

NSW Coastal Conference presentation – Caleb Rankin
 Coauthors: Anita Chalmers; Jason Morton; Kylie Russell; Troy Gaston; Mahmood Sadat-Noori; William Glamore

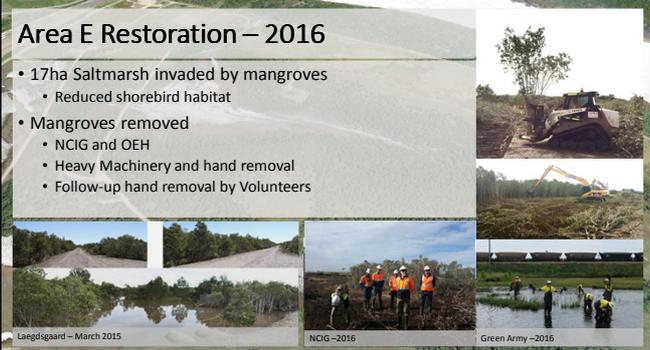
- 17ha Saltmarsh invaded by mangroves
- Reduced shorebird habitat
- Mangroves removed
- NCIG and OEH
- Heavy Machinery and hand removal
- Follow-up hand removal by Volunteers

Laegdsgaard – March 2015 NCIG – 2016 Green Army – 2016

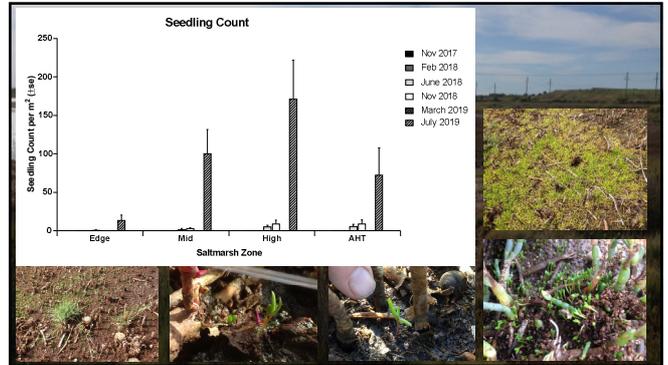
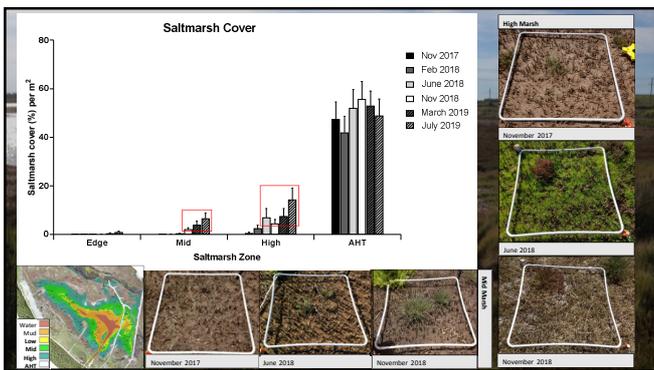
Caleb Rankin – May 2019 November 2017 – July 2019

- *S. quiniflora* is restoring fastest (Winning & MacFarlane, 2010)
- Lowered tide not impacting weed cover
- Saltmarsh cover is on track to restore within 10 years (Craft, 2019)
