Recent coastal change and emergency management in Byron Bay

Geobag walls at Clarkes Beach, Byron Bay

WRL TR 2021/12, August 2021
By J.T Carley and F Flocard

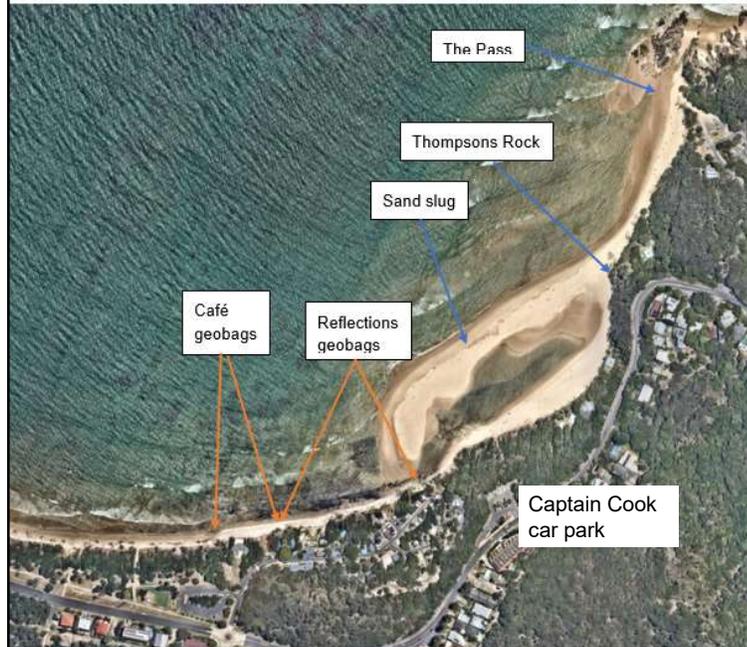
Foreshore features

2007 to 2020 change

Minimal erosion of the 3 m AHD contour from The Pass to the Captain Cook car park/ Thompsons Rock just east of Reflections,

Due to the predominance of rock outcrops (including Thompsons Rock) backing the beach

Horizontal erosion of 13 to 26 m between the Captain Cook car park and Jonson Street

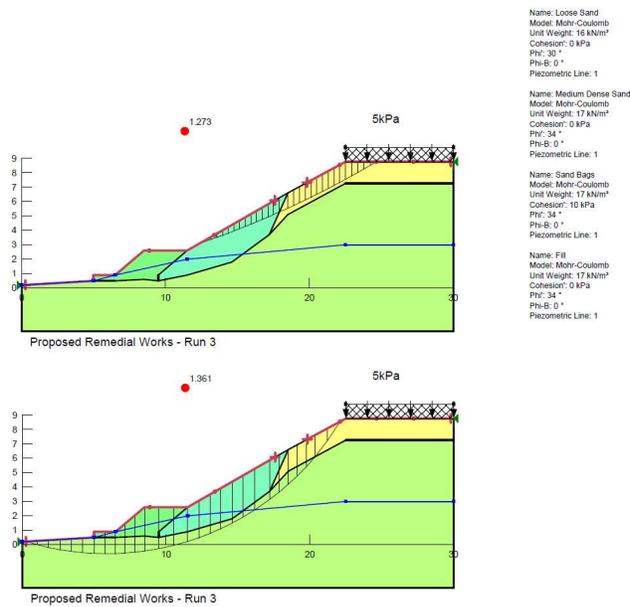
Geotechnical engineer assessment

Name: Loose Sand
 Model: Mohr-Coulomb
 Unit Weight: 16 kN/m³
 Cohesion: 0 kPa
 Phi: 30 °
 Phi-B: 0 °
 Piezometric Line: 1

Name: Medium Dense Sand
 Model: Mohr-Coulomb
 Unit Weight: 17 kN/m³
 Cohesion: 0 kPa
 Phi: 34 °
 Phi-B: 0 °
 Piezometric Line: 1

Name: Sand Bags
 Model: Mohr-Coulomb
 Unit Weight: 17 kN/m³
 Cohesion: 10 kPa
 Phi: 34 °
 Phi-B: 0 °
 Piezometric Line: 1

Name: Fill
 Model: Mohr-Coulomb
 Unit Weight: 17 kN/m³
 Cohesion: 0 kPa
 Phi: 34 °
 Phi-B: 0 °
 Piezometric Line: 1

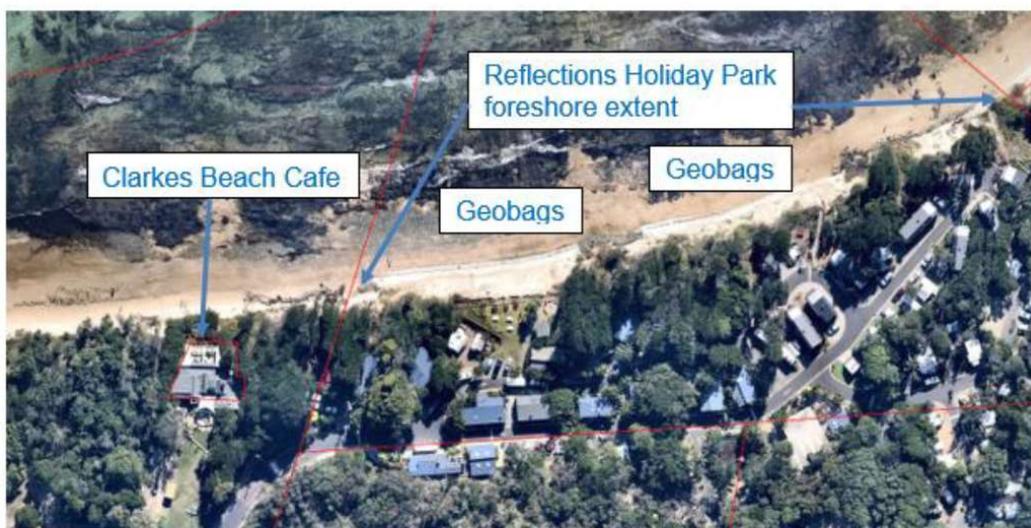
Figure 2.1 Foreshore features 4 July 2020 – prior to Café geobags (Nearmap)

Foreshore 4 July 2020

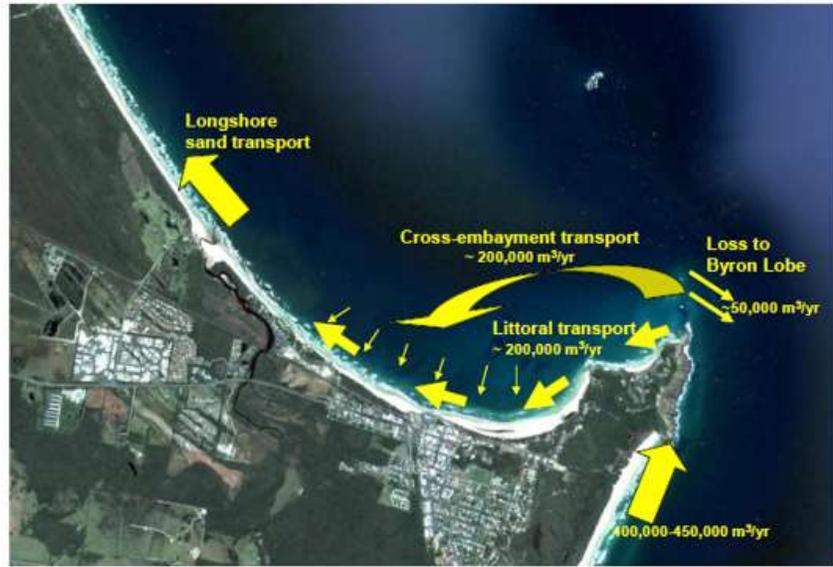
Figure 3.3 Conceptual sand transport (BMT WBM, 2013)

BMT 2013 study

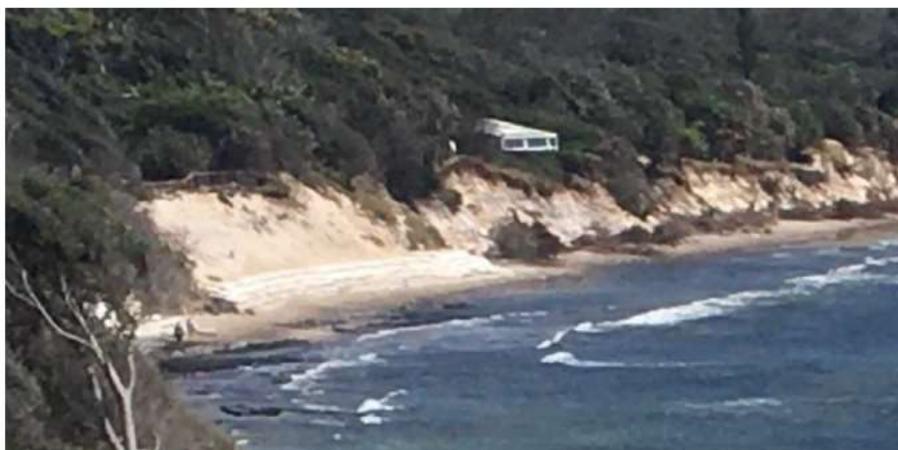
(b) Shoreline recession

(CMM, 2019): Shoreline recession refers to continuing landward movement of the shoreline or a net landward movement of the shoreline over a specified time. As shoreline recession occurs, the beach fluctuation zone is translated landward.

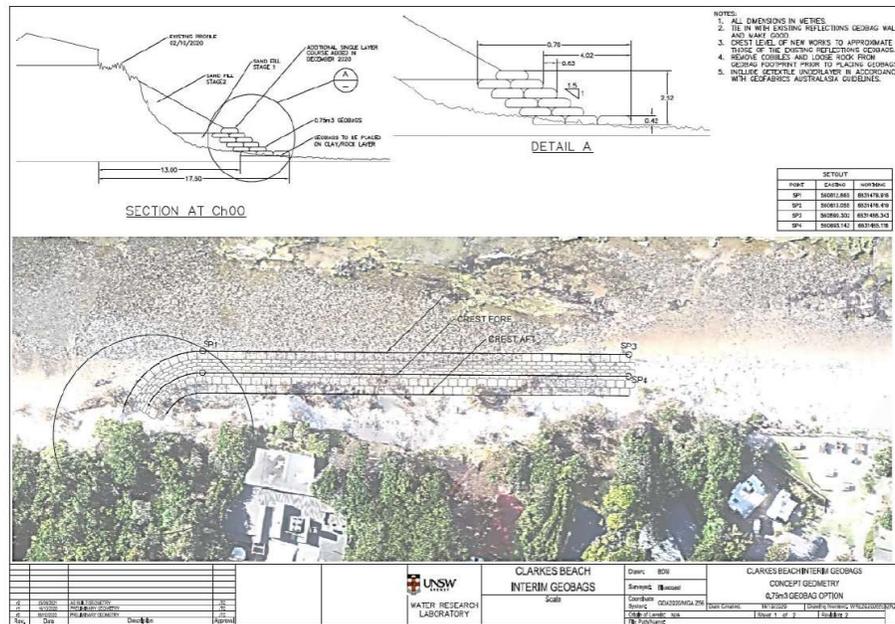
Figure 2.6 Plan and cross section of Café geobags – as modified

Geobag design

Interim geobag (0.75 m³) walls were constructed fronting Reflections in July 2019 in two lengths of approximately 70 m each, with a total effective length of approximately 160 m.

In October/November 2020, an approximately 90 m long geobag wall was constructed in front of the Beach Byron Bay Cafe.

The new wall is contiguous with and westward of the Reflections geobag wall.

An additional course of geobags was added to a large section of the crest of the Café geobag wall in December 2020 in response to a large storm wave event

The wall was offset seaward of the base of the erosion escarpment to provide geotechnical stability to the Café building and the sand dune.

It was backfilled with compatible sand at a stable angle of repose.

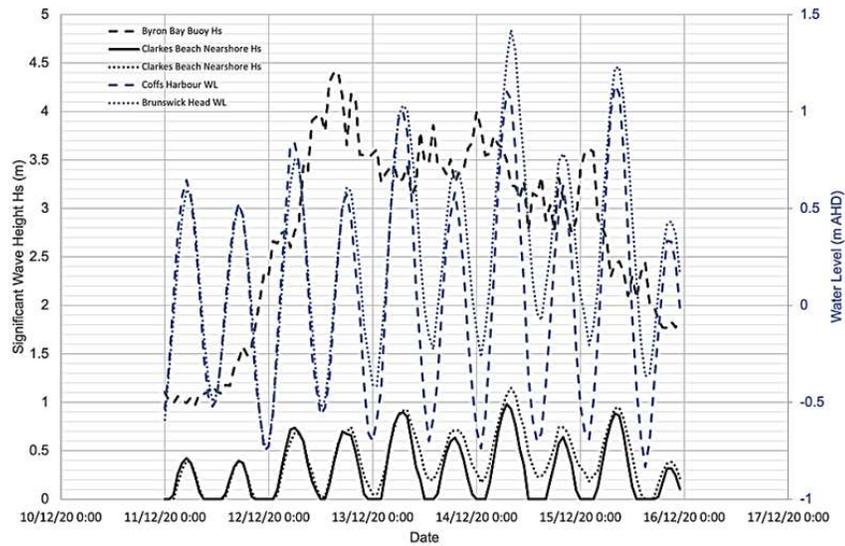
Figure 6.12 Waves and water levels for December 2020 storm event

December 2020: 1 to 2 year ARI event

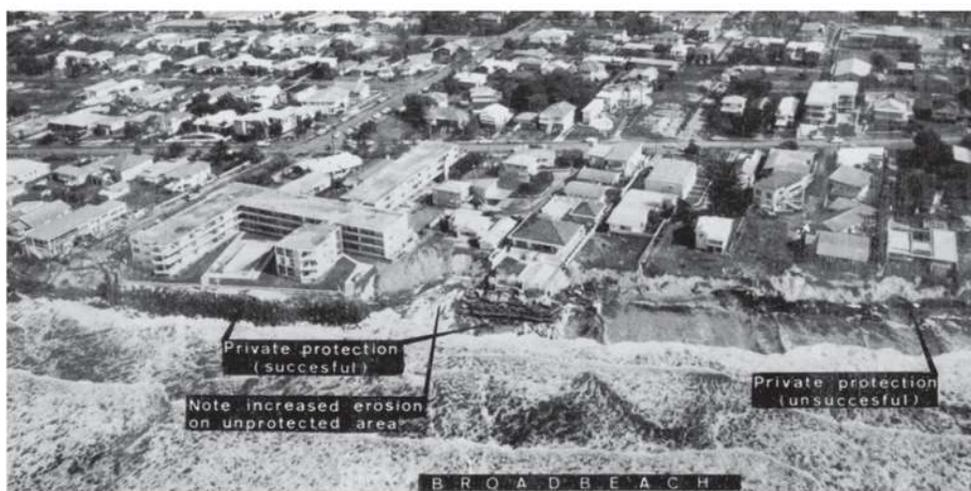
Figure 7.1 Seawall end effect Gold Coast 1967 (Delft, 1970)

Seawall end effects

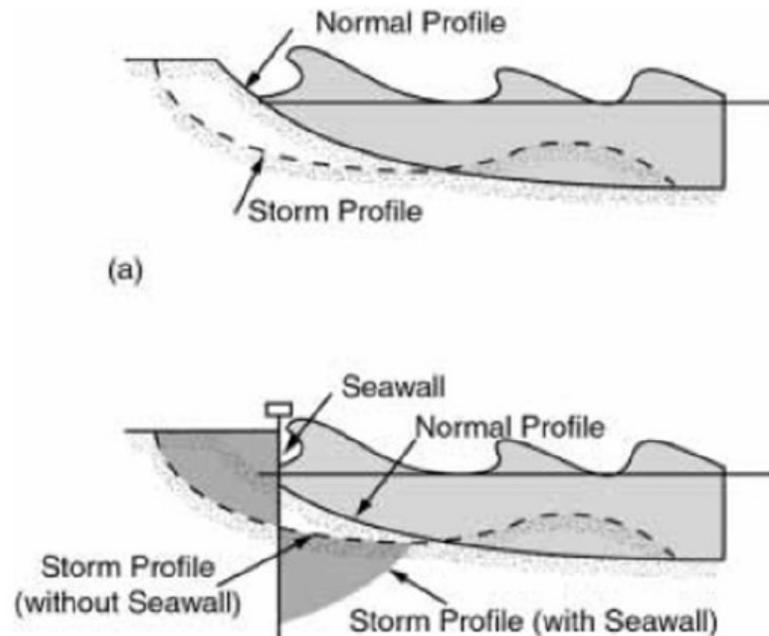
Figure 7.16 Dean (1986) approximate principle of locked up sand

Bob Dean approximate principle

Sand trapped by wall through recession

This yields the quantities shown below for the case where the beach remains eroded:

- Sand locked up by recession acting on Café geobags: 208 m³/year
- Sand locked up by recession acting on Reflections geobags 368 m³/year
- Sand locked up by recession Reflections + Café geobags: 576 m³/year

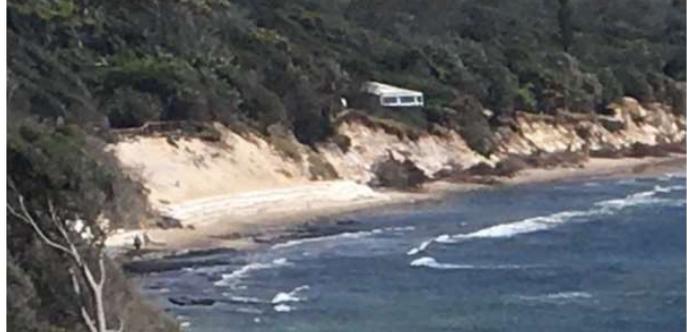
Figure 8.3 Zoomed image from proposed CoastSnap station

Note: Image was taken prior to construction of Café geobags. Reflections geobags are visible. Due to distance, geobags are not highly visible, but exposure can be observed, and can be detected by automated routines
