Investigation of Dune Profile Changes at Park Beach, Coffs Harbour, NSW.

By Jayden Kachel

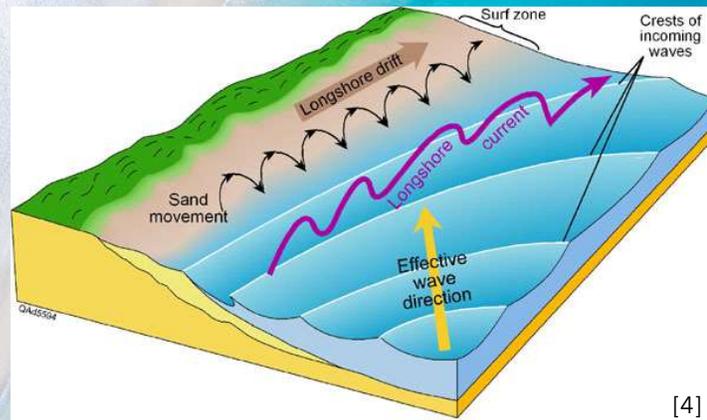
- Longshore sediment transport (LST), also known as littoral or longshore drift, is a naturally occurring sediment transport system [2][3]

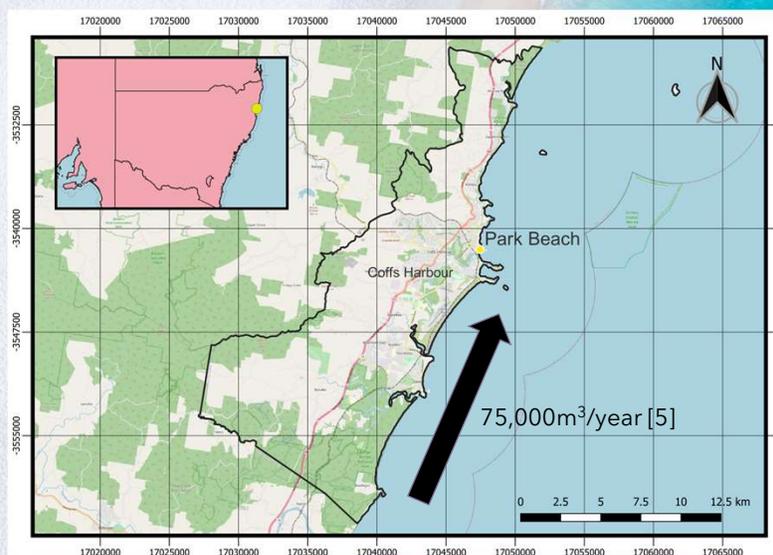
Longshore Sediment Transport

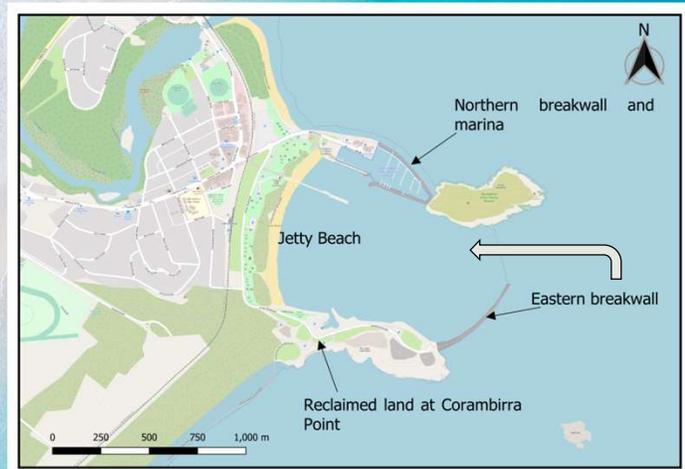
- Three main constructions have changed the shape of the coastline to create a harbour, which has impacted sediment transport.
- Up to 50,000m³ (2/3) of the sediment transported by LST is trapped in the harbour because of these changes to the coastline [6].

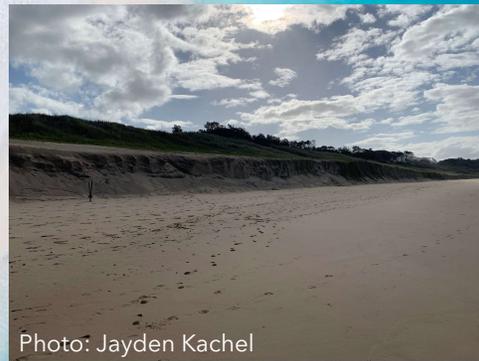
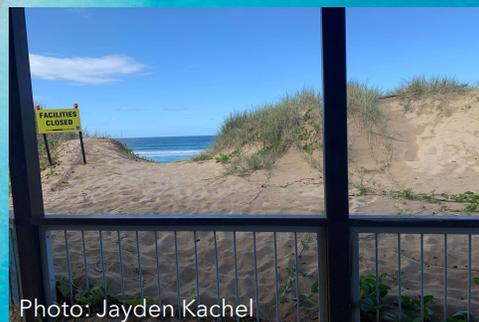
- This study aims to investigate if there has been a build-up of sediment on Park Beach and identify why there has been an increase in build-up over recent years.

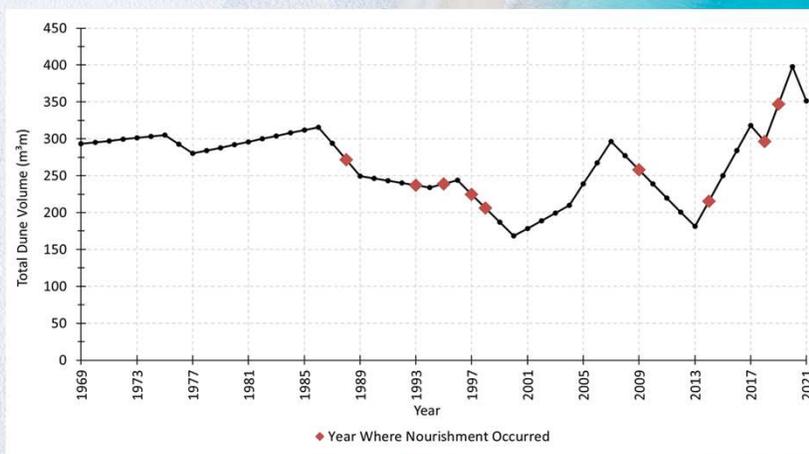
Dredging and nourishment information was obtained from historical reports, news articles and Crown Lands.

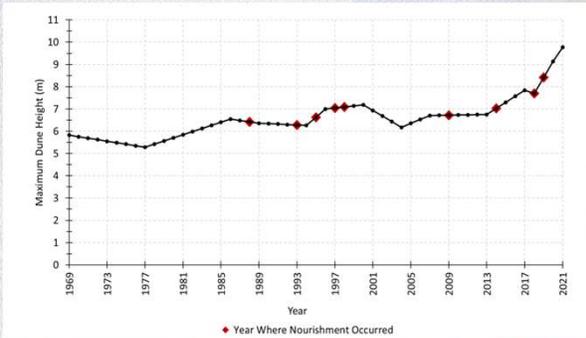
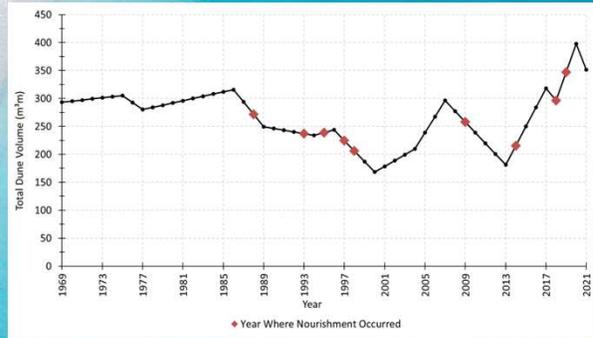
- Through data analysis, this study has confirmed that there has been a gradual increase in dune height since 1969
- It has also confirmed that in the last three years, there has been a major increase in dune height and volume.

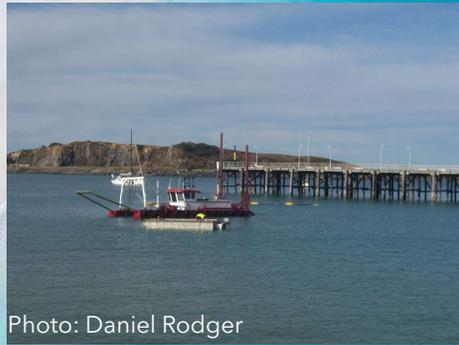
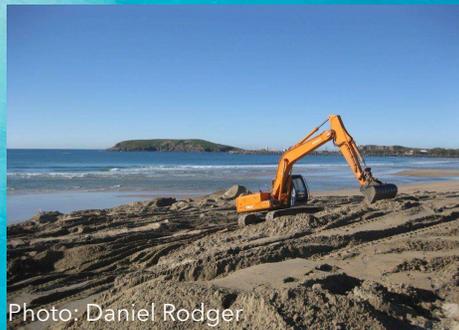
- To allow boats to access the inner harbour, a large portion of the 50,000m³ of sediment that is trapped by LST annually needs to be removed (dredged) [6] [7].
- To offset downdrift recession Park Beach receives the nourishment.

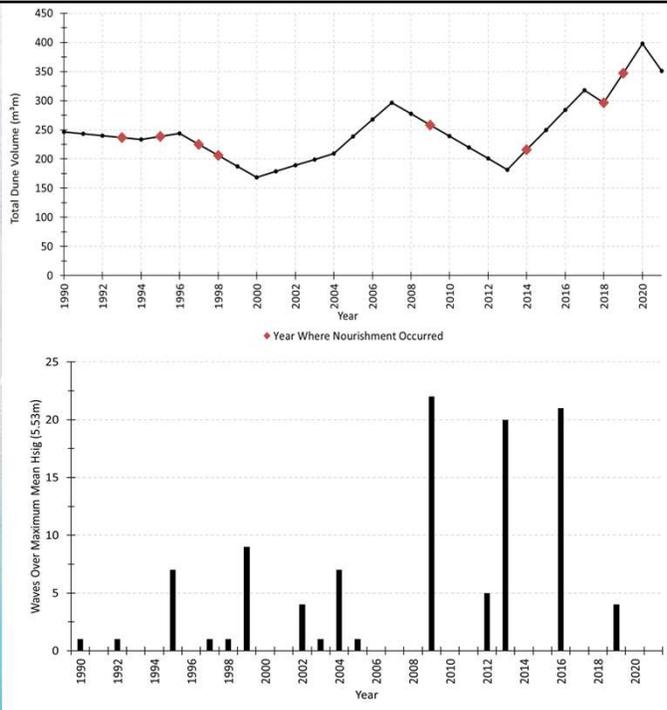
- Nourishment lag (delay)
- Storm events
- A flood event in 2009 as well as large storm events in 2013 and 2016 are suspected to have created the dips in the Volume Graph for their respective years.

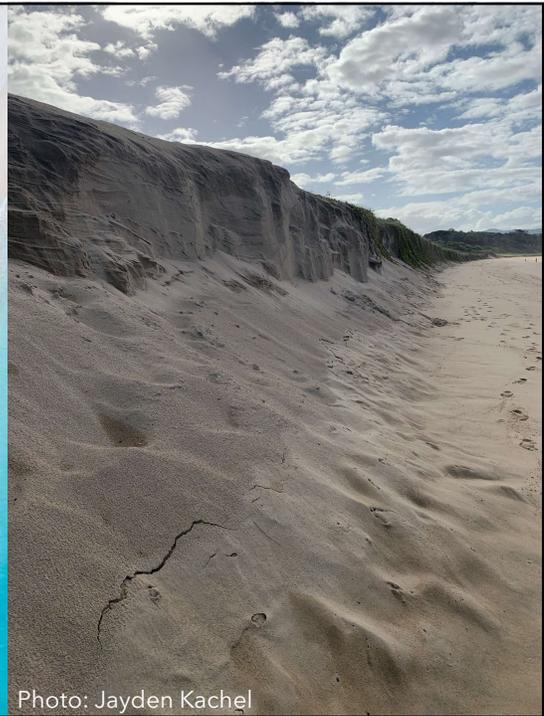
- From 2018-2021
- Caused by the most recent 2019 nourishment event.
- 16,000m³ placed onto the beach and moulded by bulldozer [8]
- 10,000m³ placed into nearshore zone

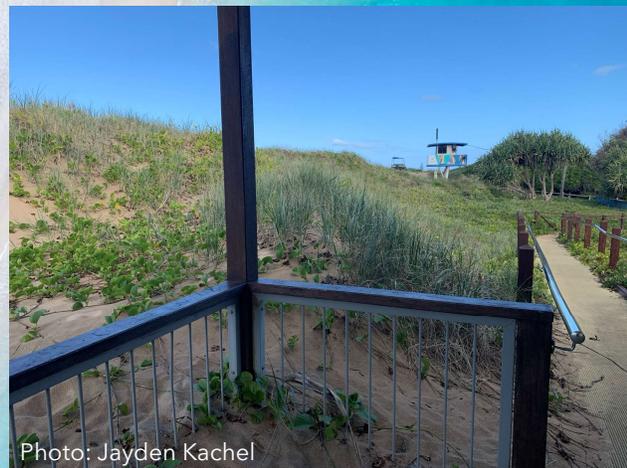
- Between 2011-2021 the increased dune volume at Park Beach has changed from 65m³/m to 160m³/m (above 4m AHD) [6]
