INVESTIGATING STRATEGIES TO REPAIR HISTORIC TIDE WALLS ON THE CLARENCE RIVER AND ADJACENT BEACH AND RIVER BANK PROTECTION

I Jayewardene¹, A Hartley², B Blumberg¹, E Couriel¹

Abstract

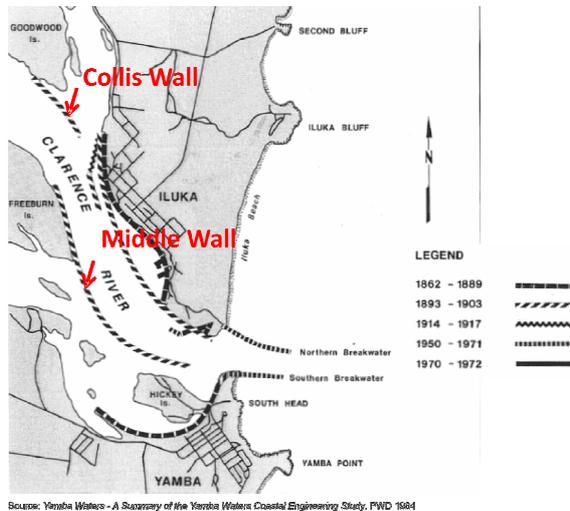
A brief history of the construction of the training wall is provided in Coltheart (1997). **Figure 1** indicates the three training walls that had been completed by 1903. No details are available of the design specifications for these walls similar to those available for Moriartys Wall, hence, any repairs will be based on assessment of the armour of the existing wall and the design values obtained from numerical modelling.

Figure 1: Construction history of training walls on the Clarence River, NSW

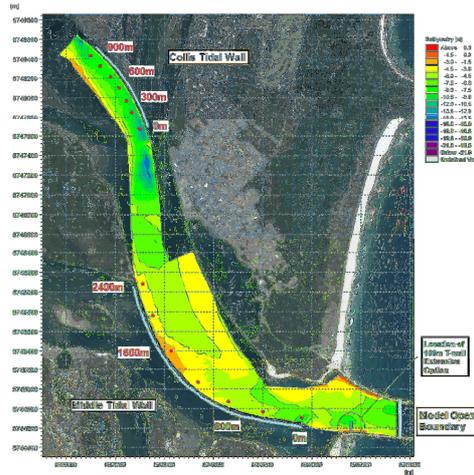
Figure 6a: Model boundary conditions for estimating wave heights at Collis Wall and middle wall with 100m groyne on Yamba training wall base

The model was constructed to extend from inside the breakwater entrance to upstream of the Collis Wall (Figure 6a). The open boundary with independent wave conditions was chosen to be approximately 300 m within the Clarence River breakwater entrance to reduce wave breaking within the model calculations. The model extent and bathymetry are shown in Figure 6a, 6b and 6c.

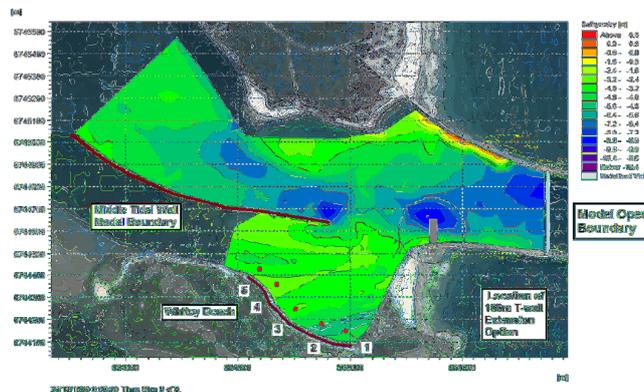
Figure 6b: Wave heights at Whiting Beach with 100 m groyne

The wave conditions at the walls for each boundary condition are given in **Table 2** and **Table 3**. Chainage for each structure and the beach start at the easternmost end of the walls and the beach (**Figures 6b** and **6c**). **Table 2** indicates that during an extreme wave event wave penetration to the Collis Wall is insignificant. The table also indicates that H_s is approximately 1.0 m at the western end of the middle wall during an extreme event.

Wave conditions were extracted 25 m out from points spaced along the length of each wall. The locations of the model output points are shown in **Figures 6b** and **6c**.

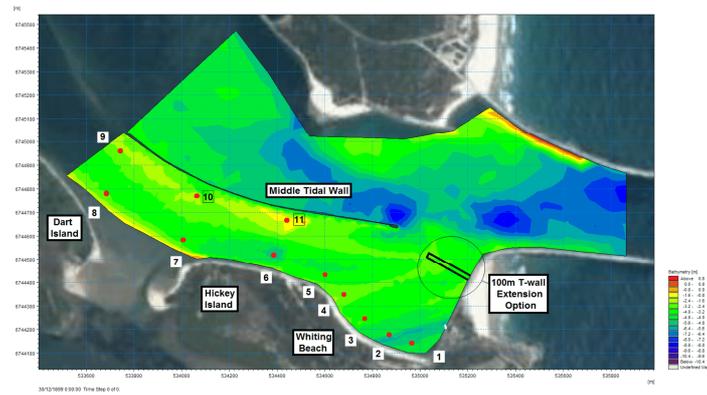
Figure 6c: Wave at Whiting Beach and surrounds with 220 m groyne

Table 5 indicates results when a 220 m tee wall is constructed at the base of the southern breakwater at its originally constructed position. The results indicate that when a tee groyne is constructed at the base of the southern Clarence breakwater (Figure 6c) a lowering of significant wave height at Whiting Beach of 85% to 14% is realised. This is significantly greater than the 100 m tee groyne located at the previous location. Also for locations 1 to 5 on Whiting Beach the wave direction is far more perpendicular to the beach (**Table 5**) resulting in smaller alongshore currents and hence less westward longshore sediment transport. The maximum wave height, too, is very similarly influenced. The directionality of the wave reaching the Collis Wall and the middle wall remain almost unchanged by the tee section construction.
