# **RISK ASSESSMENT METHODS FOR ASSESSING EROSION PROTECTION STRUCTURES – BYRON BAY CASE STUDY**

**Adamantidis, C. A. (WorleyParsons)**

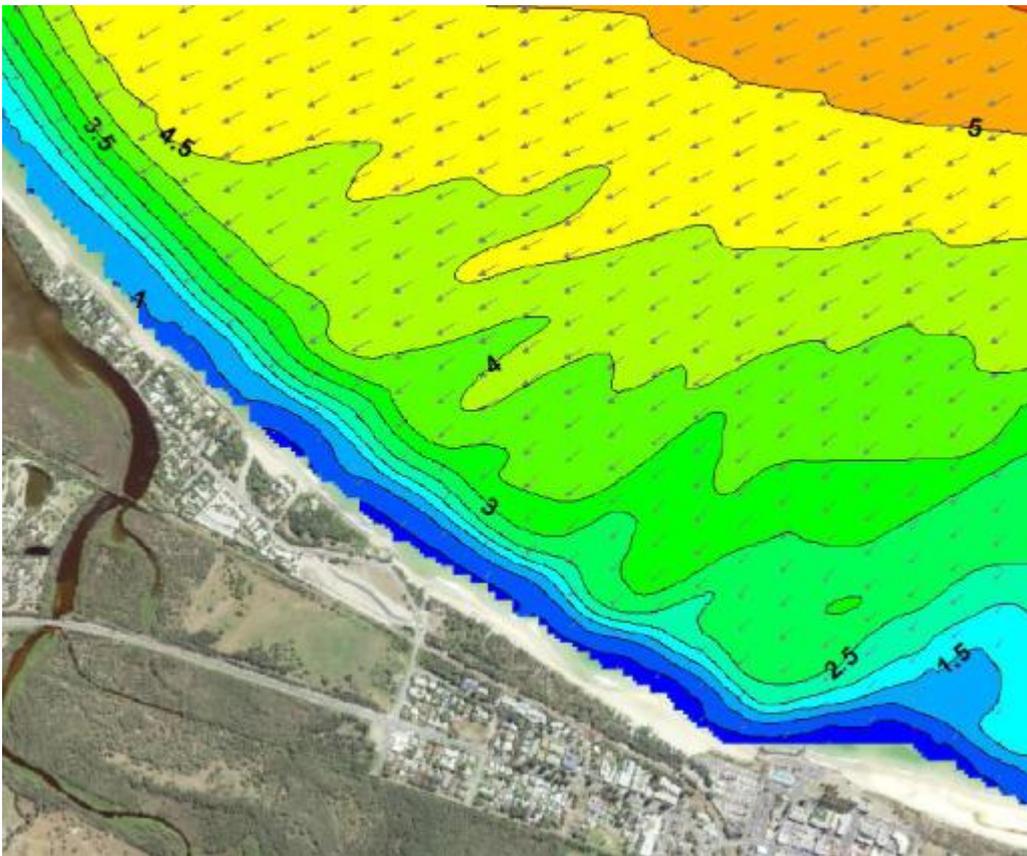
**Figure 6** - Transformed 100 year ARI significant wave height ( $H_{m0}$ , m) from the east

Significant wave heights were modelled under the 1, 10 and 100 year ARI wave conditions from the east. Waves from all sectors from south-east to north-east were modelled, and it was found that waves from the east result in the highest wave energy arriving at the structures. Wave heights tend to increase along the beach from the southeast (which is partially sheltered by Cape Byron) to the northwest (Figure 6).

Wave conditions close to the shore are depth limited, which can be seen by the sharp drop in wave heights close to the shore. In effect, this means that the 1 year ARI wave heights are almost as high as the 100 year ARI wave heights. This is because the largest waves in the wave train break offshore in deeper water, so the height of the waves that are able to reach the shore and break onto the erosion protection structures is limited by the bathymetry and the nearshore water depth.

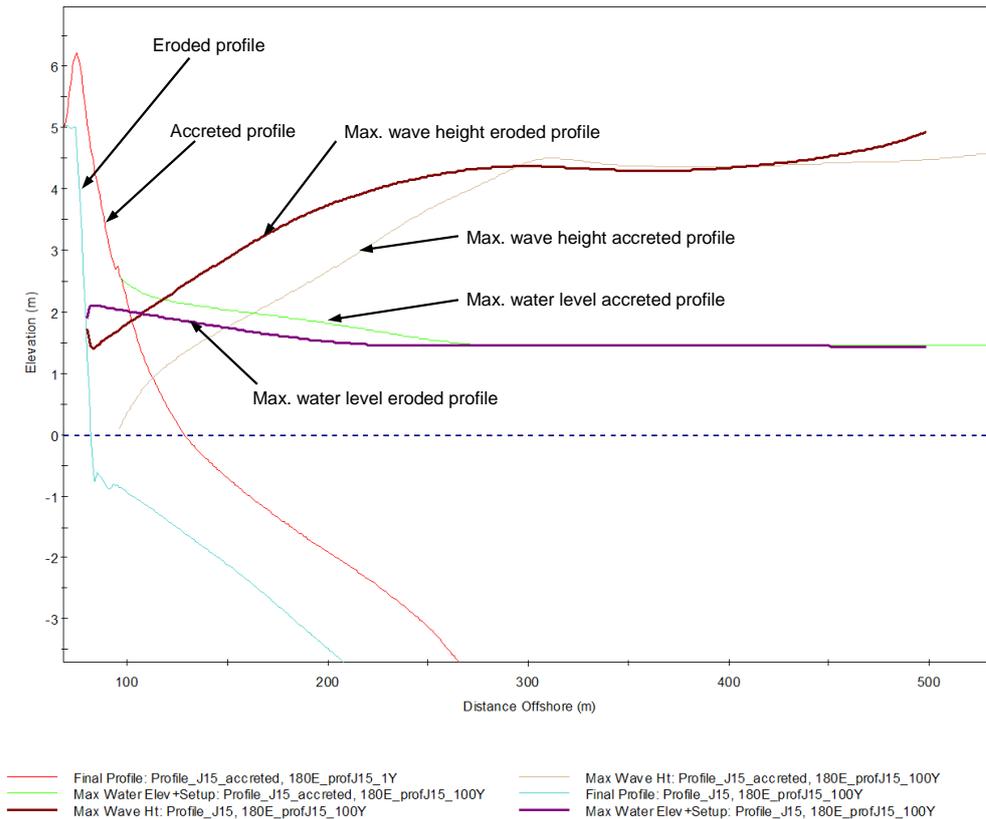
**Figure 7 – SBEACH simulation of eroded and accreted conditions at Jonson Street.**

The influence of whether the beach is eroded or accreted was considered also. The limiting factor for design occurs when the beach is in a scoured condition. Using the SBEACH model (Figure 7), it was found that, should the beach profile be accreted, the structures would temporarily withstand the wave conditions occurring under a 100 year ARI storm event. However, it would be expected that the beach would rapidly scour down to levels that would allow the much higher maximum breaking wave heights to reach the structure.

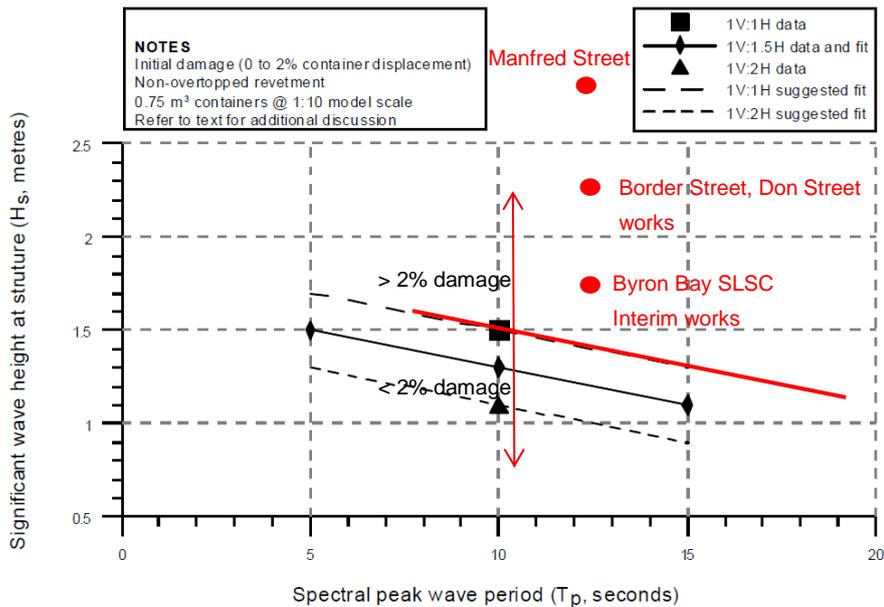
**Figure 8** – Hydraulic stability of geotextile container revetments (after Coghlan *et al.*, 2009)

The exposure to direct wave attack varies for the different geotextile revetments. The revetment at the Byron Bay Surf Lifesaving Club is currently protected by a wide vegetated dune, and the wave heights expected to cause initial damage at the structure would not be realised unless the frontal dune erodes away. Conversely, the geotextile structure at Manfred Street is located further seaward into the active beach zone, and so is exposed to direct wave attack more frequently than the other geotextile structures.

The performance of each of the structures against the hydraulic stability criteria developed by Coghlan *et al.* (2009) is illustrated in Figure 8.

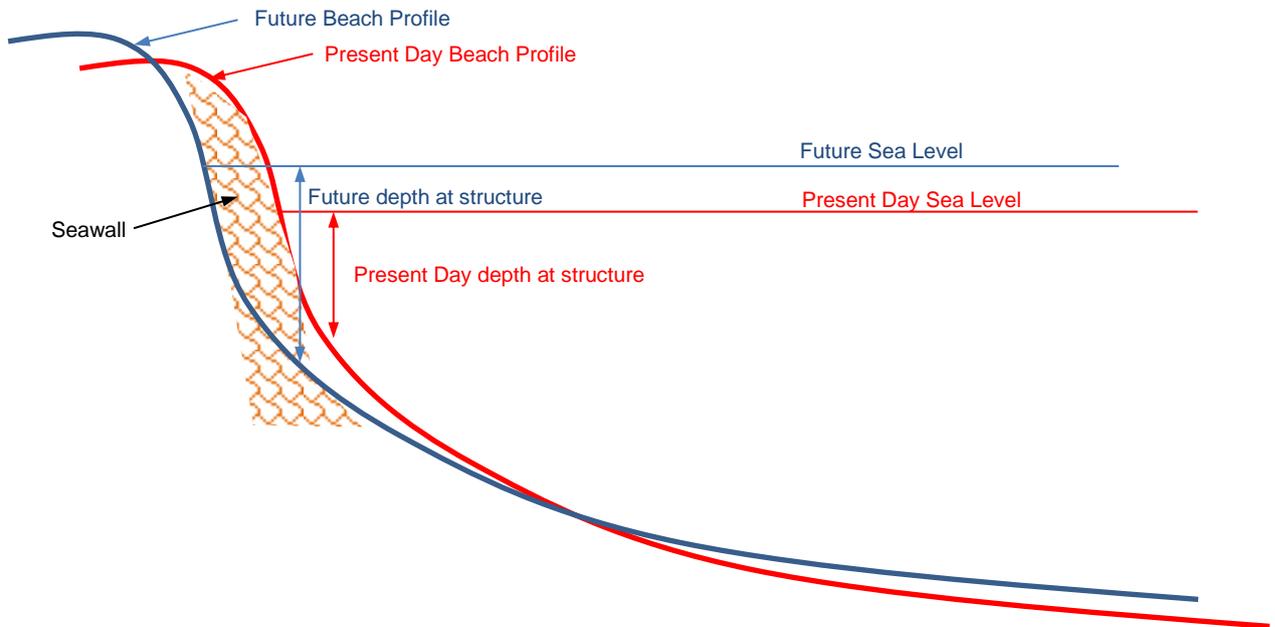
**Figure 9** – Effect of sea level rise on water depth in front of the erosion protection structures within the Byron Bay embayment

The effect of both a lowering in the beach profile and a rise in sea level at the structure is illustrated in Figure 9, based on the changes in the nearshore wave equilibrium profile as predicted by the Bruun Rule (Bruun 1954, 1962, 1983).

It is therefore considered that the risk associated with climate change for the erosion protection structures is a function of:

- The crest level of the structure;
- The hydraulic stability of the structure against wave attack;
- The location of the structure within the beach profile; and
- The toe level of the structure.

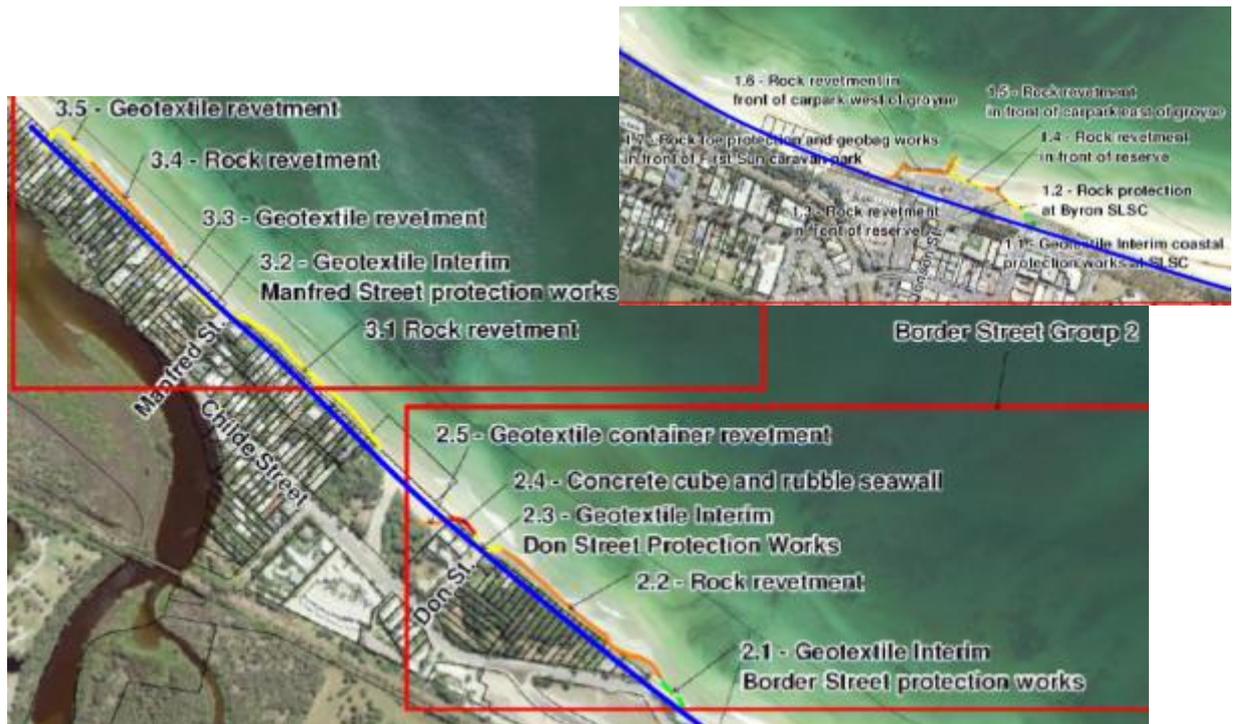
**Figure 11** – Position of erosion protection structures relative to the natural curvature of the beach

From the historical escarpment locations, it was found that the profile of the Jonson Street Protection Works is seaward of the historical shoreline position and therefore acts as a headland, protruding onto the active beach. This has the effect of compartmentalising the beach into two distinct areas – Main Beach east of the Jonson Street Protection Works, and Belongil Beach west of the Jonson Street Protection Works. A similar effect can be inferred for some of the other structures within the Byron Bay embayment which are located relatively seaward along the beach profile (denoted by the protrusion of the structures seaward of the blue line in Figure 11).

The timing and nature of the impact on the foreshore alignment was taken into account in rating the impact of the structures on coastal processes. While some of the erosion protection structures initially had a significant impact on the foreshore alignment (i.e. shortly following construction), some of these structures are no longer having an impact as they appear to be fully bypassed by longshore sediment transport. Other structures may still be having an effect on the surrounding foreshore which is ongoing and is yet to be fully realised.
