# GEOTECHNICAL ASPECTS OF SEAWALL STABILITY WITH CLIMATE CHANGE

Lex Nielsen WorleyParsons [lex.nielsen@worleyparsons.com](mailto:lex.nielsen@worleyparsons.com)  
Agustria Salim Pells Sullivan Meynink  
Doug Lord Coastal Environment  
Geoff Withycombe Sydney Coastal Councils Group  
Ian Armstrong Sydney Coastal Councils Group

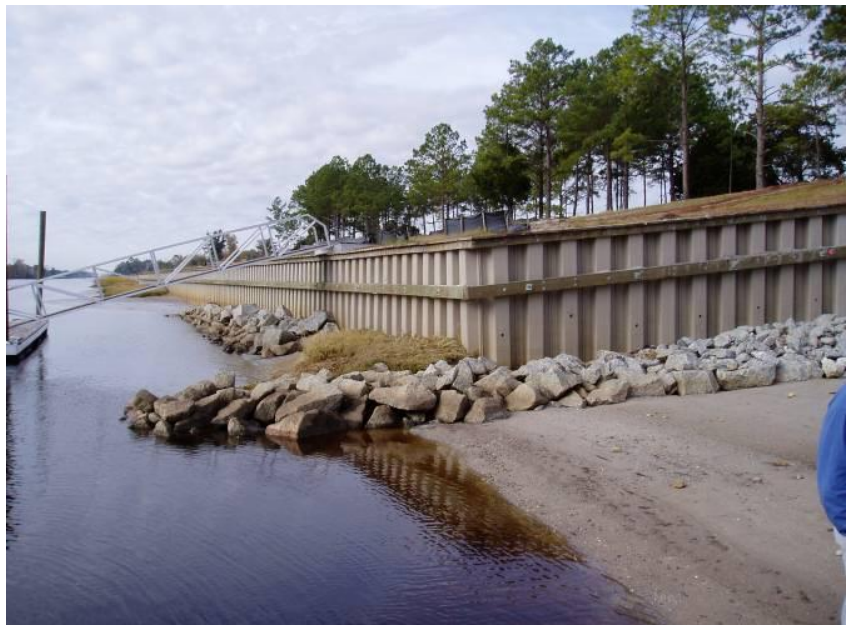
**Figure 2: Anchored bulkhead wall**

**Left: Sand-fill anchored timber bulkhead wall schema** (source: Dames & Moore 1980)

**Right: Anchored Vinyl bulkhead wall** (source: JSTEEL Australasia)

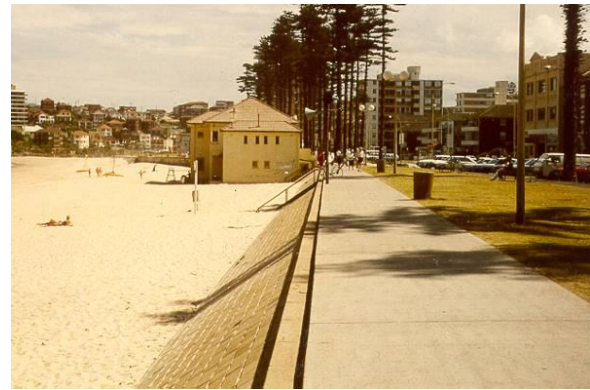
**Figure 7: Rigid sloping revetment Left: Typical design for an interlocking concrete slab revetment (source USACE 2011); Right: Promenade and seawall**

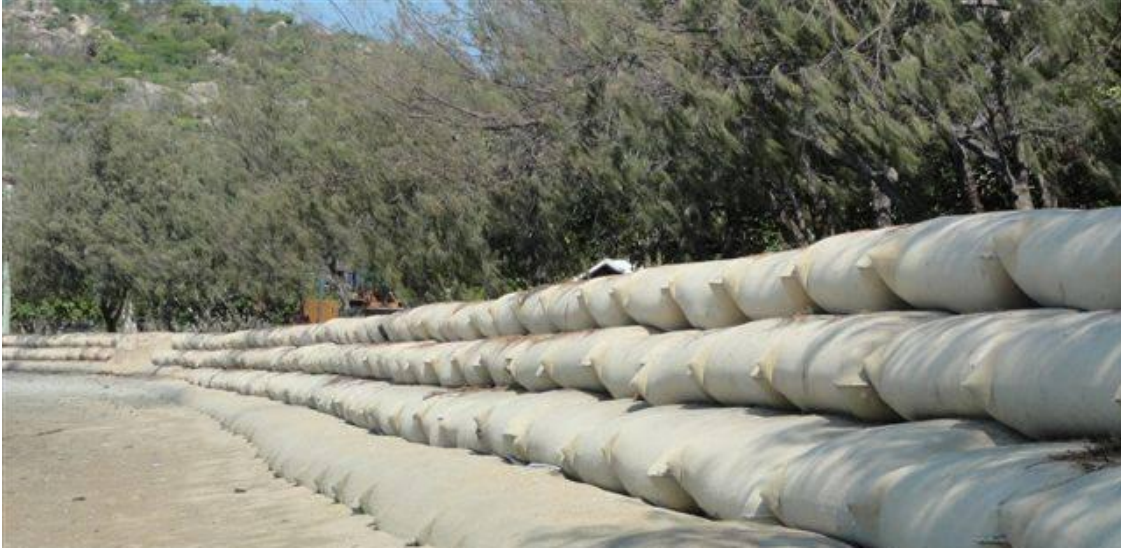
**Figure 9: Sandbag gravity seawall** (source: Geofabrics Australasia)

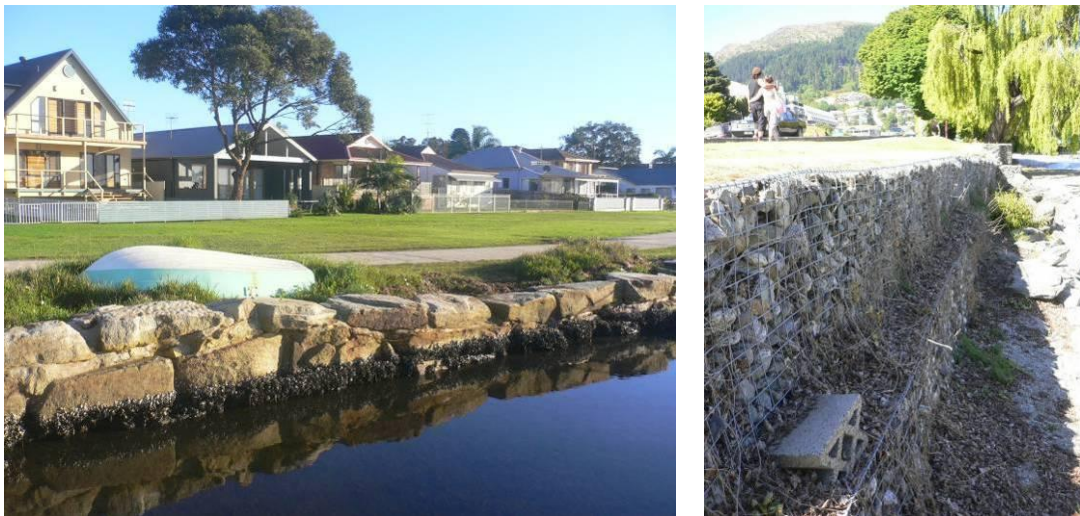
**Figure 10: Flexible near-vertical mass gravity seawall** Left: **Rock boulder gravity seawall** (Source Deborah Lam); Right: **Gabion gravity seawall** (Source Deborah Lam)

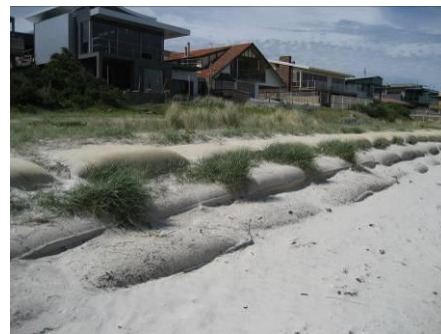
**Figure 12: Sandbag revetment** (source: Geofabrics Australasia)

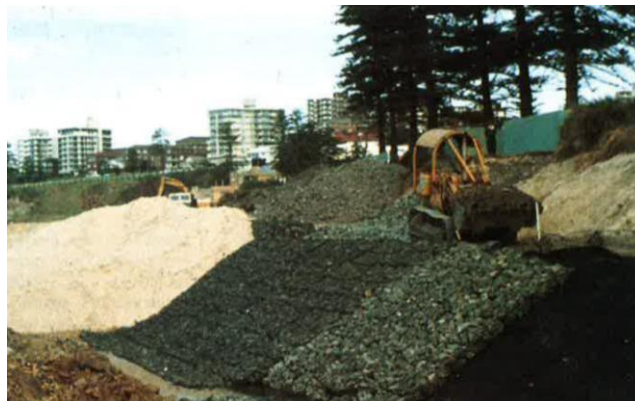
**Figure 13: Sloping Reno-mattress dune revetment under construction** (Source: NSW Gov., 1990)

Flexible sloping rock mattress revetments consist of woven mesh units that are connected together and filled with rock. They are used, commonly, in the rehabilitation and protection of riverine environments and have been used also in beachfront environments, for example, at Bondi (see Figure 5) and Wollongong (Figure 13). The wire fabric is susceptible to damage, vandalism and corrosion.

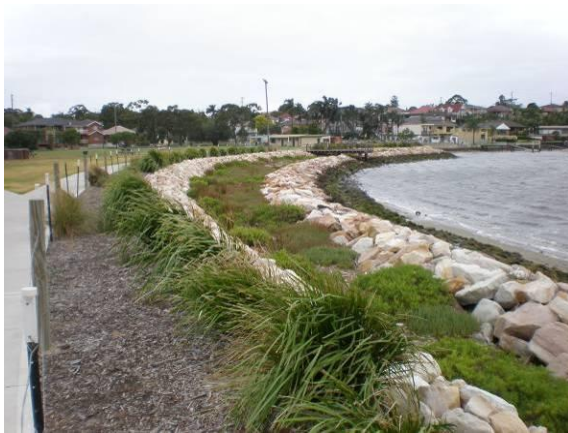
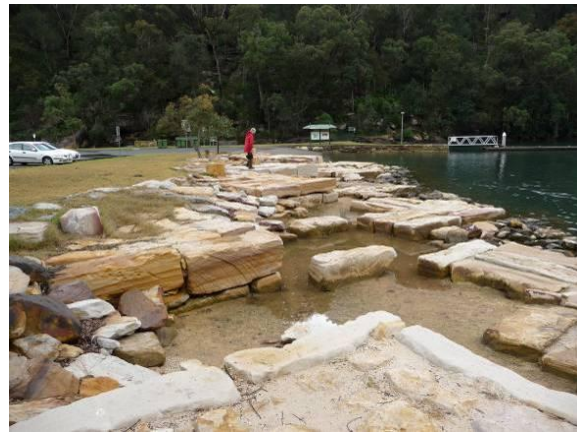
**Figure 14: Environmentally friendly seawalls** Left: **Step-type seawall with saltmarsh** (Source WorleyParsons) Right: **Estuary bank protection** (Source WorleyParsons)

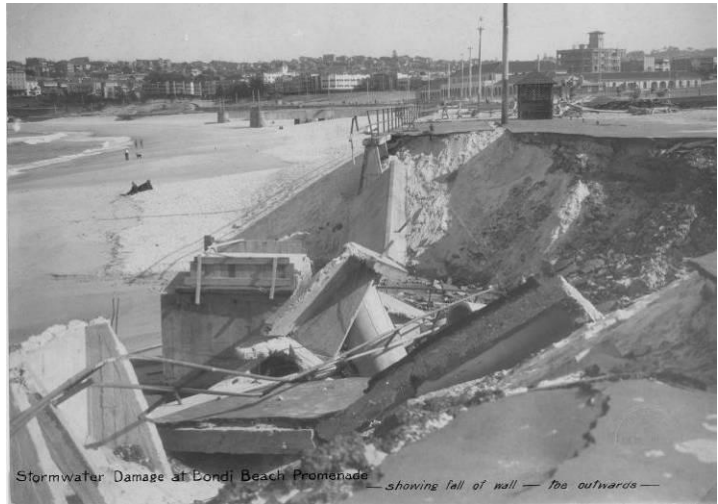
**Figure 17: Rotation slip failure of counterfort gravity seawall resulting from toe erosion** (source Left: USACE 2011; Right: Waverly Council)

As with anchored bulkheads, gravity seawalls can experience rotational slip failure. This can occur if the disturbing forces are increased, say, by development behind the wall, rises in groundwater levels or the resisting forces are reduced, say, as a result of toe scour. As illustrated in Figure 17, the counterfort seawall at North Bondi Beach failed with the toe moving outwards following scour of the beach sand in front of it.

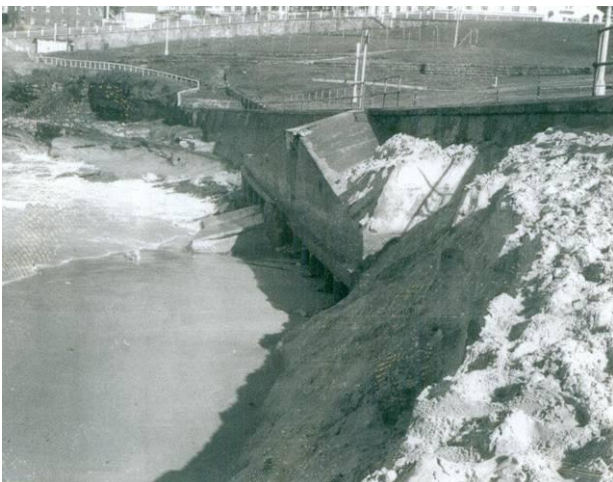
**Figure 18: Loss of backfill of mass gravity seawall at South Bondi Beach 13<sup>th</sup> June 1974 as a result of toe scour and undermining of the footing**  
(Source Waverley Council; photo by J D Aiosa)

Some seawalls may not collapse when the sand in front of the footing is scoured and the footing undermined. However, this can result in the loss of backfill, as shown in Figure 18.

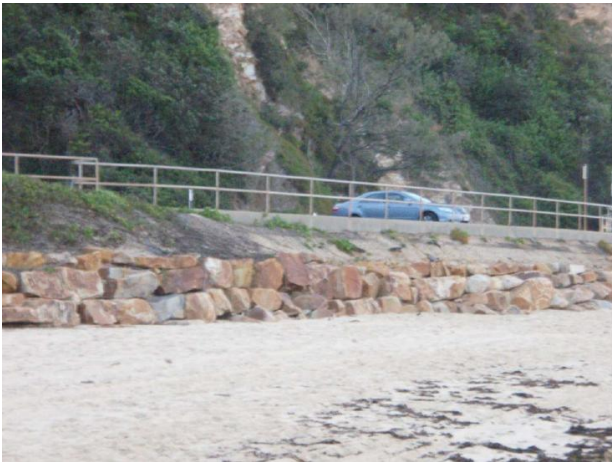
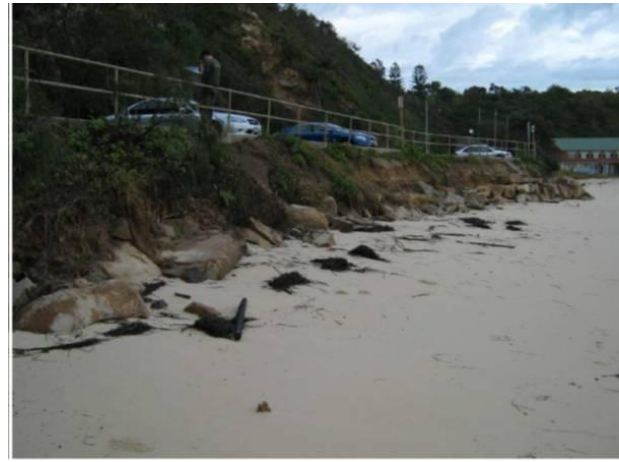
**Figure 21: Left: Blockwork Gravity Wall** (source Chris Adamantidis); **Right: Blockwork Gravity wall failure due to wave overtopping** (source Chris Adamantidis)

The failure modes of this type of seawall are similar to those for rigid mass gravity seawalls (rotational slip failure, sliding, bearing and overturning) with an additional component being the dislodgement of individual or a number of blocks. As each wall element may move independently, wave loads may dislodge the wall elements out of position, especially when rear side scour occurs during heavy over-wash (Figure 21). A further failure mode is backfill wash-out through the wall, should there be inadequate filtering between the soil backfill and the blockwork.

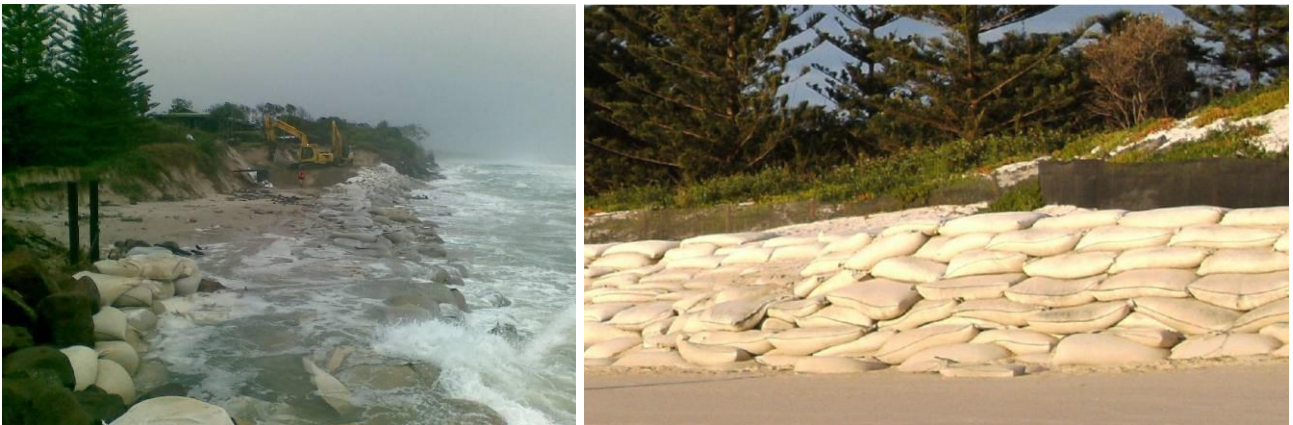
**Figure 22: Sandbag seawall failures** Left: Pull-out of sand bags due to wave overtopping  
 Right: Pull-out of sand bags due to low frictional properties of geotextile  
 (source Left: Ben Fitzgibbon, Byron Shire Council; Right: Manly Hydraulics Laboratory)

Other geotechnical failure modes of sandbag revetments include bag pullout and drag down resulting from wave overtopping and collapse as a result of poor friction at the geotextile interface.

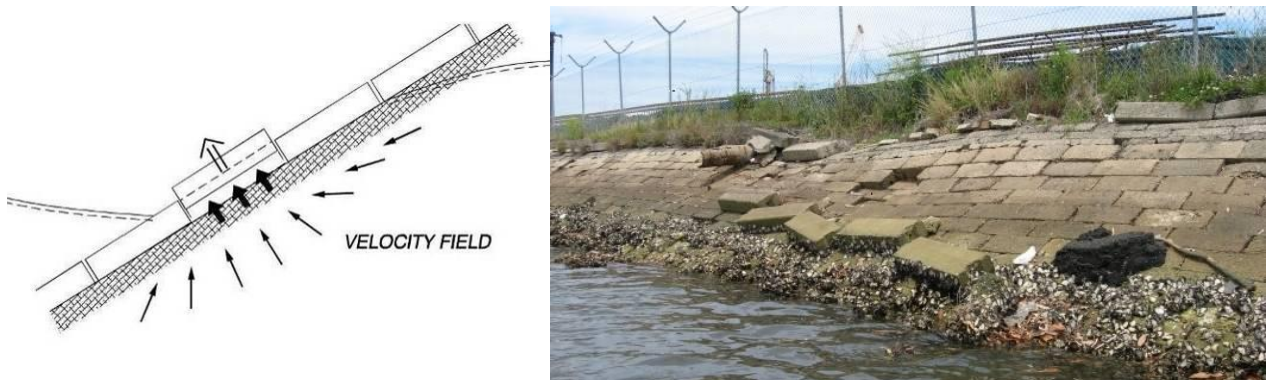
**Figure 23: Rigid sloping revetment push-out and subsidence failure modes**  
 Left: Push out schema for sloping slab revetments; Right: Subsidence due to incompetent substrata (source Left USACE 2011; Right Tom Pinzone)

Push-out of slab elements can occur due to uplift pressures resulting from inadequate drainage. Slab elements could be pushed out when the resultant pressure forces exceed the resultant gravity and friction forces. Subsidence can occur when the substratum is incompetent, which can occur due to lack of consolidation prior to construction or as a result of high pore water pressures.

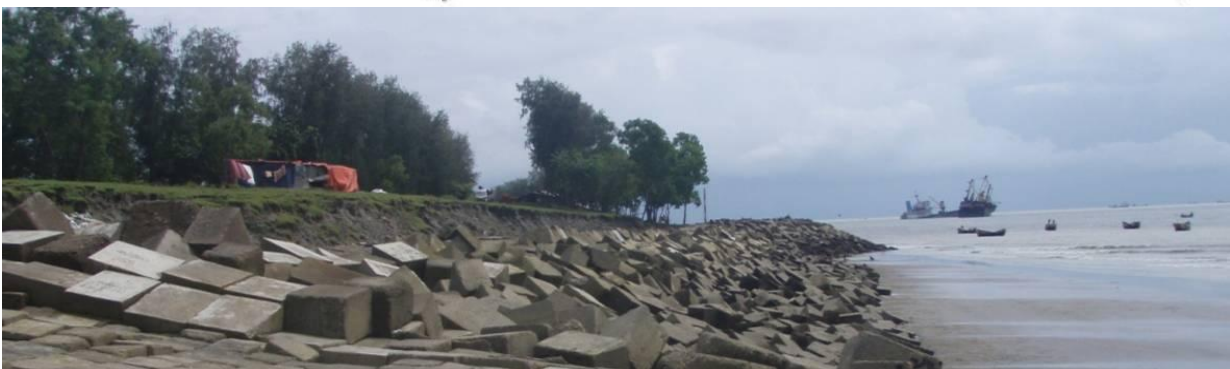
**Figure 25: Concrete blockwork revetment failure due to wave overtopping**  
(source Top: USACE 2011; Bottom: Chris Adamantidis)

Excess overtopping could cause erosion and subsequent collapse of top of seawall structure (Figure 25).

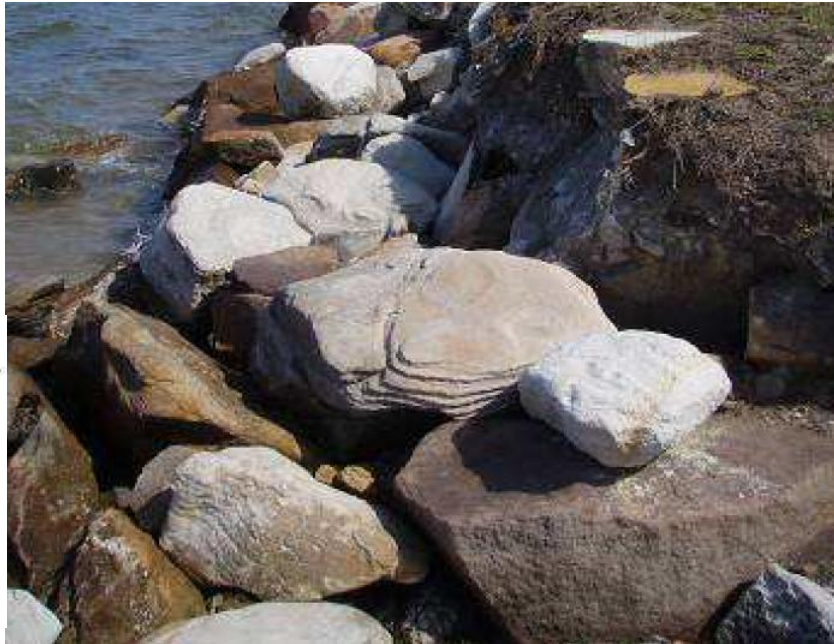
**Figure 26: Toe erosion causing subsidence of a boulder wall**

(source Left: USACE 2011; Right: Chris Adamantidis)

Lowering of the beach level below the design toe level of the structure could cause subsequent undermining. This can result in subsidence of the toe and/or dislodgement of the armour units.

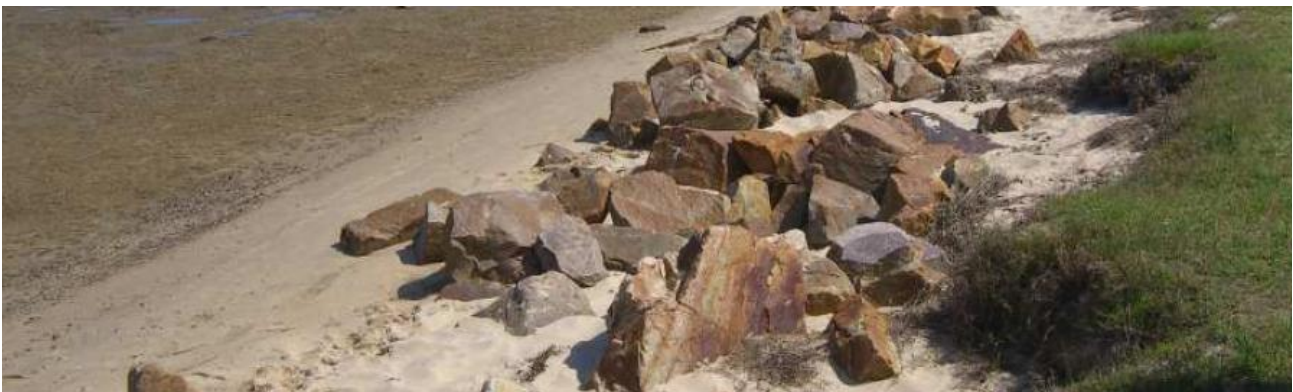
**Figure 27: Subsidence of Rock Armour into sand due to inadequate underlayer filtering**  
(source Top: USACE 2011; Right: Chris Adamantidis)

Underlayer rock and armour units may sink into seabed if the filter layers are inadequate or if the bearing capacity of the seabed material is reduced, which can occur under elevated wave-induced pore water pressures during storms. This could also cause sliding of main armour.
