# COFFS HARBOUR EASTERN BREAKWATER REMEDIATION THE CHALLENGES OF RESTORING EXISTING COASTAL INFRASTRUCTURE

## ABSTRACT

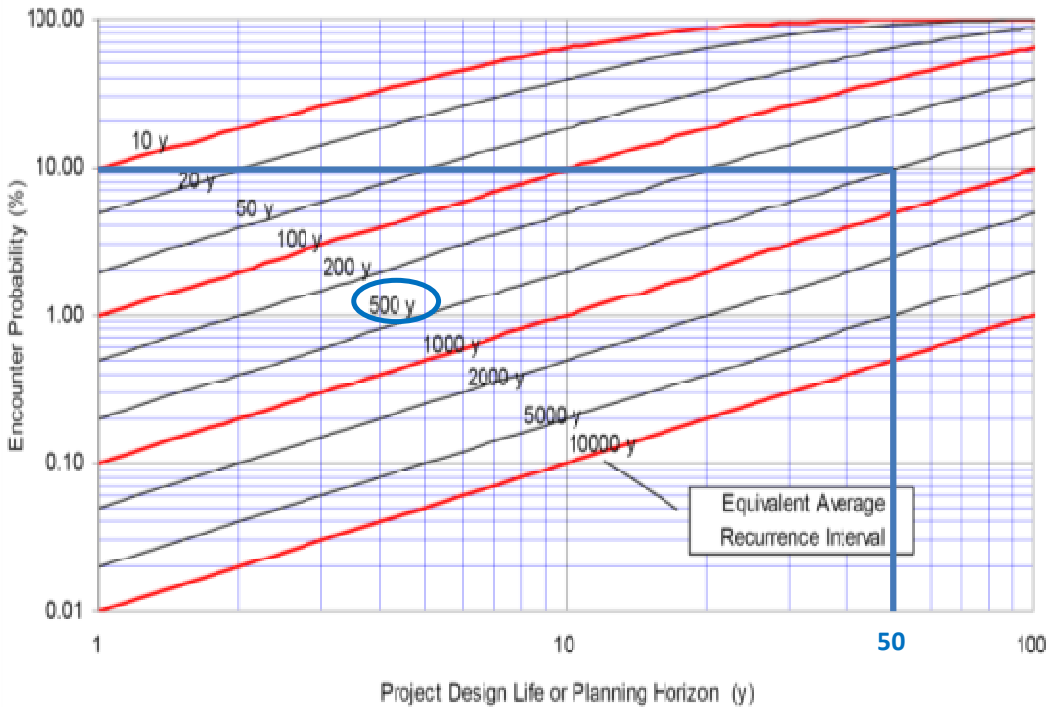
**Figure 3 - Relationship between encounter probability, average recurrence interval (ARI) and project design life**

In the first iteration an acceptable risk of occurrence of the design event of 10% over the 50 year service life was adopted. A 10% risk of occurrence over 50 years equates to a 500 year ARI design storm event. This, like the 'zero damage' starting point was considered to be difficult to achieve and cost prohibitive and lead to a further iteration with the adoption of the design criteria based on 15-20% damage over 50 years design life and to 3-4% damage in any 10 years period - i.e. a design service life of 10 years with some minor maintenance. This equates to a 100 year ARI design event (refer Figure 3).

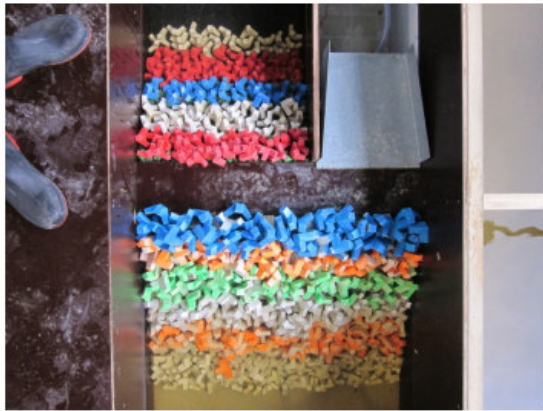
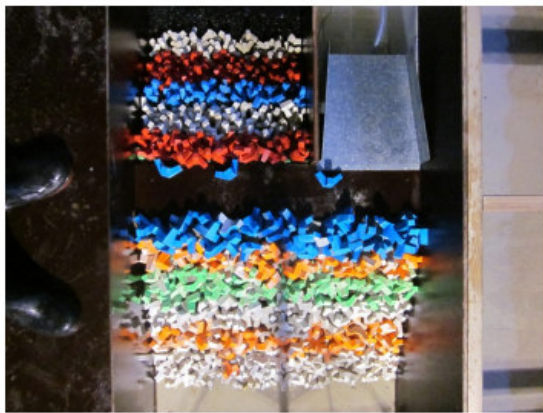
As Built

After 100 Year (+ SLR) Test

**Figure 6: 2D physical modelling in the wave flume at WRL**

Photos from the WRL 2D model are shown in Figure 6. With the model as built (Figure 6a) and following a 100 year storm and sea level rise test (Figure 6b). It shows some minor damage to the hanbar units.
