# DUNE ENHANCEMENT TO SOLVE ENTRANCE INSTABILITY

**C Adamantidis**<sup>1</sup>, B. Morgan<sup>1</sup>, A Stratton<sup>2</sup>, K Clarke<sup>2</sup> <sup>1</sup>Advisian Pty Ltd., Sydney, NSW <sup>2</sup>Shoalhaven City Council, NSW

#### Abstract

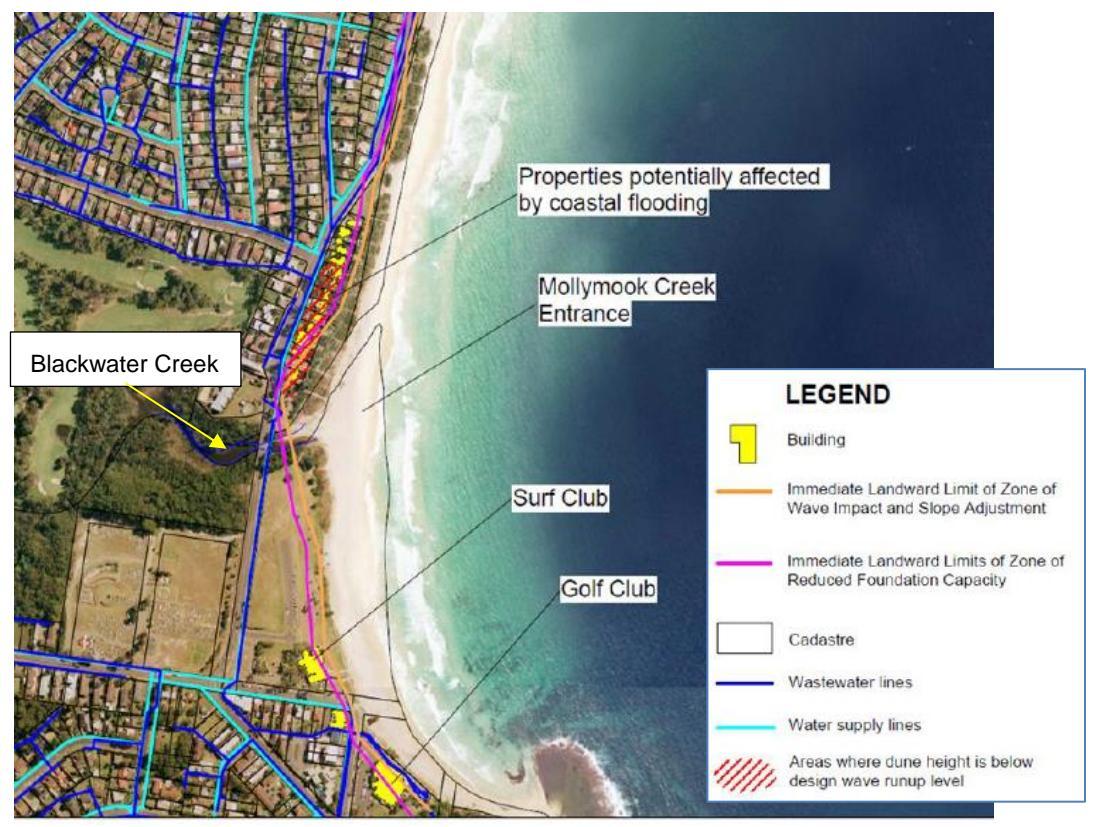
Figure 1 – Previous coastal hazard mapping for immediate timeframe area north of Blackwater Creek (SMEC 2011)

Prior to the most recently adopted coastal hazard mapping being completed for Mollymook and prior to the dune enhancement works undertaken in April 2016, the coastal hazard assessment identified that the area immediately north of Blackwater Creek was subject to coastal erosion and inundation risk, as indicated in Figure 1.

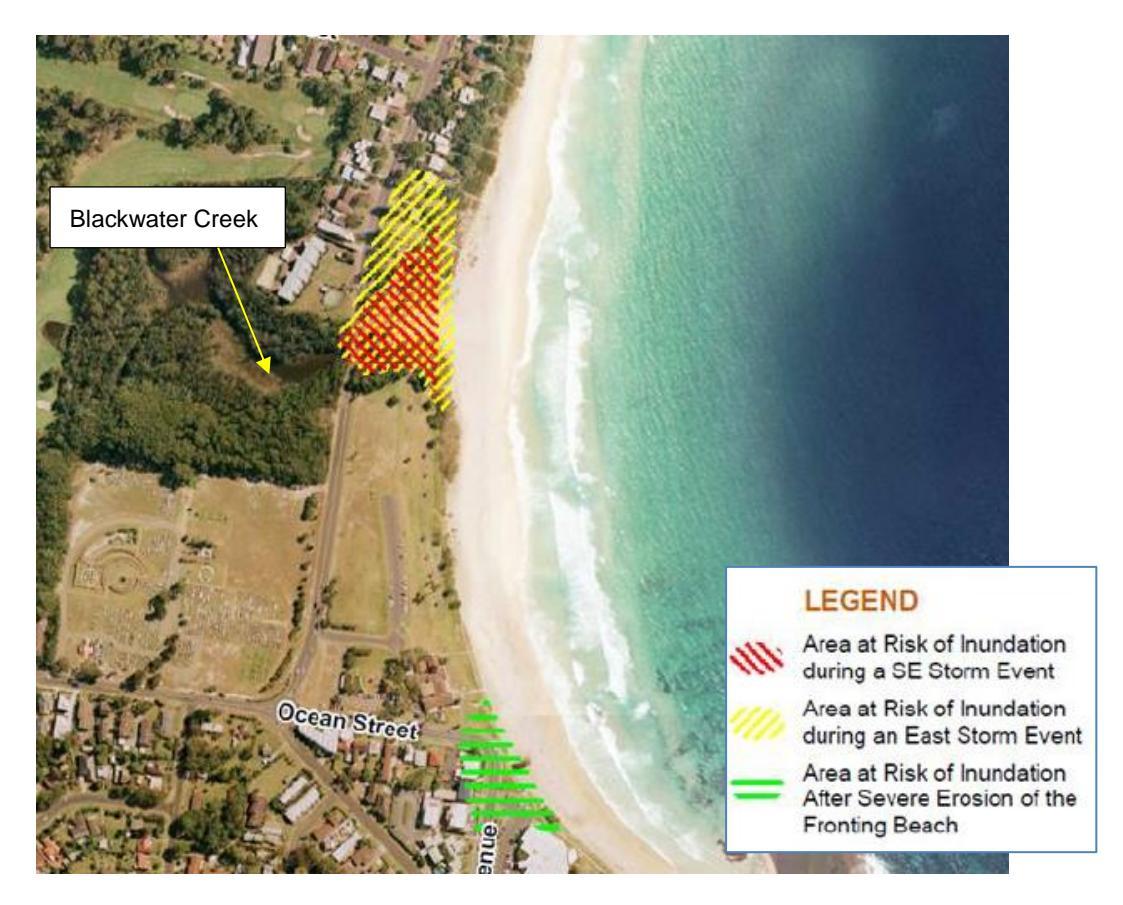
Figure 2 – Area subject to coastal inundation north of Blackwater Creek prior to construction of tripper wall (SMEC 2011)

The dune height in front of the dwellings located directly north of the creek entrance was identified in SMEC 2011 as being low, due to the presence of the creek entrance and lateral movement of the creek entrance along the beach, in particular, the tendency for the creek to break out toward the north. A wave runup assessment of the beach found that the dune would be likely to be overtopped in a design storm event, leading to a risk of inundation to infrastructure. A possible solution for this issue was identified, which was the creation of a geotextile tripper wall along the entrance as illustrated in Figure 3. Such a tripper wall would reduce the impact of the creek flow on the dune and allow a building up of the dune north of the wall. Once protected by the tripper wall, it was suggested that the dune height be reshaped to reach a 6 m height to prevent wave run-up from overtopping the dune, allowing the dune to naturally build up over time. Beach scraping or Nature Assisted Beach Enhancement (NABE) could assist in this process. The dune could then be stabilised by planting vegetation and fenced. The reasoning behind this was to provide better protection to the houses located north of the creek entrance and hazard lines would move seaward as sand store builds up in this area.

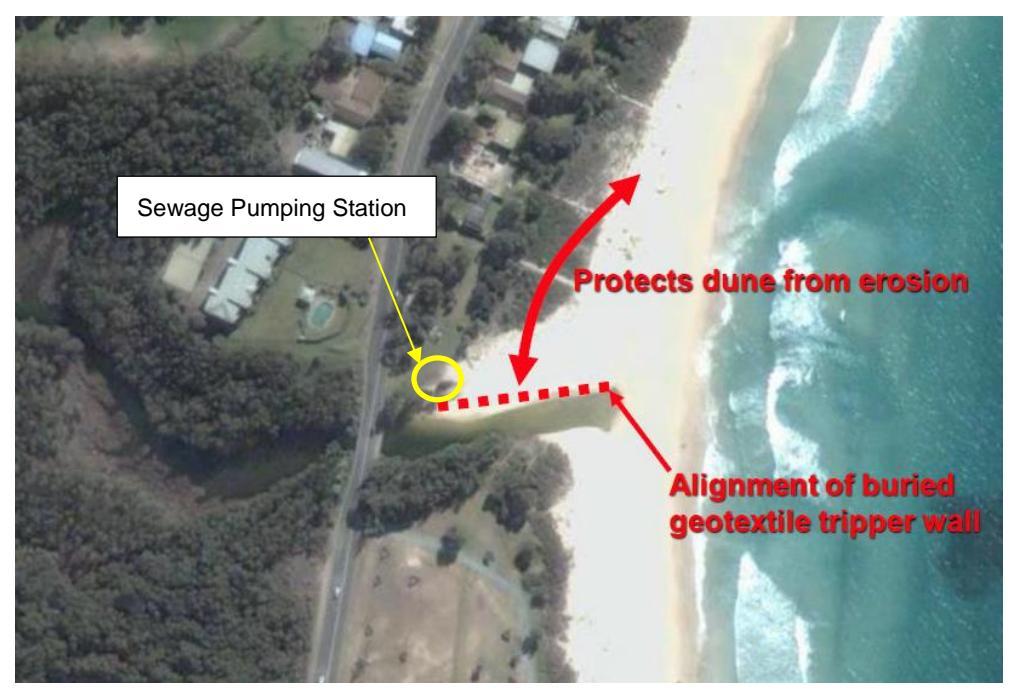
Figure 3 – Suggested alignment for buried tripper wall north of Blackwater Creek showing location of Sewage Pumping Station (SMEC 2011)

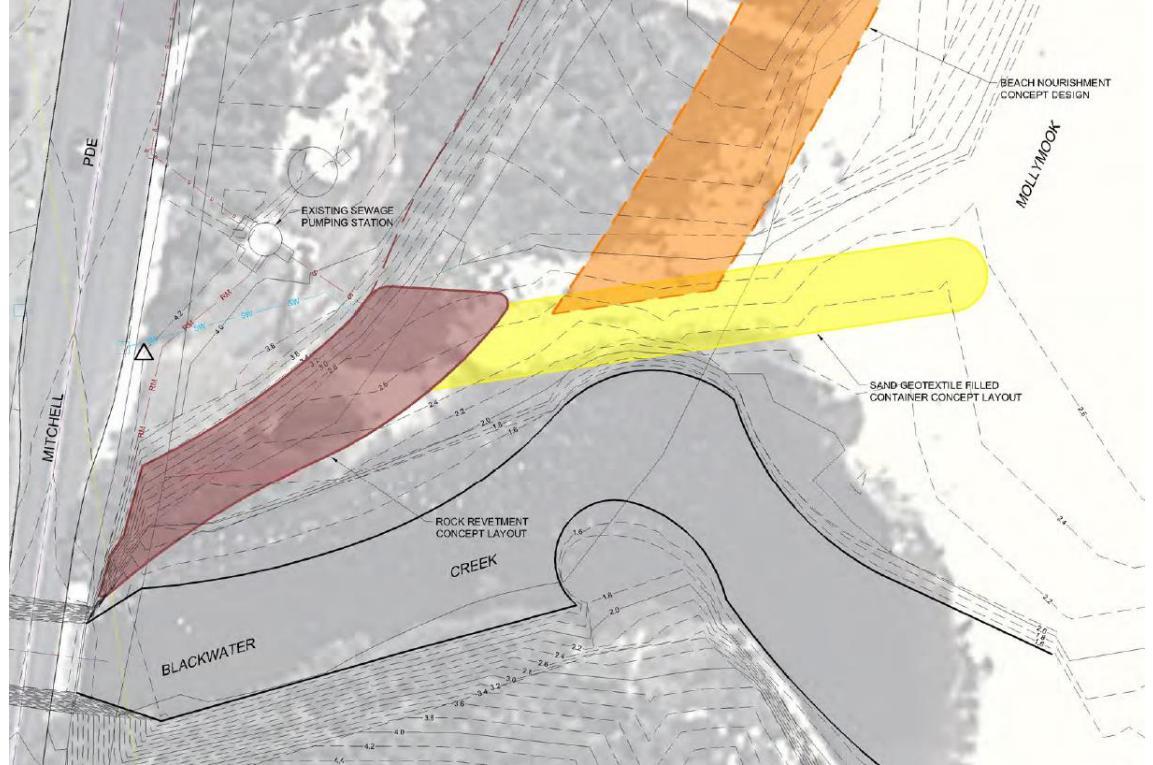
The conceptual layout of the works at Blackwater Creek is illustrated in Figure 4.

Figure 4 – Conceptual layout of works at Blackwater Creek (Haskoning Australia, 2015)

In 2015, Council commissioned a design of an engineered tripper wall structure, similar to what was envisaged in the Draft Coastal Zone Management Plan but with the dual purpose of providing coastal protection to the sewage pumping station. The tripper wall structure comprised a buried revetment along the northern foreshore of the creek fronting the sewage pumping station to provide erosion protection, linked with a buried geotextile container structure designed to reduce the likelihood of Blackwater Creek breaking out toward the north.

The dune enhancement works were commissioned and constructed in April 2016. A total of  $3,680 \text{ m}^3$  of sand was placed at the crest of the dune along the beach for a distance of 280 m north from Blackwater Creek, to achieve a dune crest level of 5.5 m AHD.

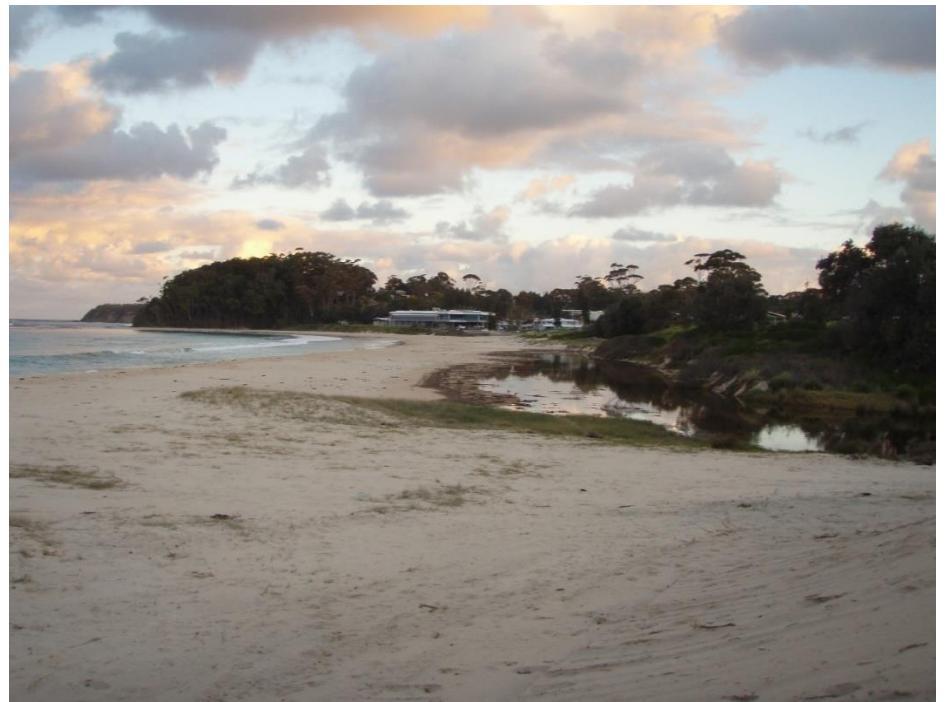
Figure 5 – Photo showing creek breakout along dune toward south

- Breakout of the creek now tends to occur toward the south (Figure 5), with sand available on the beach berm to contribute to natural dune growth on the northern side of the creek entrance
- Overtopping of the dune is now less likely to occur, allowing the dune vegetation to become established, therefore contributing to natural dune-building by modifying the onshore wind field
- The additional sand volume on the beach, both from the placement of beach nourishment sand and natural build-up of the beach berm due to the creek now breaking out toward the south is now directly available to satisfy the storm erosion demand
- The higher dune has reduced the extent of wave runup along this section of the beach.

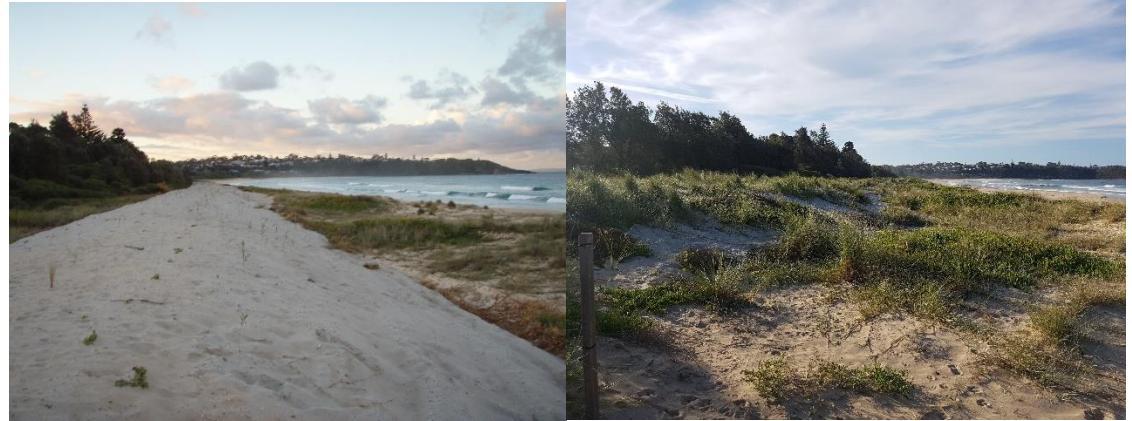
Figure 6 – Left – Enhanced dune, 30 May 2016. Right – Enhanced Dune, 17 May 2018

Comparison of the works immediately following construction (but prior to the 2016 East Coast Low) is provided in Figure 6. This comparison shows that the dune vegetation has become well established and visually, the area of the works is indistinguishable from the surrounding natural foredune.

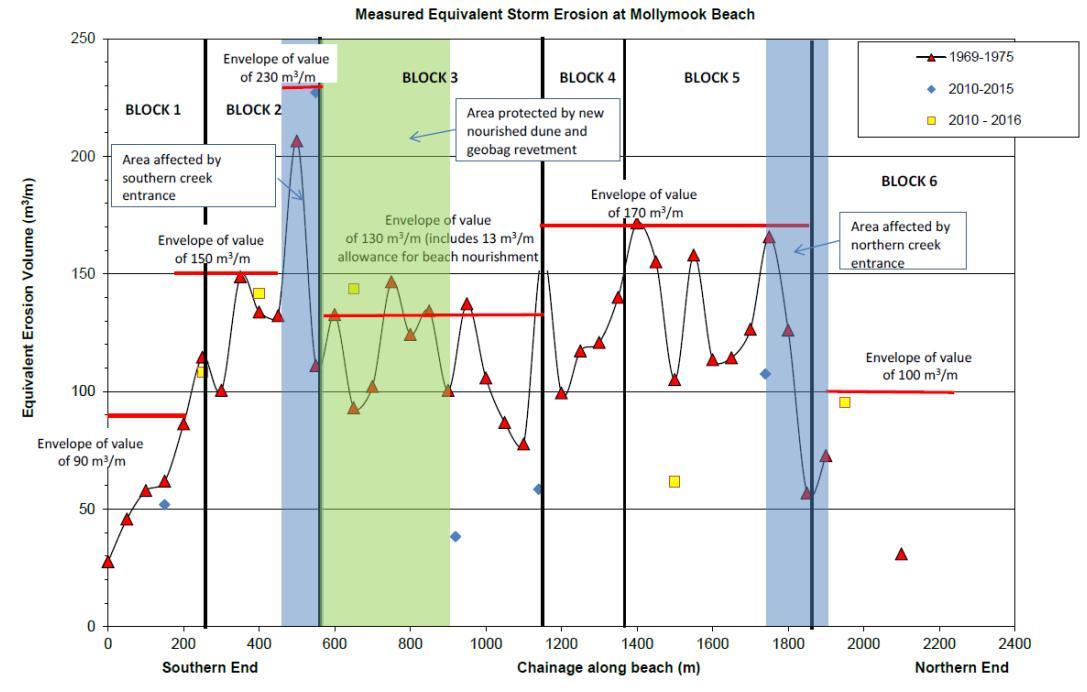
Figure 7 – Storm erosion demand assessment for Mollymook (Advisian 2016). Note the assessment of storm erosion demand from the 2016 East Coast Low event (comparison between 2010 and 2016 photogrammetry) and the estuary entrance instability erosion demand measured in the 1974 storm event (comparison between 1969 and 1975 photogrammetry).

The east-northeast approach direction of the June 2016 East Coast Low made that event particularly significant for the southern ends of the open-coast beaches, and for the section of Mollymook Beach near Blackwater Creek, due to the approach direction, that storm event appears to have led to a similar volume of storm erosion when compared with the May-June 1974 storm event (Figure 7).

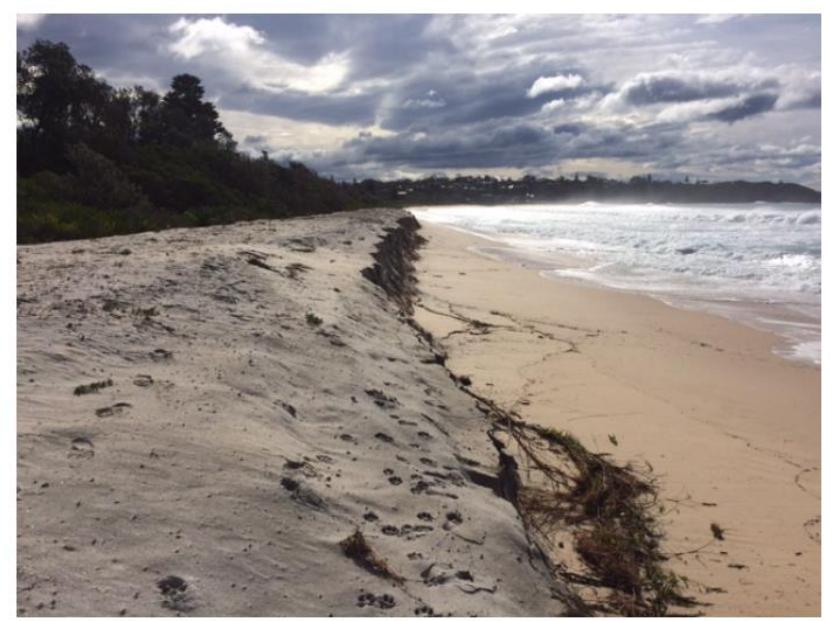
Figure 8 – Photo of enhanced dune damaged by East Coast Low, 7 June 2016

The dune suffered minor damage due to the storm, as indicated in Figure 8. Shoalhaven Council undertook an assessment of the performance of the works immediately following the storm and provided the following observations:

- The original beachfront was substantially washed out leaving a cutting up to the foredune of 1-1.5 metres.
- The new dune works have remained mostly intact with some damage to the front of the new dune along the northern half. Areas at the southern end which had a greater quantity and mix of vegetation on the old foredune have remained intact.

- There is evidence of storm wave action overtopping the dune including beach sand washed in to the scrub behind the dune, erosion caused by water running down the back of the dune in quantity and tide marks on the top surface of the dune.

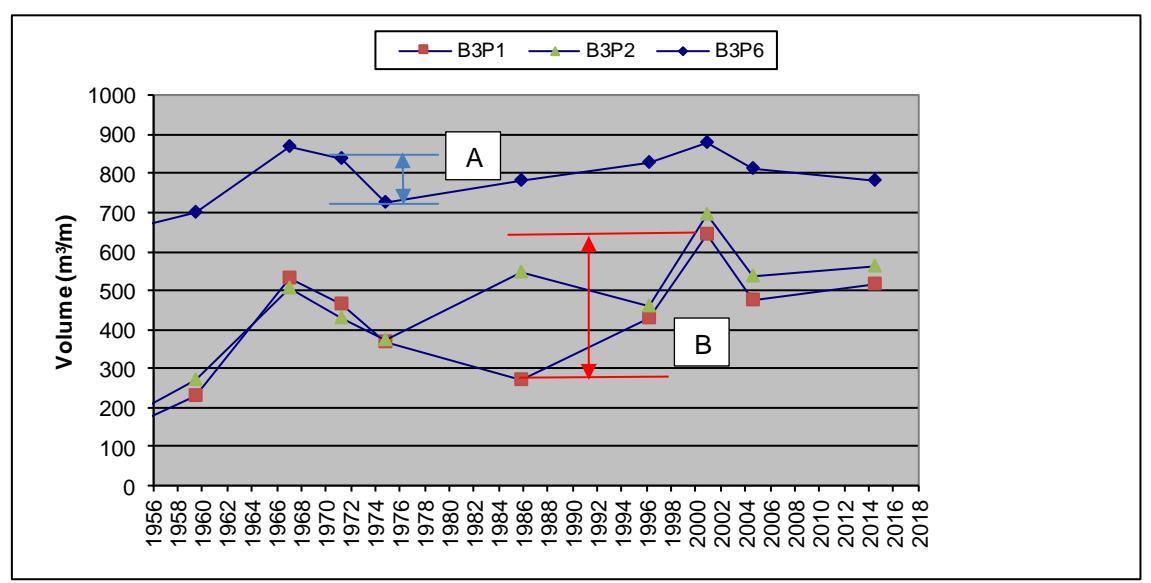
Figure 9 – Beach berm volume fluctuations at Mollymook Beach north of Blackwater Creek. "A" – area outside of direct zone of influence of creek entrance, beach berm volume change ~150 m<sup>3</sup>/m from 1971 to 1975, indicative of storm erosion demand from May-June 1974 storm erosion event. "B" – area immediately north of creek entrance, beach berm volume fluctuations 200 – 300 m<sup>3</sup>/m, indicative of estuary entrance instability hazard.

Advisian (2016) and SMEC (2006) found that at Blackwater Creek entrance, there were very large fluctuations in sub-aerial beach volumes which corresponded with fluctuations in the state of the estuary entrance. While the area north of the creek that was outside the zone of direct influence of the creek dynamics was found to be subject to a storm erosion demand of 170 m<sup>3</sup>/m, the fluctuation in sand volume of the entrance area depending on the direction of the breakout of the creek was found to be much higher than this. The historical volume fluctuation of the beach profile at the entrance to Blackwater Creek is shown in Figure 9, with this fluctuation being highest closer to the creek entrance and not necessarily correlated with the occurrence of a coastal erosion event.

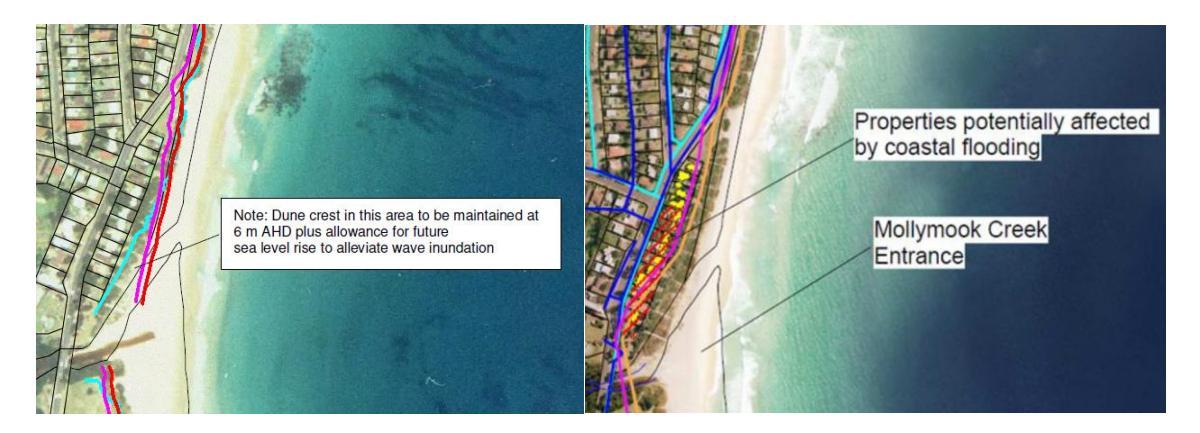
# Figure 10 – Left – 2016 Coastal Hazard Assessment, immediate timeframe (Advisian 2016). Right – 2011 SMEC Coastal Hazard Assessment, immediate timeframe.

A revised coastal hazard assessment has been carried out using the waterRIDE<sup>TM</sup> Coastal Toolkit described in Adamantidis *et al.* (2014) and adopting the revised storm erosion demand values and base profiles described above. A comparison of the immediate coastal hazard under a 1% AEP coastal storm event prior to and following the implementation of the works is provided in Figure 10. This shows that the coastal hazard for the lots in the area north of the creek entrance has been completely eliminated as a result of the works.
